Profile/Photo Observation Report

Date:	03/29/2018	Weather:		Coding:	PACP 6.0
Pipe Length (ft):	193.1	Owner:	NA	Pre Clean:	No Pre-Cleaning
P.O.#:		Surveyor:	Jen Costello	PSR:	P-507-022-021
Customer:		Clean Date:	01/01/1900	Shape:	C

Street:	OFF CSOKASY LN	Flow Control:	Not Controlled
City:	Hobart, IN	Year Renewed:	
Location:	Yard	Tape/Media #:	
Purpose:	Routine Assessment	Dia/Height:	8"
Use:	Sanitary	Material:	VCP
Drain Area:	NA	Lining:	
Category:	NA		
Comment:	Flow direction wrong

Location Details:		Direction of Survey:	Upstream
US MH:	M-507-021	DS MH:	M-507-022
		Total Length Surveyed (ft):	185.7

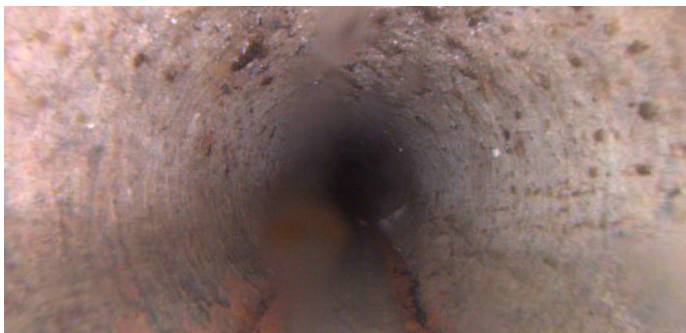
Code: **AMH**
Description: **Manhole**

Distance (ft): **.0**
Structural Grade: **0**
O&M Grade: **0**
Clock Start/From:
Clock To:
1st Value:
2nd Value:
Value Percent:
Continuous Index:
Within 8" of Joint: **NO**
Remarks: **M-507-022**

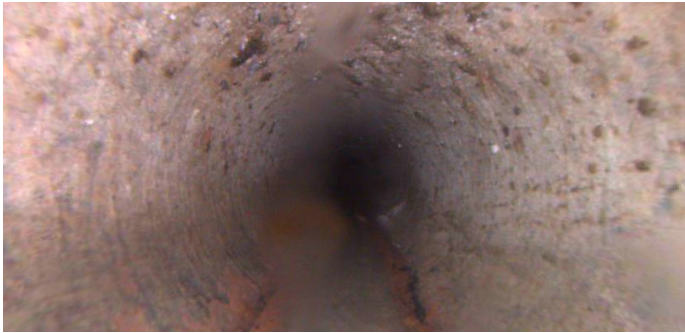
Code:	MWL
Description:	Water Level

Distance (ft):	.0
Structural Grade:	0
O&M Grade:	0
Clock Start/From:	
Clock To:	
1st Value:	
2nd Value:	
Value Percent:	5.000
Continuous Index:	
Within 8" of Joint:	NO
Remarks:

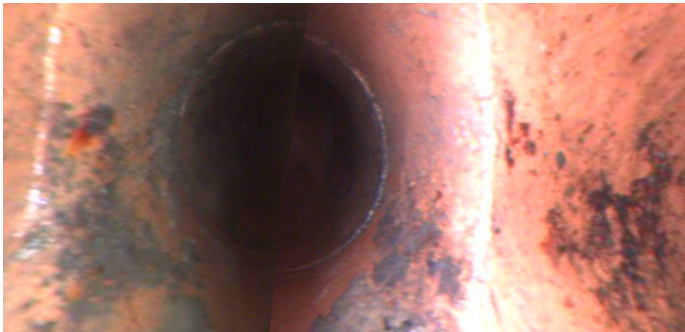
Code: **TF**
Description: **Tap Factory**

Distance (ft): **68.1**
Structural Grade: **0**
O&M Grade: **0**
Clock Start/From: **9**
Clock To:
1st Value: **4.000**
2nd Value:
Value Percent:
Continuous Index:
Within 8" of Joint:
Remarks:

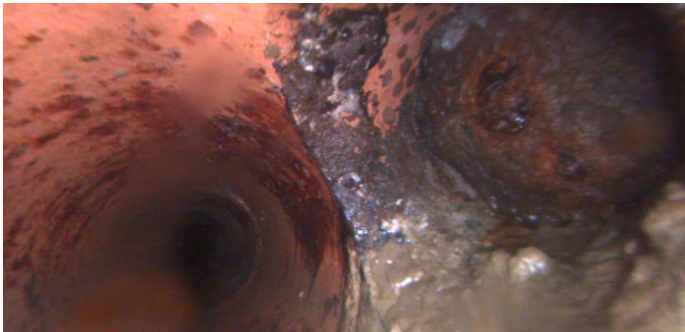
Code: **TFC**
Description: **Tap Factory Capped**

Distance (ft): **79.8**
Structural Grade: **0**
O&M Grade: **0**
Clock Start/From: **2**
Clock To:
1st Value: **4.000**
2nd Value:
Value Percent:
Continuous Index:
Within 8" of Joint:
Remarks:

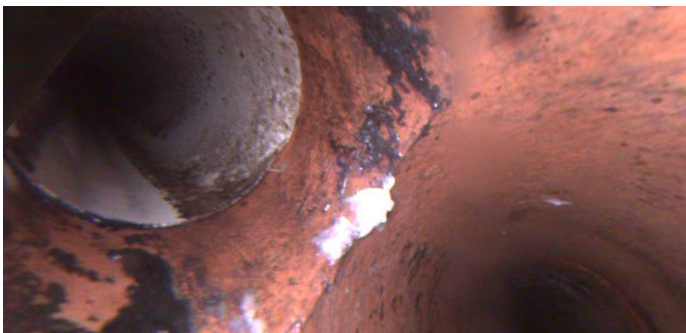
Code: **TF**
Description: **Tap Factory**

Distance (ft): **138.4**
Structural Grade: **0**
O&M Grade: **0**
Clock Start/From: **10**
Clock To:
1st Value: **4.000**
2nd Value:
Value Percent:
Continuous Index:
Within 8" of Joint:
Remarks:

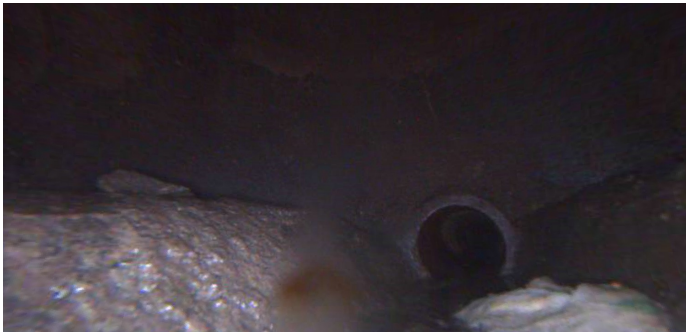
Code: **AMH**
Description: **Manhole**

Distance (ft): **185.7**
Structural Grade: **0**
O&M Grade: **0**
Clock Start/From:
Clock To:
1st Value:
2nd Value:
Value Percent:
Continuous Index:
Within 8" of Joint: **NO**
Remarks: **M-507-021**
