Profile/Photo Observation Report

Date:	01/30/2025	Weather:		Coding:	PACP 7.0
Pipe Length (ft):	216.0	Owner:	City of Hobart	Pre Clean:	Heavy Cleaning
P.O.#:	YES502259	Surveyor:	S. Bucklin	PSR:	P-507-027-026
Customer:	City of Hobart	Clean Date:	10/08/2024	Shape:	C

Street:	S. DeKalb St.	Flow Control:	Not Controlled
City:	Hobart, IN	Year Renewed:	
Location:	Easement/Right of Way	Tape/Media #:	
Purpose:	Sewer System Evaluation Survey (SS	Dia/Height:	12"
Use:	Sanitary Sewage Pipe	Material:	VCP
Drain Area:		Lining:	None
Category:	NA		
Comment:

Location Details:		Direction of Survey:	Downstream
US MH:	M-507-027	DS MH:	M-507-026
		Total Length Surveyed (ft):	215.5

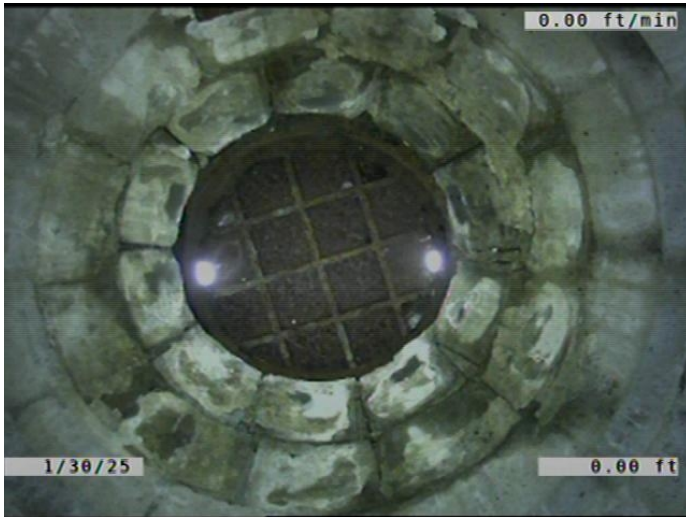
Code: **AMH**
Description: **Manhole**

Distance (ft): **.0**
Structural Grade: **0**
O&M Grade: **0**
Clock Start/From:
Clock To:
1st Value:
2nd Value:
Value Percent:
Continuous Index:
Within 8" of Joint: **NO**
Remarks: **M-507-027**

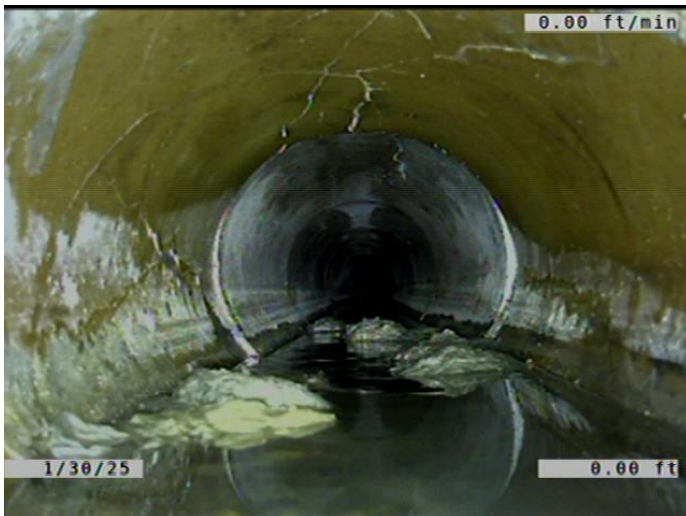
Code: **MWL**
Description: **Miscellaneous Water Level**

Distance (ft): **.0**
Structural Grade: **0**
O&M Grade: **0**
Clock Start/From:
Clock To:
1st Value:
2nd Value:
Value Percent: **15.000**
Continuous Index:
Within 8" of Joint: **NO**
Remarks:

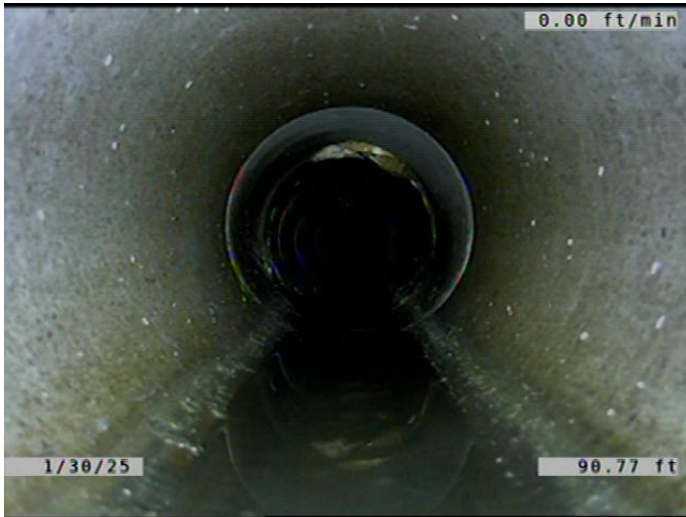
Code: **MWL**
 Description: **Miscellaneous Water Level**

Distance (ft): **90.8**
 Structural Grade: **0**
 O&M Grade: **0**
 Clock Start/From:
 Clock To:
 1st Value:
 2nd Value:
 Value Percent: **5.000**
 Continuous Index:
 Within 8" of Joint: **NO**
 Remarks:

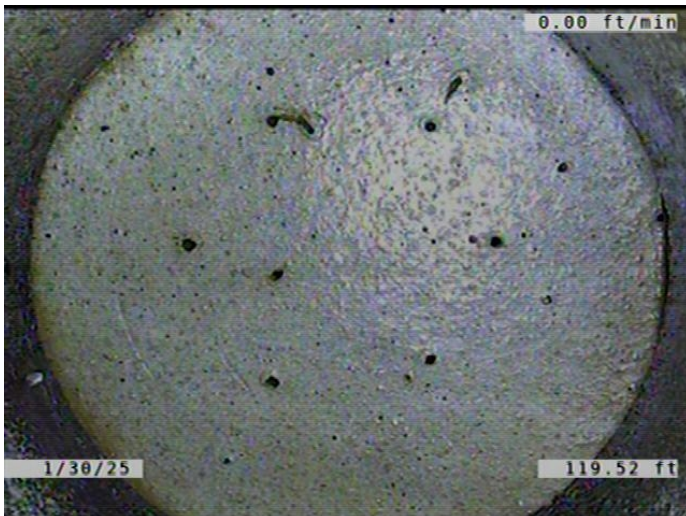
Code: **TFC**
Description: **Tap Factory Capped**

Distance (ft): **119.5**
Structural Grade: **0**
O&M Grade: **0**
Clock Start/From: **2**
Clock To:
1st Value: **6.000**
2nd Value:
Value Percent:
Continuous Index:
Within 8" of Joint: **YES**
Remarks:

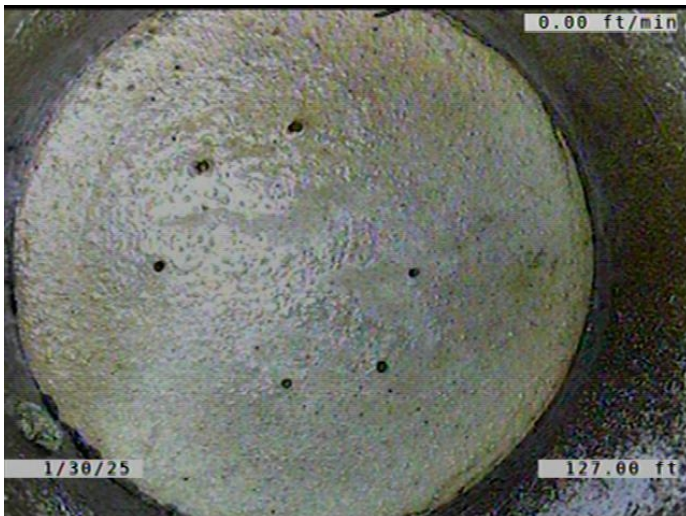
Code: **TFC**
Description: **Tap Factory Capped**

Distance (ft): **127.0**
Structural Grade: **0**
O&M Grade: **0**
Clock Start/From: **11**
Clock To:
1st Value: **6.000**
2nd Value:
Value Percent:
Continuous Index:
Within 8" of Joint: **YES**
Remarks:

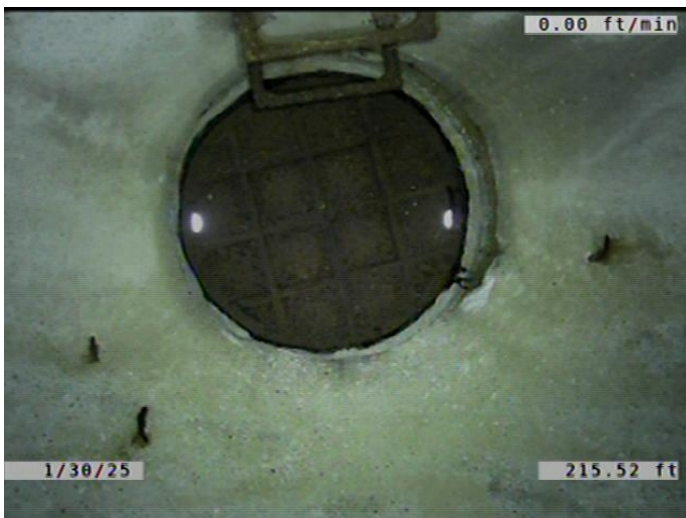
Code: **AMH**
Description: **Manhole**

Distance (ft): **215.5**
Structural Grade: **0**
O&M Grade: **0**
Clock Start/From:
Clock To:
1st Value:
2nd Value:
Value Percent:
Continuous Index:
Within 8" of Joint: **NO**
Remarks: **M-507-026**
