Profile/Photo Observation Report

Date:	12/11/2024	Weather:		Coding:	PACP 7.0
Pipe Length (ft):	196.0	Owner:	City of Hobart	Pre Clean:	Heavy Cleaning
P.O.#:	YES502259	Surveyor:	S. Bucklin	PSR:	P-507-028-027
Customer:	City of Hobart	Clean Date:	09/27/2024	Shape:	C

Street:	South Dekalb Street	Flow Control:	Not Controlled
City:	Hobart, IN	Year Renewed:	
Location:	Local rural streets with light traffic, t	Tape/Media #:	
Purpose:	Sewer System Evaluation Survey (SS	Dia/Height:	10"
Use:	Sanitary Sewage Pipe	Material:	VCP
Drain Area:		Lining:	None
Category:	NA		
Comment:			
Location Details:		Direction of Survey:	Downstream
US MH:	M-507-028	DS MH:	M-507-027
		Total Length Surveyed (ft):	191.9

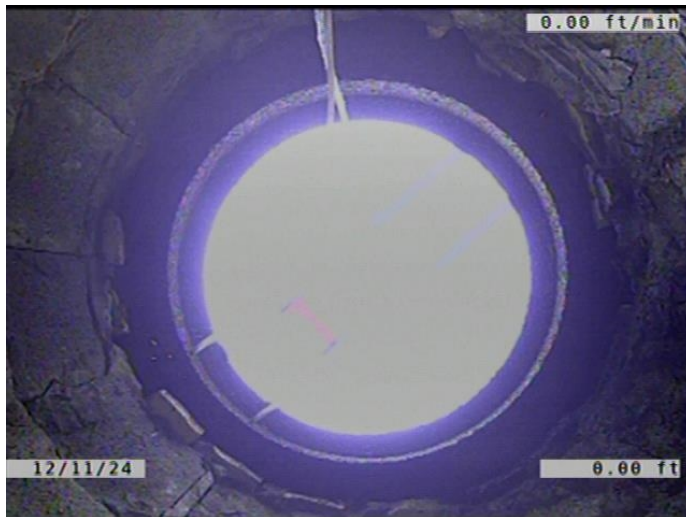
Code: **AMH**
Description: **Manhole**

Distance (ft): **.0**
Structural Grade: **0**
O&M Grade: **0**
Clock Start/From:
Clock To:
1st Value:
2nd Value:
Value Percent:
Continuous Index:
Within 8" of Joint: **NO**
Remarks: **M-507-028**

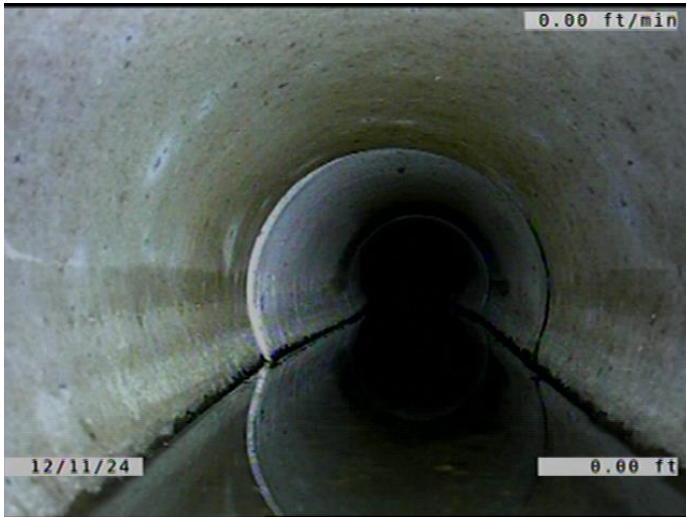
Code: **MWL**
Description: **Miscellaneous Water Level**

Distance (ft): **.0**
Structural Grade: **0**
O&M Grade: **0**
Clock Start/From:
Clock To:
1st Value:
2nd Value:
Value Percent: **10.000**
Continuous Index:
Within 8" of Joint: **NO**
Remarks:

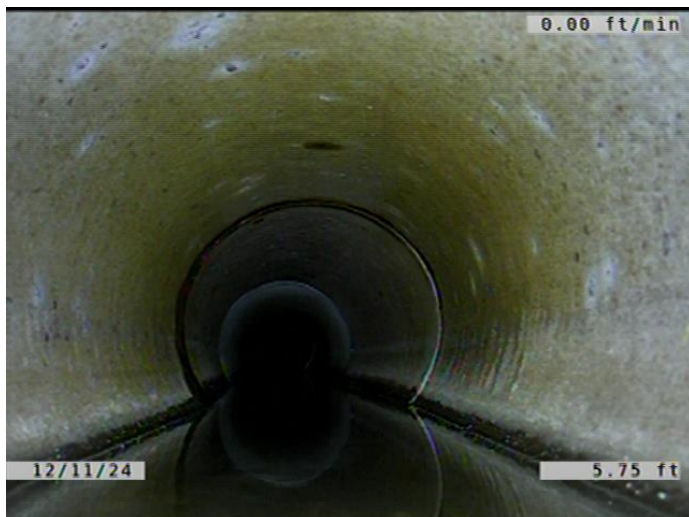
Code: **LL**
 Description: **Line Left**

Distance (ft): **5.7**
 Structural Grade: **0**
 O&M Grade: **1**
 Clock Start/From:
 Clock To:
 1st Value:
 2nd Value:
 Value Percent: **5.000**
 Continuous Index:
 Within 8" of Joint: **NO**
 Remarks:

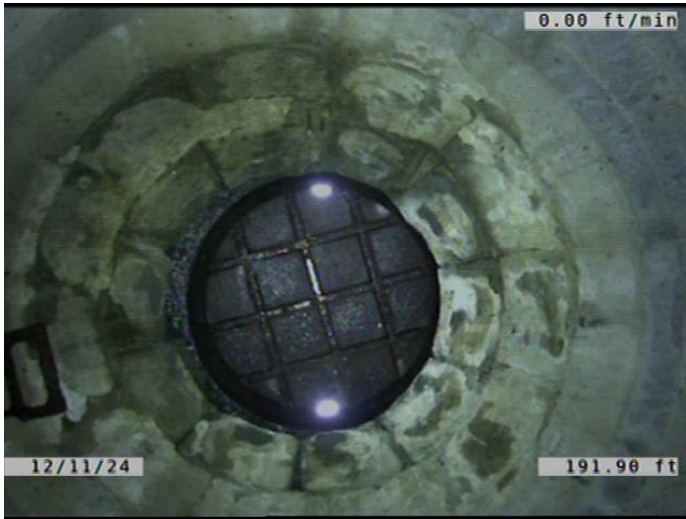
Code:	AMH
Description:	Manhole
Distance (ft):	191.9
Structural Grade:	0
O&M Grade:	0
Clock Start/From:	
Clock To:	
1st Value:	
2nd Value:	
Value Percent:	
Continuous Index:	
Within 8" of Joint:	NO
Remarks:	M-507-027
