Profile/Photo Observation Report

| Street: | OFF CSOKASY LN | Flow Control: | Not Controlled |
| City: | Hobart, IN | Year Renewed: | |
| US MH: | M-507-029 | DS MH: | M-507-030 |

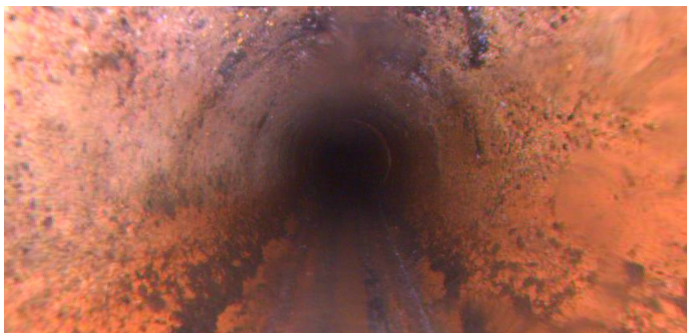
Code: **AMH**
Description: **Manhole**

Distance (ft): **.0**
Structural Grade: **0**
O&M Grade: **0**
Clock Start/From:
Clock To:
1st Value:
2nd Value:
Value Percent:
Continuous Index:
Within 8" of Joint: **NO**
Remarks: **M-507-030**

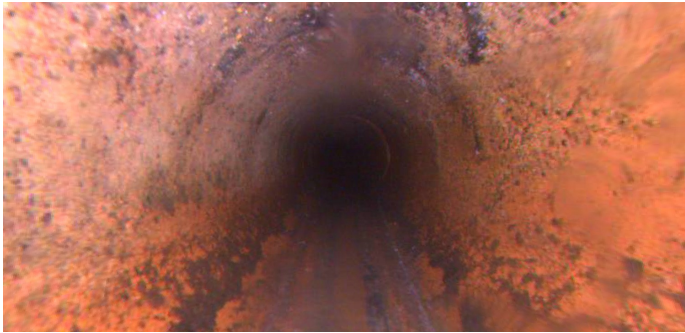
| Code: | MWL |
| Description: | Water Level |

| Distance (ft): | .0 |
| Value Percent: | 5.000 |

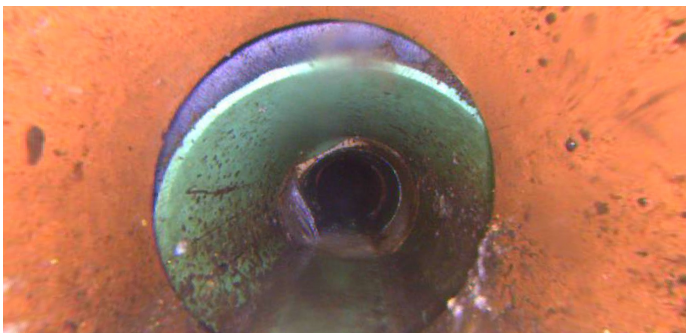
Code: **MMC**
Description: **Material Change**

Distance (ft): **88.4**
Structural Grade: **0**
O&M Grade: **0**
Clock Start/From:
Clock To:
1st Value:
2nd Value:
Value Percent:
Continuous Index:
Within 8" of Joint: **NO**
Remarks: **PVC**

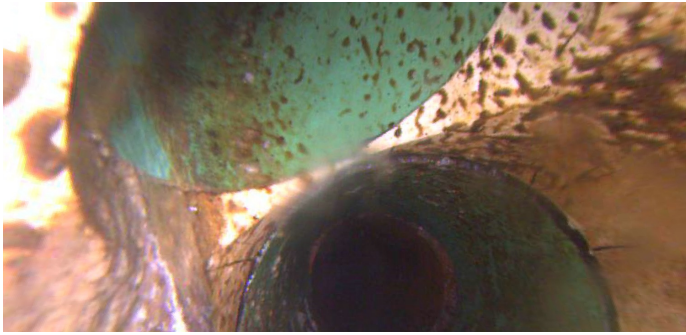
Code: **TFA**
Description: **Tap Factory Active**

Distance (ft): **89.7**
Structural Grade: **0**
O&M Grade: **0**
Clock Start/From: **11**
Clock To:
1st Value: **4.000**
2nd Value:
Value Percent:
Continuous Index:
Within 8" of Joint:
Remarks:

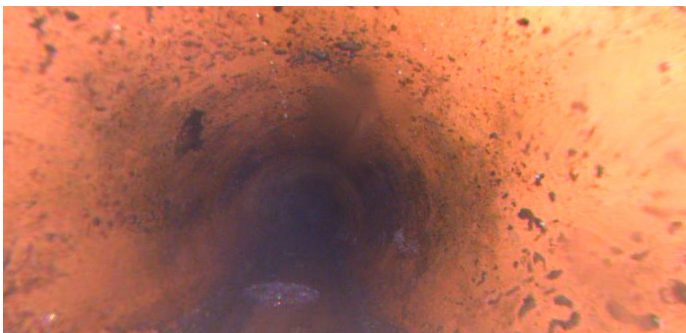
Code: **MMC**
Description: **Material Change**

Distance (ft): **91.1**
Structural Grade: **0**
O&M Grade: **0**
Clock Start/From:
Clock To:
1st Value:
2nd Value:
Value Percent:
Continuous Index:
Within 8" of Joint: **NO**
Remarks: **vcp**

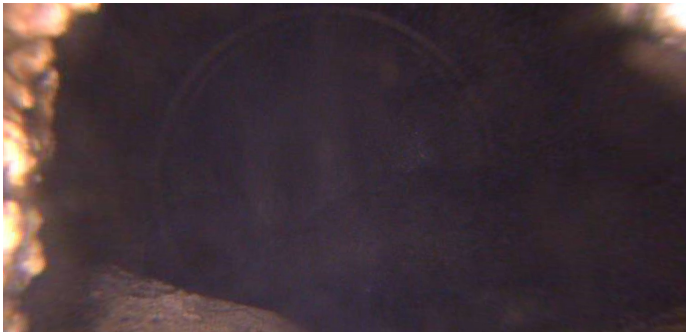
Code: **AMH**
Description: **Manhole**

Distance (ft): **157.1**
Structural Grade: **0**
O&M Grade: **0**
Clock Start/From:
Clock To:
1st Value:
2nd Value:
Value Percent:
Continuous Index:
Within 8" of Joint: **NO**
Remarks: **M-507-029**
