Profile/Photo Observation Report

Date:	01/16/2025	Weather:		Coding:	PACP 7.0
Pipe Length (ft):	420.0	Owner:	City of Hobart	Pre Clean:	Heavy Cleaning
P.O.#:	YES502259	Surveyor:	S. Bucklin	PSR:	P-507-044-043
Customer:	City of Hobart	Clean Date:	12/05/2024	Shape:	C

Street:	South Delaware Street	Flow Control:	Not Controlled
City:	Hobart, IN	Year Renewed:	
Location:	Local rural streets with light traffic, t	Tape/Media #:	
Purpose:	Sewer System Evaluation Survey (SS	Dia/Height:	15"
Use:	Sanitary Sewage Pipe	Material:	PVC
Drain Area:		Lining:	None
Category:	NA		
Comment:			
Location Details:		Direction of Survey:	Downstream
US MH:	M-507-044	DS MH:	M-507-043
		Total Length Surveyed (ft):	135.2

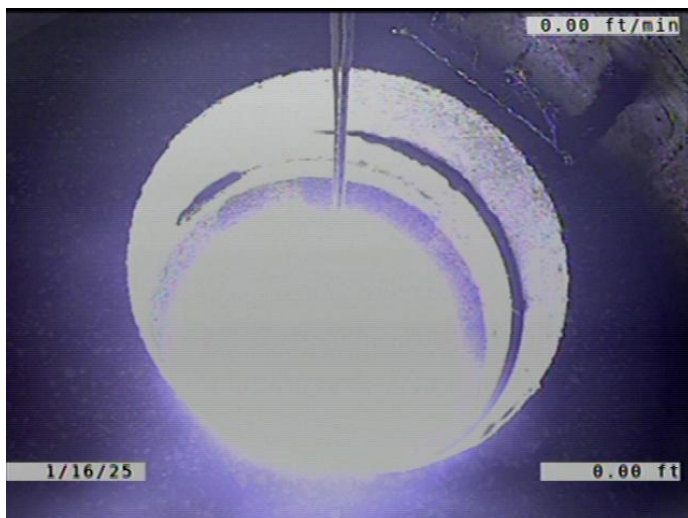
Code: **AMH**
Description: **Manhole**

Distance (ft): **.0**
Structural Grade: **0**
O&M Grade: **0**
Clock Start/From:
Clock To:
1st Value:
2nd Value:
Value Percent:
Continuous Index:
Within 8" of Joint: **NO**
Remarks: **M-507-044**
