Profile/Photo Observation Report

Date:	03/26/2018	Weather:		Coding:	PACP 6.0
Pipe Length (ft):	332.7	Owner:	NA	Pre Clean:	No Pre-Cleaning
P.O.#:		Surveyor:	Justin Gonzales	PSR:	P-507-061-062
Customer:		Clean Date:	01/01/1900	Shape:	C

Street:	W 13TH PL	Flow Control:	Not Controlled
City:	Hobart, IN	Year Renewed:	
Location:	Light Highway	Tape/Media #:	
Purpose:	Routine Assessment	Dia/Height:	8"
Use:	Sanitary	Material:	PVC
Drain Area:	NA	Lining:	
Category:	NA		
Comment:	P_C at 326 ft debris . Flow direction wrong		
Location Details:		Direction of Survey:	Downstream
US MH:	M-507-062	DS MH:	M-507-061
		Total Length Surveyed (ft):	327.7

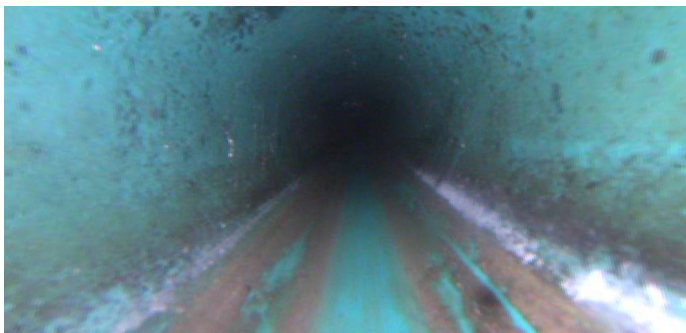
Code: **AMH**
Description: **Manhole**

Distance (ft): **.0**
Structural Grade: **0**
O&M Grade: **0**
Clock Start/From:
Clock To:
1st Value:
2nd Value:
Value Percent:
Continuous Index:
Within 8" of Joint: **NO**
Remarks: **M-507-062**

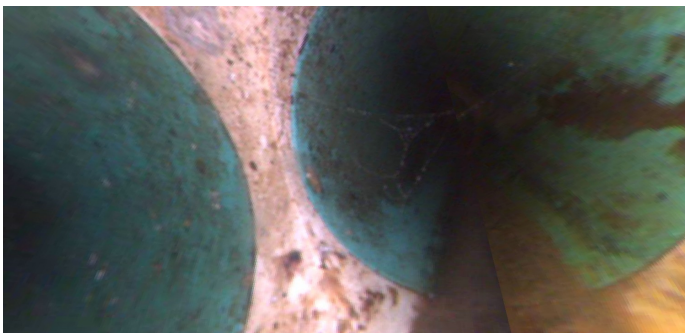
Code: **TF**
Description: **Tap Factory**

Distance (ft): **13.8**
Structural Grade: **0**
O&M Grade: **0**
Clock Start/From: **2**
Clock To:
1st Value: **4.000**
2nd Value:
Value Percent:
Continuous Index:
Within 8" of Joint:
Remarks:

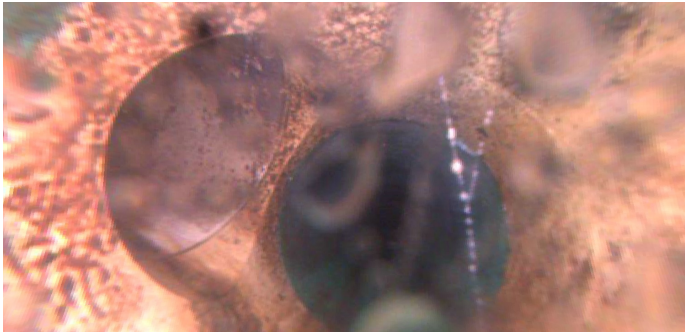
Code: **TF**
Description: **Tap Factory**

Distance (ft): **57.6**
Structural Grade: **0**
O&M Grade: **0**
Clock Start/From: **9**
Clock To:
1st Value: **4.000**
2nd Value:
Value Percent:
Continuous Index:
Within 8" of Joint:
Remarks:

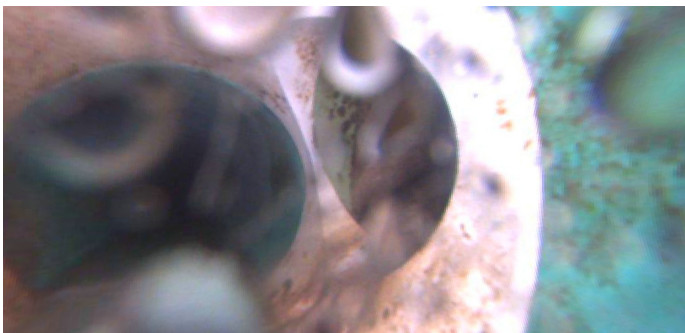
Code: **TF**
Description: **Tap Factory**

Distance (ft): **63.2**
Structural Grade: **0**
O&M Grade: **0**
Clock Start/From: **3**
Clock To:
1st Value: **4.000**
2nd Value:
Value Percent:
Continuous Index:
Within 8" of Joint:
Remarks:

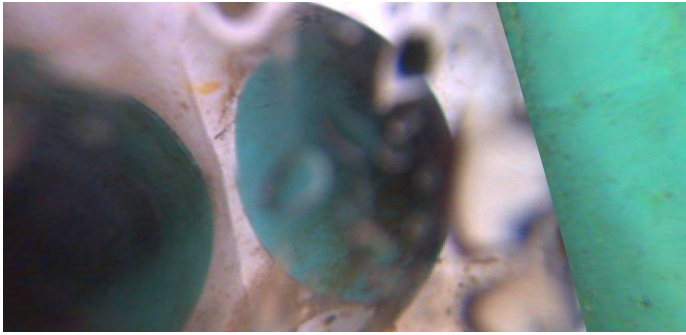
Code: **TF**
Description: **Tap Factory**

Distance (ft): **121.4**
Structural Grade: **0**
O&M Grade: **0**
Clock Start/From: **2**
Clock To:
1st Value: **4.000**
2nd Value:
Value Percent:
Continuous Index:
Within 8" of Joint:
Remarks:

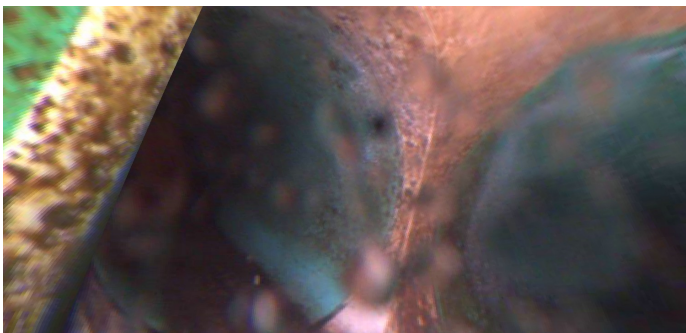
Code: **TF**
Description: **Tap Factory**

Distance (ft): **158.5**
Structural Grade: **0**
O&M Grade: **0**
Clock Start/From: **10**
Clock To:
1st Value: **4.000**
2nd Value:
Value Percent:
Continuous Index:
Within 8" of Joint:
Remarks:

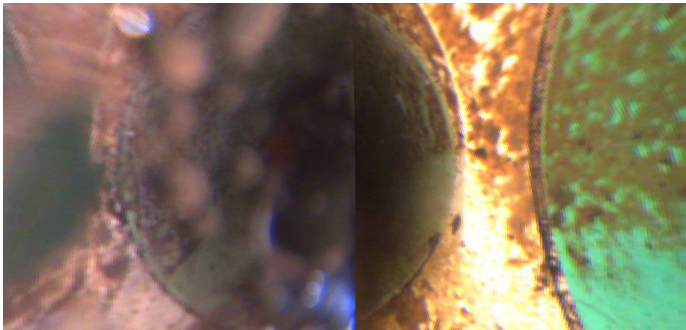
Code: **TF**
Description: **Tap Factory**

Distance (ft): **226.3**
Structural Grade: **0**
O&M Grade: **0**
Clock Start/From: **2**
Clock To:
1st Value: **4.000**
2nd Value:
Value Percent:
Continuous Index:
Within 8" of Joint:
Remarks:

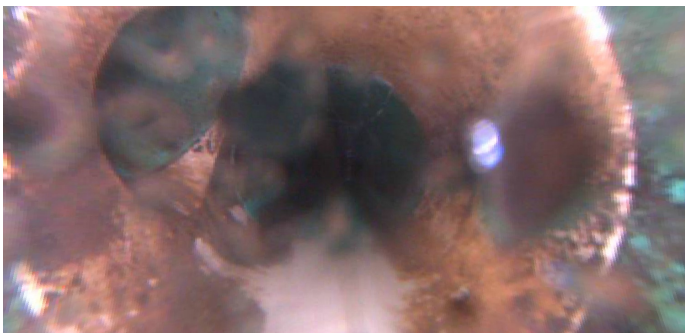
Code: **TF**
Description: **Tap Factory**

Distance (ft): **263.4**
Structural Grade: **0**
O&M Grade: **0**
Clock Start/From: **10**
Clock To:
1st Value: **4.000**
2nd Value:
Value Percent:
Continuous Index:
Within 8" of Joint:
Remarks:

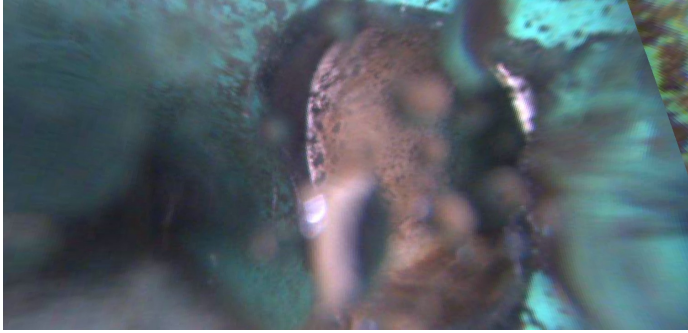
Code: **TF**
Description: **Tap Factory**

Distance (ft): **281.9**
Structural Grade: **0**
O&M Grade: **0**
Clock Start/From: **3**
Clock To:
1st Value: **4.000**
2nd Value:
Value Percent:
Continuous Index:
Within 8" of Joint:
Remarks:

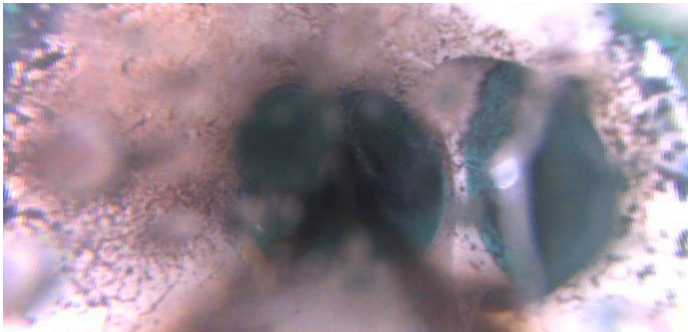
Code: **TF**
Description: **Tap Factory**

Distance (ft): **285.1**
Structural Grade: **0**
O&M Grade: **0**
Clock Start/From: **3**
Clock To:
1st Value: **4.000**
2nd Value:
Value Percent:
Continuous Index:
Within 8" of Joint:
Remarks:

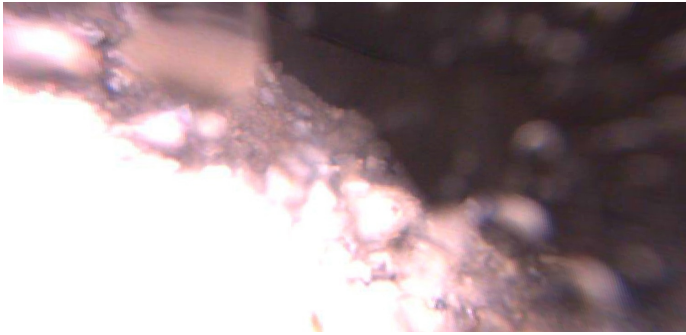
Code: **AMH**
Description: **Manhole**

Distance (ft): **327.7**
Structural Grade: **0**
O&M Grade: **0**
Clock Start/From:
Clock To:
1st Value:
2nd Value:
Value Percent:
Continuous Index:
Within 8" of Joint: **NO**
Remarks: **M-507-061**
