Profile/Photo Observation Report

Date:	03/26/2018	Weather:		Coding:	PACP 6.0
Pipe Length (ft):	332.7	Owner:	NA	Pre Clean:	No Pre-Cleaning
P.O.#:		Surveyor:	Justin Gonzales	PSR:	P-507-061-062
Customer:		Clean Date:	01/01/1900	Shape:	C

Street:	FOXCROFT STREET	Flow Control:	Not Controlled
City:	Hobart, IN	Year Renewed:	
Location:	Light Highway	Tape/Media #:	
Purpose:	Routine Assessment	Dia/Height:	8"
Use:	Sanitary	Material:	PVC
Drain Area:	NA	Lining:	
Category:	NA		
Comment:	P_C at 326 ft debris . Flow direction wrong		
Location Details:		Direction of Survey:	Downstream
US MH:	M-507-062	DS MH:	M-507-061
		Total Length Surveyed (ft):	327.7

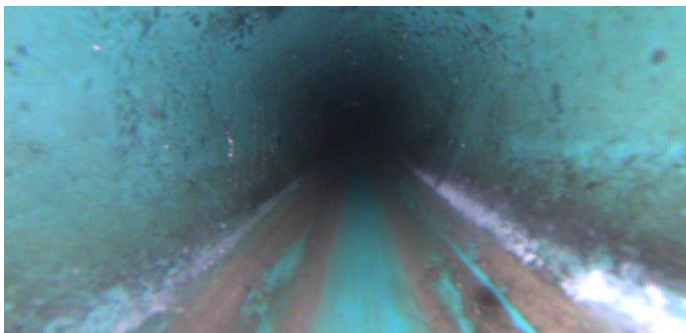
Code: **AMH**
Description: **Manhole**

Distance (ft): **.0**
Structural Grade: **0**
O&M Grade: **0**
Clock Start/From:
Clock To:
1st Value:
2nd Value:
Value Percent:
Continuous Index:
Within 8" of Joint: **NO**
Remarks: **M-507-062**

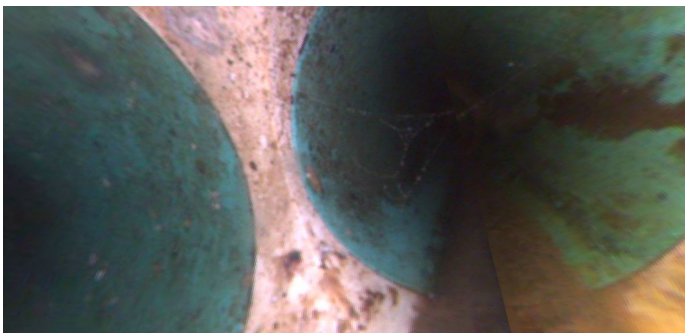
Code: **TF**
Description: **Tap Factory**

Distance (ft): **13.8**
Structural Grade: **0**
O&M Grade: **0**
Clock Start/From: **2**
Clock To:
1st Value: **4.000**
2nd Value:
Value Percent:
Continuous Index:
Within 8" of Joint:
Remarks:

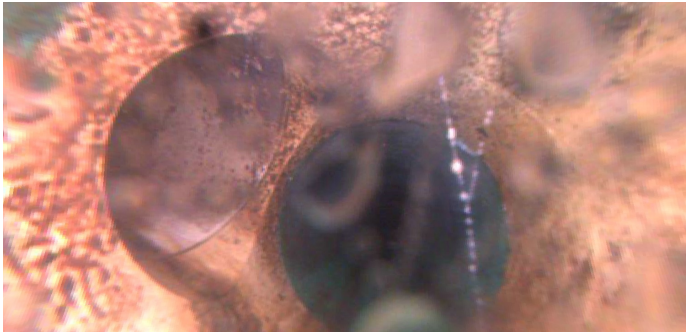
Code: **TF**
Description: **Tap Factory**

Distance (ft): **57.6**
Structural Grade: **0**
O&M Grade: **0**
Clock Start/From: **9**
Clock To:
1st Value: **4.000**
2nd Value:
Value Percent:
Continuous Index:
Within 8" of Joint:
Remarks:

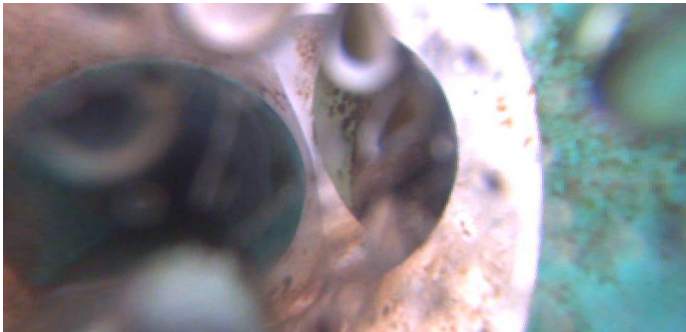
Code: **TF**
Description: **Tap Factory**

Distance (ft): **63.2**
Structural Grade: **0**
O&M Grade: **0**
Clock Start/From: **3**
Clock To:
1st Value: **4.000**
2nd Value:
Value Percent:
Continuous Index:
Within 8" of Joint:
Remarks:

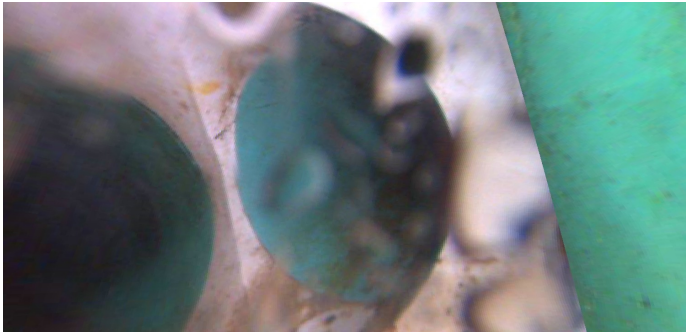
Code: **TF**
Description: **Tap Factory**

Distance (ft): **121.4**
Structural Grade: **0**
O&M Grade: **0**
Clock Start/From: **2**
Clock To:
1st Value: **4.000**
2nd Value:
Value Percent:
Continuous Index:
Within 8" of Joint:
Remarks:

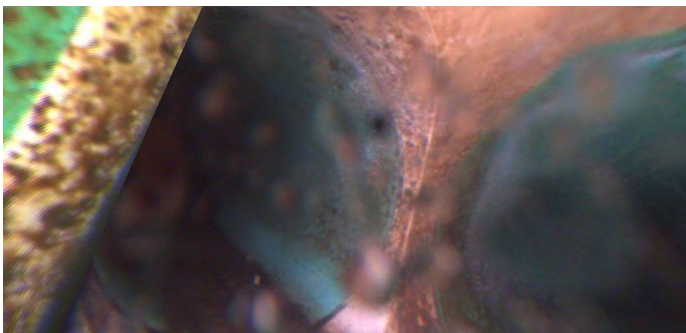
Code: **TF**
Description: **Tap Factory**

Distance (ft): **158.5**
Structural Grade: **0**
O&M Grade: **0**
Clock Start/From: **10**
Clock To:
1st Value: **4.000**
2nd Value:
Value Percent:
Continuous Index:
Within 8" of Joint:
Remarks:

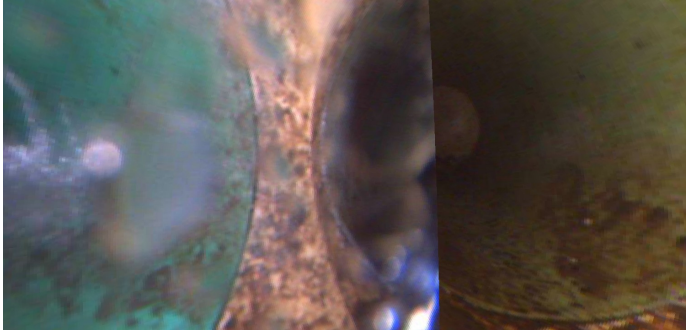
Code: **TFC**
Description: **Tap Factory Capped**

Distance (ft): **174.6**
Structural Grade: **0**
O&M Grade: **0**
Clock Start/From: **2**
Clock To:
1st Value: **4.000**
2nd Value:
Value Percent:
Continuous Index:
Within 8" of Joint:
Remarks:

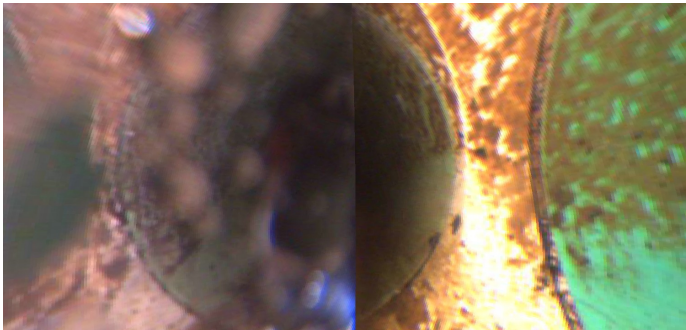
Code: **TF**
Description: **Tap Factory**

Distance (ft): **226.3**
Structural Grade: **0**
O&M Grade: **0**
Clock Start/From: **2**
Clock To:
1st Value: **4.000**
2nd Value:
Value Percent:
Continuous Index:
Within 8" of Joint:
Remarks:

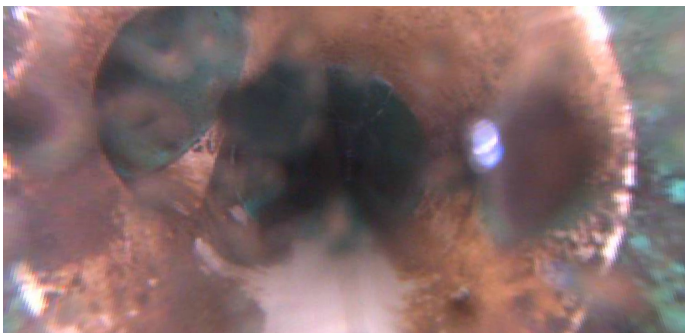
Code: **TF**
Description: **Tap Factory**

Distance (ft): **263.4**
Structural Grade: **0**
O&M Grade: **0**
Clock Start/From: **10**
Clock To:
1st Value: **4.000**
2nd Value:
Value Percent:
Continuous Index:
Within 8" of Joint:
Remarks:

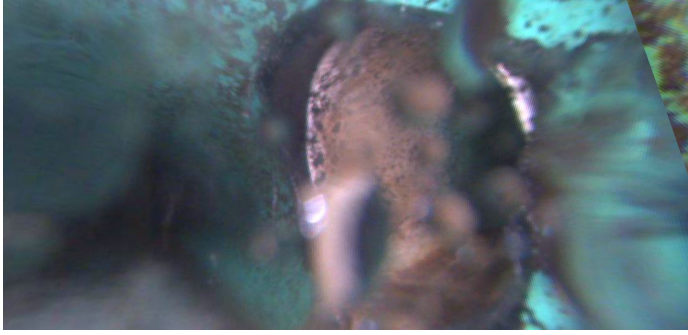
Code: **TF**
Description: **Tap Factory**

Distance (ft): **281.9**
Structural Grade: **0**
O&M Grade: **0**
Clock Start/From: **3**
Clock To:
1st Value: **4.000**
2nd Value:
Value Percent:
Continuous Index:
Within 8" of Joint:
Remarks:

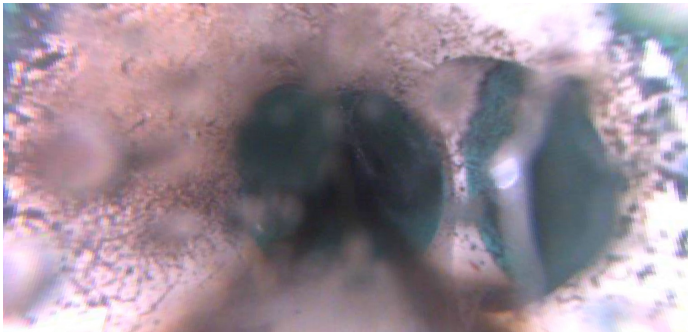
Code: **TF**
Description: **Tap Factory**

Distance (ft): **285.1**
Structural Grade: **0**
O&M Grade: **0**
Clock Start/From: **3**
Clock To:
1st Value: **4.000**
2nd Value:
Value Percent:
Continuous Index:
Within 8" of Joint:
Remarks:

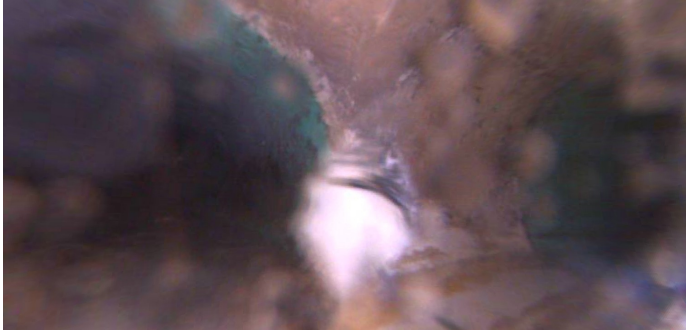
Code: **TFA**
Description: **Tap Factory Active**

Distance (ft): **323.0**
Structural Grade: **0**
O&M Grade: **0**
Clock Start/From: **3**
Clock To:
1st Value: **4.000**
2nd Value:
Value Percent:
Continuous Index:
Within 8" of Joint:
Remarks:

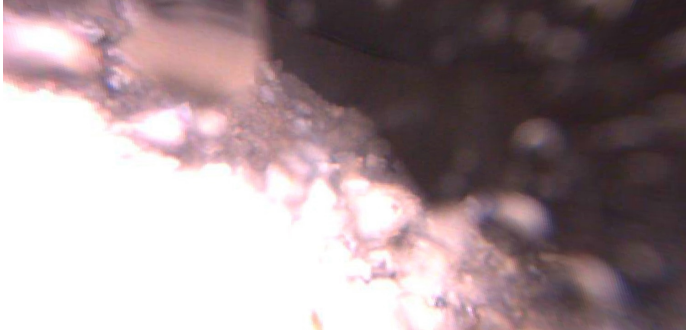
Code: **AMH**
Description: **Manhole**

Distance (ft): **327.7**
Structural Grade: **0**
O&M Grade: **0**
Clock Start/From:
Clock To:
1st Value:
2nd Value:
Value Percent:
Continuous Index:
Within 8" of Joint: **NO**
Remarks: **M-507-061**
