## Profile/Photo Observation Report

Date:	<b>01/30/2025</b>	Weather:		Coding:	<b>PACP 7.0</b>
Pipe Length (ft):	<b>125.0</b>	Owner:	<b>City of Hobart</b>	Pre Clean:	<b>Heavy Cleaning</b>
P.O.#:	<b>YES502259</b>	Surveyor:	<b>S. Bucklin</b>	PSR:	<b>P-507-086-083</b>
Customer:	<b>City of Hobart</b>	Clean Date:	<b>09/26/2024</b>	Shape:	<b>C</b>

Street:	<b>West 10th Place</b>	Flow Control:	<b>Not Controlled</b>
City:	<b>Hobart, IN</b>	Year Renewed:	
Location:	<b>Local rural streets with light traffic, t</b>	Tape/Media #:	
Purpose:	<b>Sewer System Evaluation Survey (SS</b>	Dia/Height:	<b>12"</b>
Use:	<b>Sanitary Sewage Pipe</b>	Material:	<b>VCP</b>
Drain Area:		Lining:	<b>None</b>
Category:	<b>NA</b>		
Comment:			
Location Details:		Direction of Survey:	<b>Downstream</b>
US MH:	<b>M-507-083</b>	DS MH:	<b>M-507-086</b>
		Total Length Surveyed (ft):	<b>124.0</b>

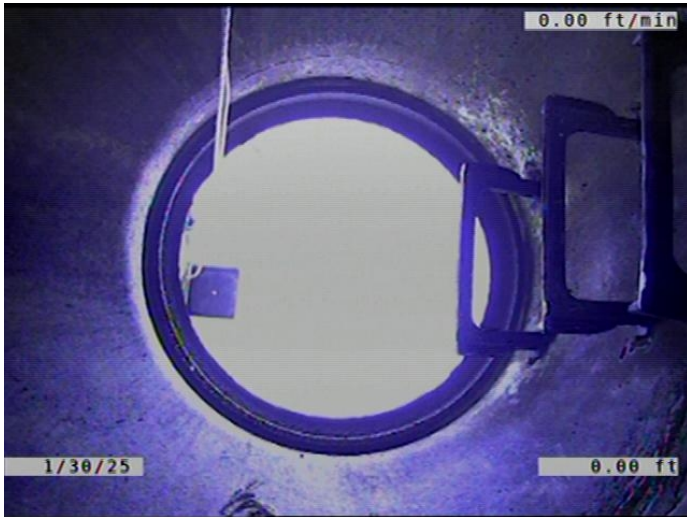
Code: **AMH**  
Description: **Manhole**

Distance (ft): **.0**  
Structural Grade: **0**  
O&M Grade: **0**  
Clock Start/From:  
Clock To:  
1st Value:  
2nd Value:  
Value Percent:  
Continuous Index:  
Within 8" of Joint: **NO**  
Remarks: **M-507-083**

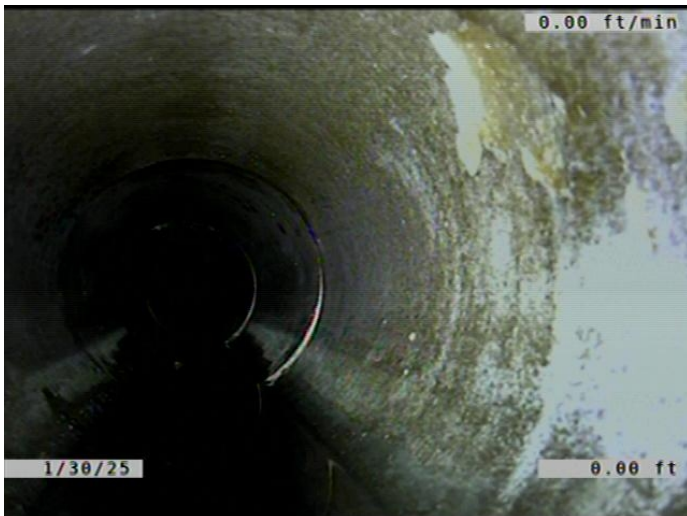
Code: **MWL**  
Description: **Miscellaneous Water Level**

Distance (ft): **.0**  
Structural Grade: **0**  
O&M Grade: **0**  
Clock Start/From:  
Clock To:  
1st Value:  
2nd Value:  
Value Percent: **10.000**  
Continuous Index:  
Within 8" of Joint: **NO**  
Remarks:

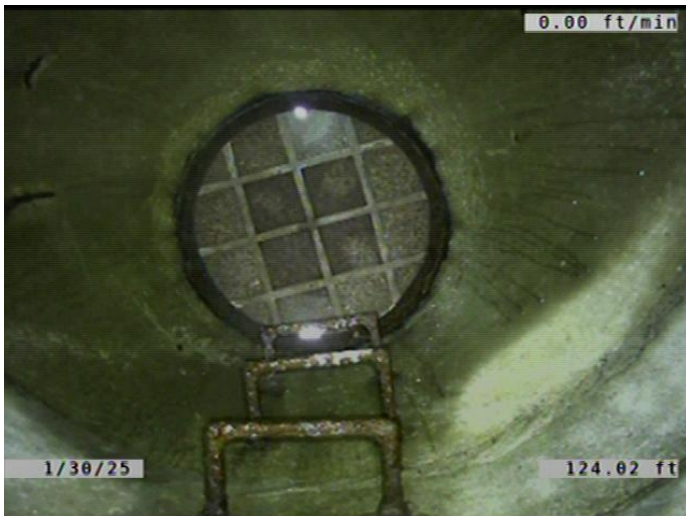
Code: **AMH**  
 Description: **Manhole**

Distance (ft): **124.0**  
 Structural Grade: **0**  
 O&M Grade: **0**  
 Clock Start/From:  
 Clock To:  
 1st Value:  
 2nd Value:  
 Value Percent:  
 Continuous Index:  
 Within 8" of Joint: **NO**  
 Remarks: **M-507-086**
