Profile/Photo Observation Report

Date:	12/12/2024	Weather:		Coding:	PACP 7.0
Pipe Length (ft):	394.0	Owner:	City of Hobart	Pre Clean:	Heavy Cleaning
P.O.#:	YES502259	Surveyor:	S. Bucklin	PSR:	P-507-084-087
Customer:	City of Hobart	Clean Date:	09/16/2024	Shape:	C

Street:	West 10th Place	Flow Control:	Not Controlled
City:	Hobart, IN	Year Renewed:	
Location:	Local rural streets with light traffic, t	Tape/Media #:	
Purpose:	Sewer System Evaluation Survey (SS	Dia/Height:	8"
Use:	Sanitary Sewage Pipe	Material:	PVC
Drain Area:		Lining:	None
Category:	NA		
Comment:			
Location Details:		Direction of Survey:	Downstream
US MH:	M-507-084	DS MH:	M-507-087
		Total Length Surveyed (ft):	381.6

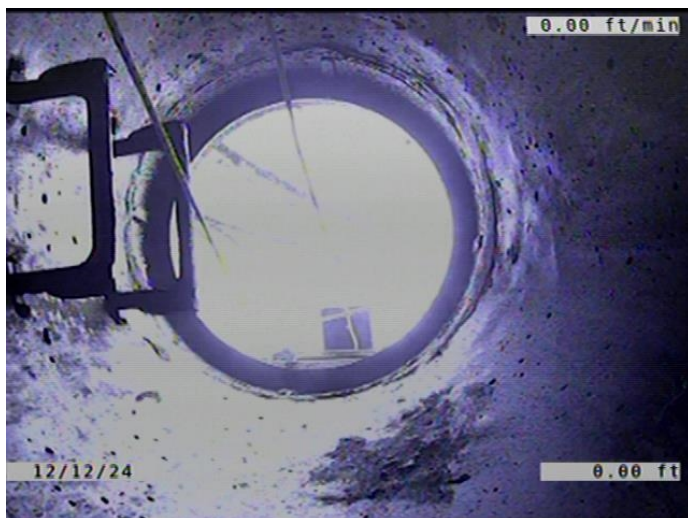
Code: **AMH**
 Description: **Manhole**

Distance (ft): **.0**
 Structural Grade: **0**
 O&M Grade: **0**
 Clock Start/From:
 Clock To:
 1st Value:
 2nd Value:
 Value Percent:
 Continuous Index:
 Within 8" of Joint: **NO**
 Remarks: **M-507-084**

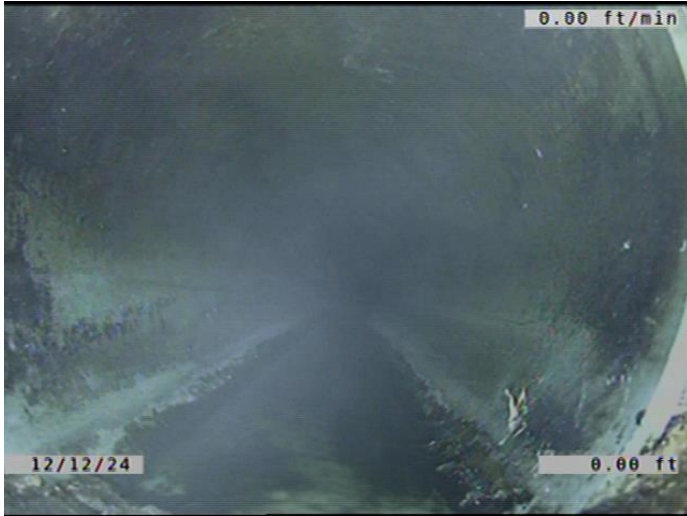
Code:	MWL
Description:	Miscellaneous Water Level
Distance (ft):	.0
Structural Grade:	0
O&M Grade:	0
Clock Start/From:	
Clock To:	
1st Value:	
2nd Value:	
Value Percent:	5.000
Continuous Index:	
Within 8" of Joint:	NO
Remarks:

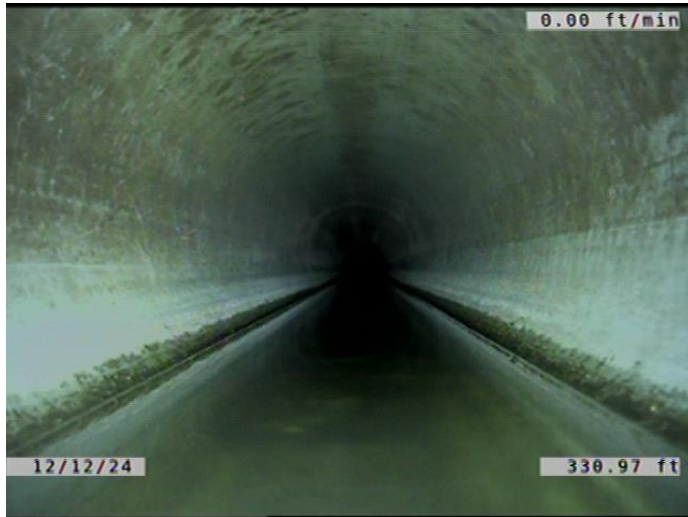
Code: **MWL**
Description: **Miscellaneous Water Level**

Distance (ft): **331.0**
Structural Grade: **0**
O&M Grade: **0**
Clock Start/From:
Clock To:
1st Value:
2nd Value:
Value Percent: **15.000**
Continuous Index:
Within 8" of Joint: **NO**
Remarks:

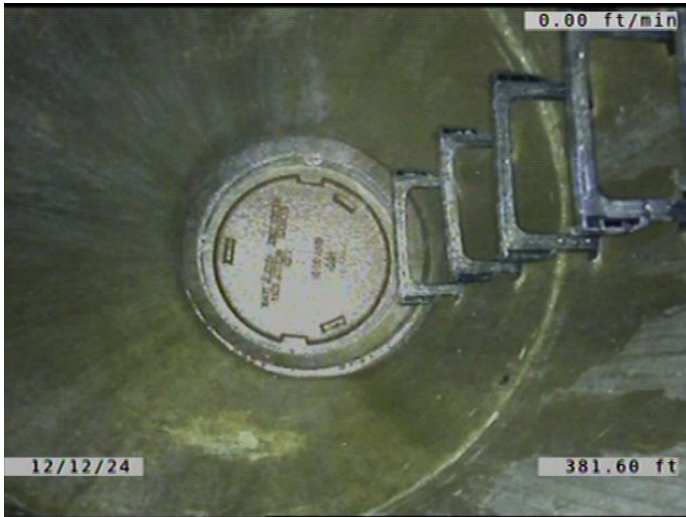
Code:	AMH
Description:	Manhole
Distance (ft):	381.6
Structural Grade:	0
O&M Grade:	0
Clock Start/From:	
Clock To:	
1st Value:	
2nd Value:	
Value Percent:	
Continuous Index:	
Within 8" of Joint:	NO
Remarks:	M-507-087
