Profile/Photo Observation Report

Street:	W 40th ave	Flow Control:	Not Controlled
City:	Hobart, IN	Year Renewed:	
Location:	Other	Tape/Media #:	
Purpose:	Not Known	Dia/Height:	10"
Use:	Sanitary	Material:	VCP
Drain Area:	NA	Lining:	
Category:	NA		
Comment:

Location Details:		Direction of Survey:	Downstream
US MH:	M-603-007	DS MH:	M-603-008
		Total Length Surveyed (ft):	32.2

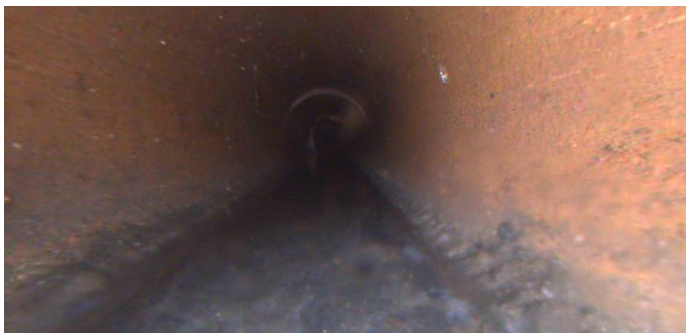
Code: **AMH**
Description: **Manhole**

Distance (ft): **.0**
Structural Grade: **0**
O&M Grade: **0**
Clock Start/From:
Clock To:
1st Value:
2nd Value:
Value Percent:
Continuous Index:
Within 8" of Joint: **NO**
Remarks: **M-603-007**

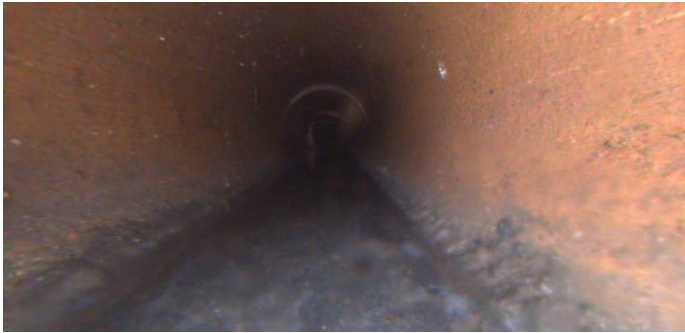
Code:	MWL
Description:	Water Level

Distance (ft):	.0
Structural Grade:	0
O&M Grade:	0
Clock Start/From:	
Clock To:	
1st Value:	
2nd Value:	
Value Percent:	10.000
Continuous Index:	
Within 8" of Joint:	NO
Remarks:

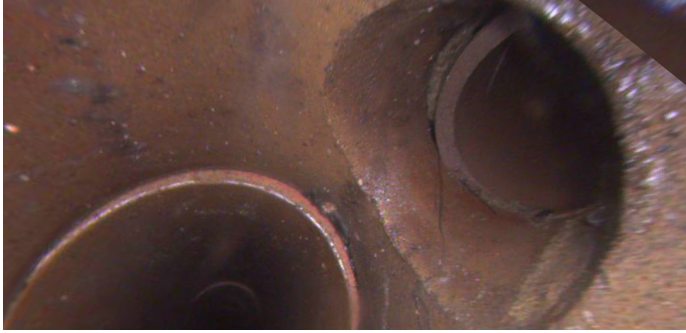
Code: **TF**
Description: **Tap Factory**

Distance (ft): **12.3**
Structural Grade: **0**
O&M Grade: **0**
Clock Start/From: **2**
Clock To:
1st Value: **4.000**
2nd Value:
Value Percent:
Continuous Index:
Within 8" of Joint:
Remarks:
