Profile/Photo Observation Report

Date:	08/05/2023	Weather:		Coding:	PACP 7.0
Pipe Length (ft):	190.2	Owner:	City of Hobart	Pre Clean:	Heavy Cleaning
P.O.#:	YES502259	Surveyor:	S. Bucklin	PSR:	P-603-011-010
Customer:	City of Hobart	Clean Date:	03/26/2023	Shape:	C

Street:	West 39th Place	Flow Control:	Not Controlled
City:	Hobart, IN	Year Renewed:	
Location:	Easement/Right of Way	Tape/Media #:	
Purpose:	Routine Assessment	Dia/Height:	10"
Use:	Sanitary Sewage Pipe	Material:	VCP
Drain Area:		Lining:	None
Category:	NA		
Comment:			
Location Details:		Direction of Survey:	Downstream
US MH:	M-603-010	DS MH:	M-603-011
		Total Length Surveyed (ft):	190.2

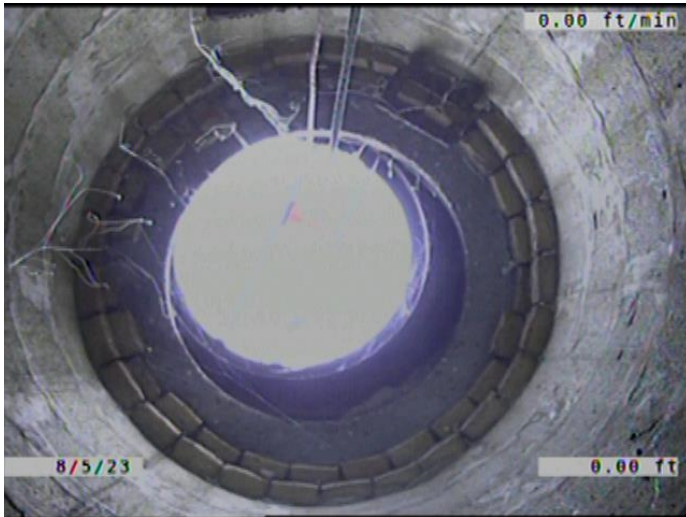
Code: **AMH**
Description: **Manhole**

Distance (ft): **.0**
Structural Grade: **0**
O&M Grade: **0**
Clock Start/From:
Clock To:
1st Value:
2nd Value:
Value Percent:
Continuous Index:
Within 8" of Joint: **NO**
Remarks: **M-603-010**

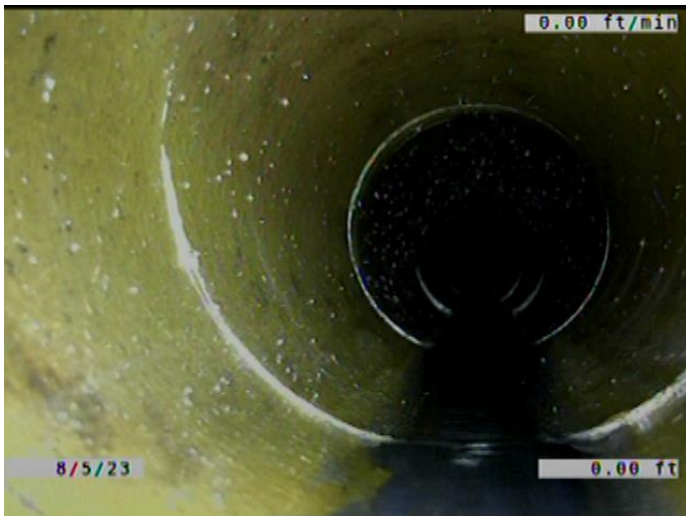
Code: **MWL**
Description: **Miscellaneous Water Level**

Distance (ft): **.0**
Structural Grade: **0**
O&M Grade: **0**
Clock Start/From:
Clock To:
1st Value:
2nd Value:
Value Percent: **5.000**
Continuous Index:
Within 8" of Joint: **NO**
Remarks:

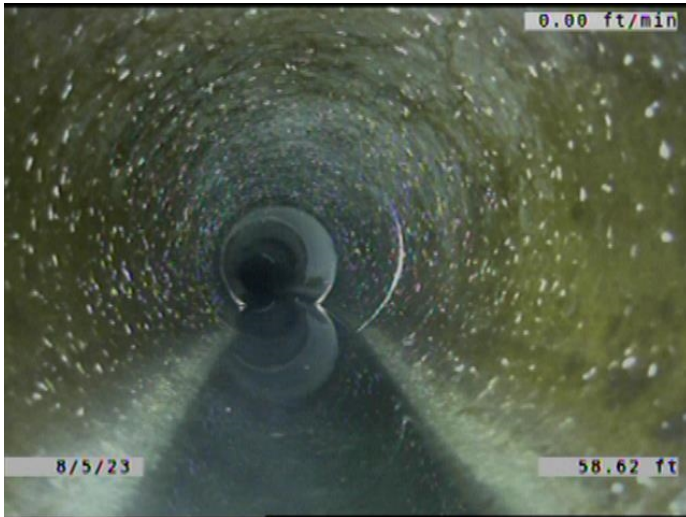
Code: **LL**
Description: **Line Left**

Distance (ft): **58.6**
Structural Grade: **0**
O&M Grade: **1**
Clock Start/From:
Clock To:
1st Value:
2nd Value:
Value Percent: **5.000**
Continuous Index:
Within 8" of Joint: **NO**
Remarks:

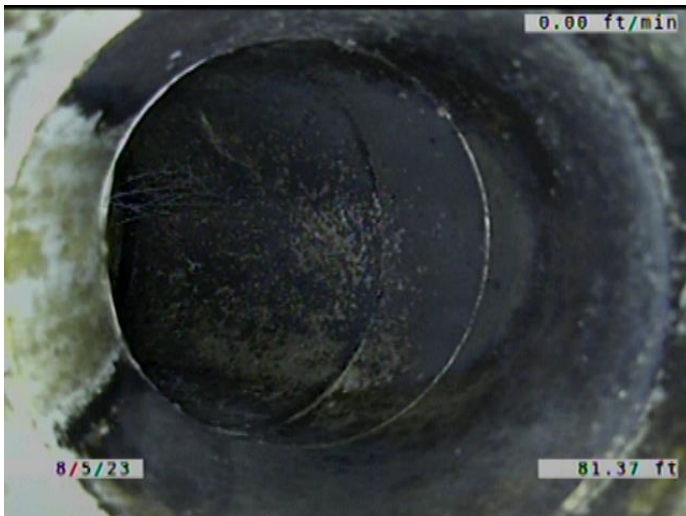
Code: **TF**
Description: **Tap Factory**

Distance (ft): **81.3**
Structural Grade: **0**
O&M Grade: **0**
Clock Start/From: **11**
Clock To:
1st Value: **6.000**
2nd Value:
Value Percent:
Continuous Index:
Within 8" of Joint: **YES**
Remarks: **CONSTANTLY RUNINNG WATER.**

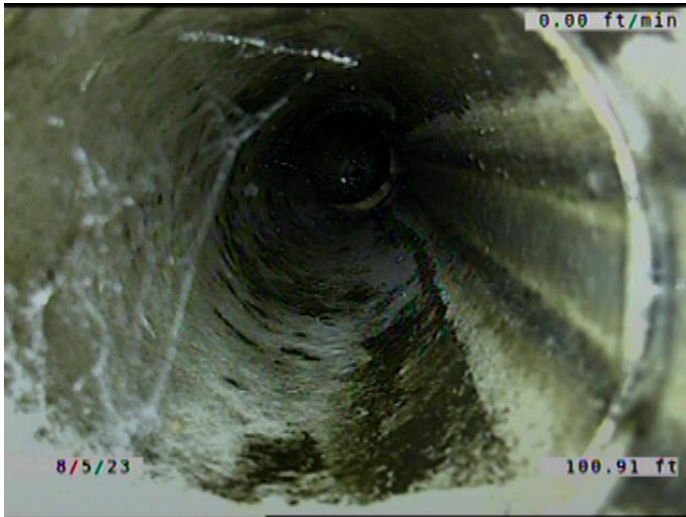
Code:	TF
Description:	Tap Factory
Distance (ft):	100.9
Structural Grade:	0
O&M Grade:	0
Clock Start/From:	2
Clock To:	
1st Value:	6.000
2nd Value:	
Value Percent:	
Continuous Index:	
Within 8" of Joint:	YES
Remarks:	LOOKS LIKE PART OF THE SERVICE IS VCP.

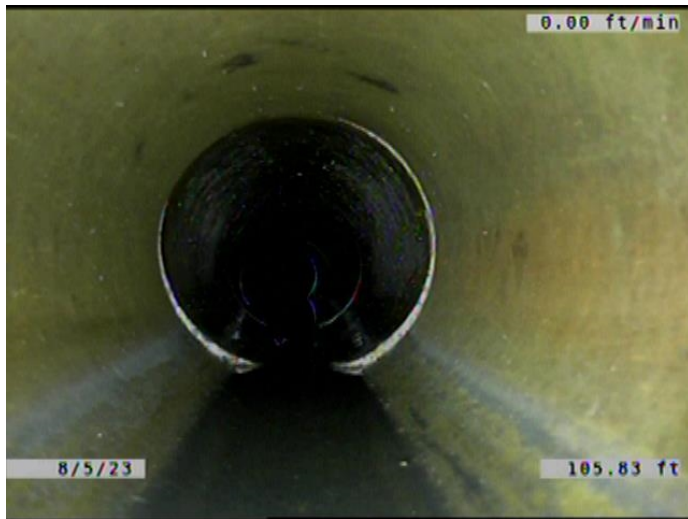
Code: **LL**
Description: **Line Left**

Distance (ft): **105.8**
Structural Grade: **0**
O&M Grade: **1**
Clock Start/From:
Clock To:
1st Value:
2nd Value:
Value Percent: **5.000**
Continuous Index:
Within 8" of Joint: **NO**
Remarks:

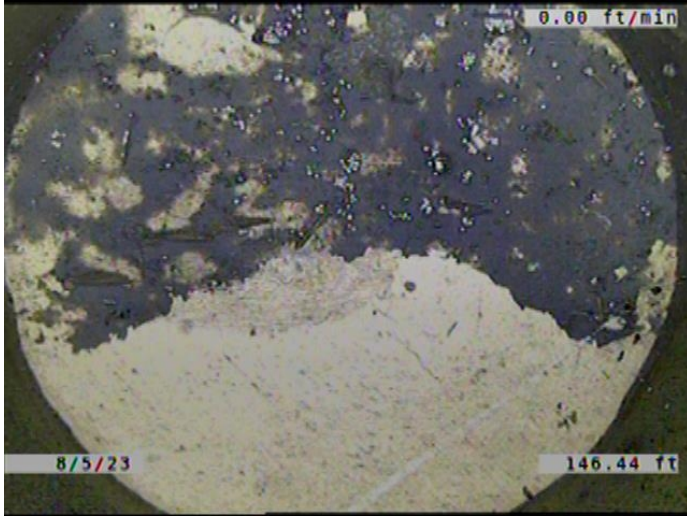
Code: **TFC**
Description: **Tap Factory Capped**

Distance (ft): **146.4**
Structural Grade: **0**
O&M Grade: **0**
Clock Start/From: **11**
Clock To:
1st Value: **6.000**
2nd Value:
Value Percent:
Continuous Index:
Within 8" of Joint: **YES**
Remarks:

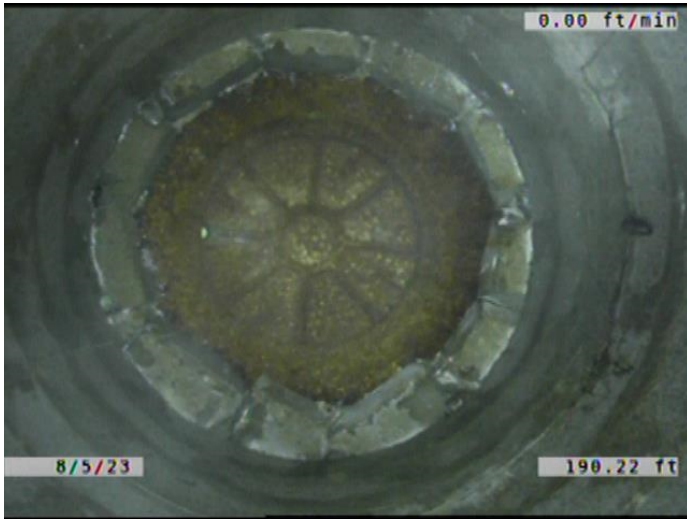
Code:	AMH
Description:	Manhole
Distance (ft):	190.2
Structural Grade:	0
O&M Grade:	0
Clock Start/From:	
Clock To:	
1st Value:	
2nd Value:	
Value Percent:	
Continuous Index:	
Within 8" of Joint:	NO
Remarks:	M-603-011
