Profile/Photo Observation Report

Date:	11/14/2021	Weather:		Coding:	PACP 7.0
Pipe Length (ft):	178.0	Owner:	City of Hobart	Pre Clean:	Heavy Cleaning
P.O.#:	YES502259	Surveyor:	S. Bucklin	PSR:	P-604-002-001
Customer:	City of Hobart	Clean Date:	11/13/2021	Shape:	C

Street:	West Cleveland Street	Flow Control:	Not Controlled
City:	Hobart, IN	Year Renewed:	
Location:	Local rural streets with light traffic, t	Tape/Media #:	
Purpose:	Routine Assessment	Dia/Height:	10"
Use:	Sanitary Sewage Pipe	Material:	VCP
Drain Area:		Lining:	None
Category:	NA		
Comment:			
Location Details:		Direction of Survey:	Downstream
US MH:	M-604-002	DS MH:	M-604-001
		Total Length Surveyed (ft):	178.0

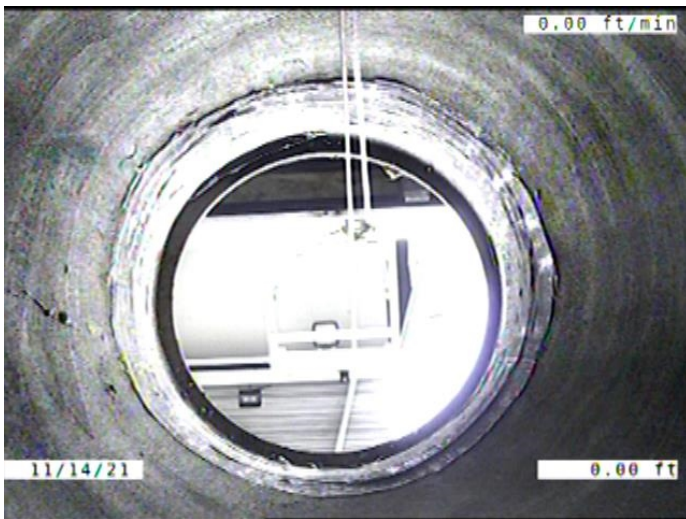
Code: **AMH**
Description: **Manhole**

Distance (ft): **.0**
Structural Grade: **0**
O&M Grade: **0**
Clock Start/From:
Clock To:
1st Value:
2nd Value:
Value Percent:
Continuous Index:
Within 8" of Joint: **NO**
Remarks: **M-604-002**

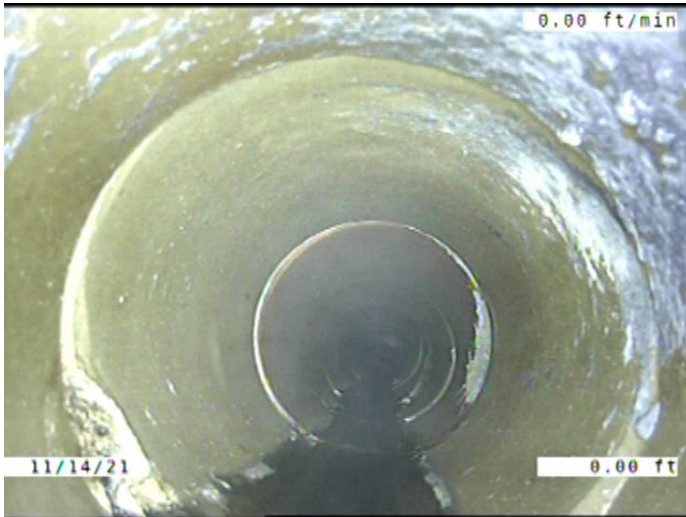
Code: **MWL**
 Description: **Miscellaneous Water Level**

Distance (ft): **.0**
 Structural Grade: **0**
 O&M Grade: **0**
 Clock Start/From:
 Clock To:
 1st Value:
 2nd Value:
 Value Percent: **5.000**
 Continuous Index:
 Within 8" of Joint: **NO**
 Remarks:

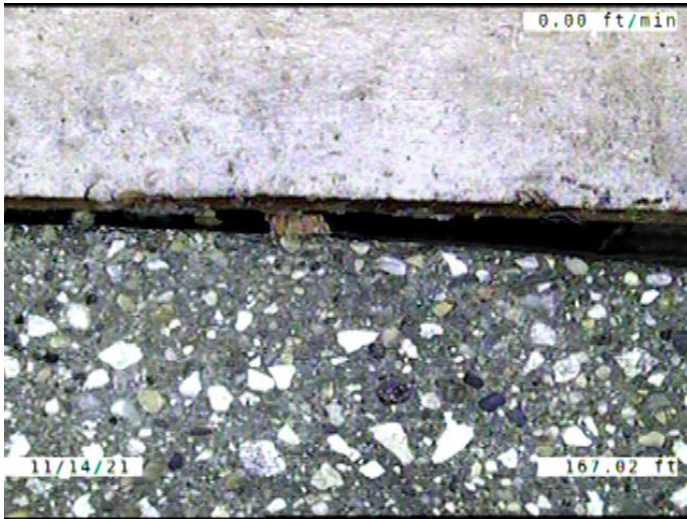
Code: **MMC**
Description: **Miscellaneous Material Change**

Distance (ft): **167.0**
Structural Grade: **0**
O&M Grade: **0**
Clock Start/From:
Clock To:
1st Value:
2nd Value:
Value Percent:
Continuous Index:
Within 8" of Joint: **NO**
Remarks: **VCP TO CONCRETE**
