# Profile/Photo Observation Report

Date:	<b>11/14/2021</b>	Weather:		Coding:	<b>PACP 7.0</b>
Pipe Length (ft):	<b>178.0</b>	Owner:	<b>City of Hobart</b>	Pre Clean:	<b>Heavy Cleaning</b>
P.O.#:	<b>YES502259</b>	Surveyor:	<b>S. Bucklin</b>	PSR:	<b>P-604-002-001</b>
Customer:	<b>City of Hobart</b>	Clean Date:	<b>11/13/2021</b>	Shape:	<b>C</b>

Street:	<b>West Cleveland Street</b>	Flow Control:	<b>Not Controlled</b>
City:	<b>Hobart, IN</b>	Year Renewed:	
Location:	<b>Local rural streets with light traffic, t</b>	Tape/Media #:	
Purpose:	<b>Routine Assessment</b>	Dia/Height:	<b>10"</b>
Use:	<b>Sanitary Sewage Pipe</b>	Material:	<b>VCP</b>
Drain Area:		Lining:	<b>None</b>
Category:	<b>NA</b>		
Comment:			
Location Details:		Direction of Survey:	<b>Downstream</b>
US MH:	<b>M-604-002</b>	DS MH:	<b>M-604-001</b>
		Total Length Surveyed (ft):	<b>178.0</b>

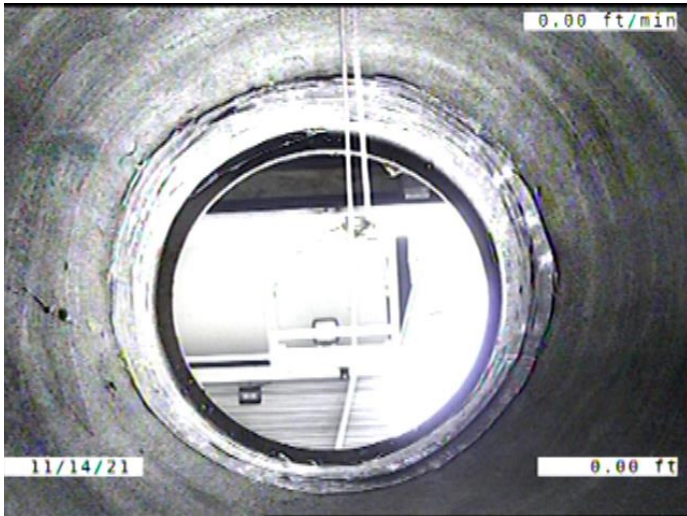
Code: **AMH**  
Description: **Manhole**

Distance (ft): **.0**  
Structural Grade: **0**  
O&M Grade: **0**  
Clock Start/From:  
Clock To:  
1st Value:  
2nd Value:  
Value Percent:  
Continuous Index:  
Within 8" of Joint: **NO**  
Remarks: **M-604-002**

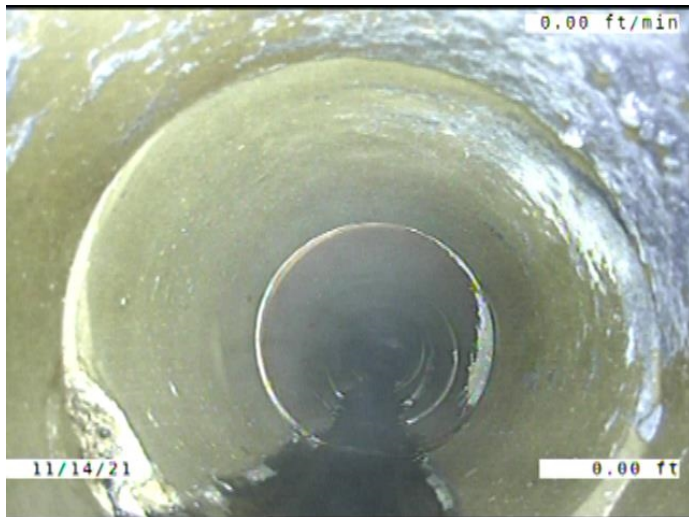
Code: **MWL**  
 Description: **Miscellaneous Water Level**

Distance (ft): **.0**  
 Structural Grade: **0**  
 O&M Grade: **0**  
 Clock Start/From:  
 Clock To:  
 1st Value:  
 2nd Value:  
 Value Percent: **5.000**  
 Continuous Index:  
 Within 8" of Joint: **NO**  
 Remarks:

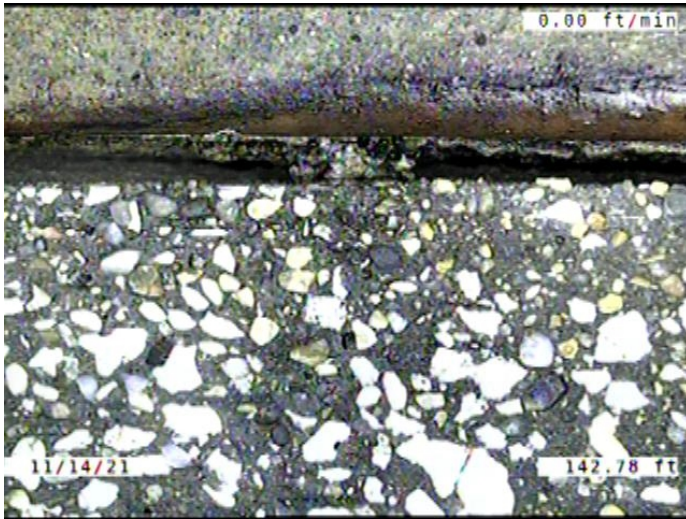
Code: **MMC**  
 Description: **Miscellaneous Material Change**

Distance (ft): **142.8**  
 Structural Grade: **0**  
 O&M Grade: **0**  
 Clock Start/From:  
 Clock To:  
 1st Value:  
 2nd Value:  
 Value Percent:  
 Continuous Index:  
 Within 8" of Joint: **NO**  
 Remarks: **VCP TO CONCRETE**

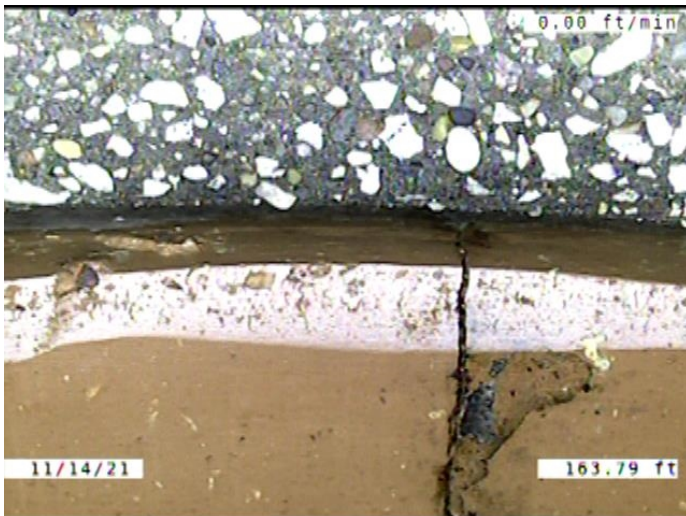
Code: **MMC**  
 Description: **Miscellaneous Material Change**

Distance (ft): **163.8**  
 Structural Grade: **0**  
 O&M Grade: **0**  
 Clock Start/From:  
 Clock To:  
 1st Value:  
 2nd Value:  
 Value Percent:  
 Continuous Index:  
 Within 8" of Joint: **NO**  
 Remarks: **CONCRETE TO VCP**

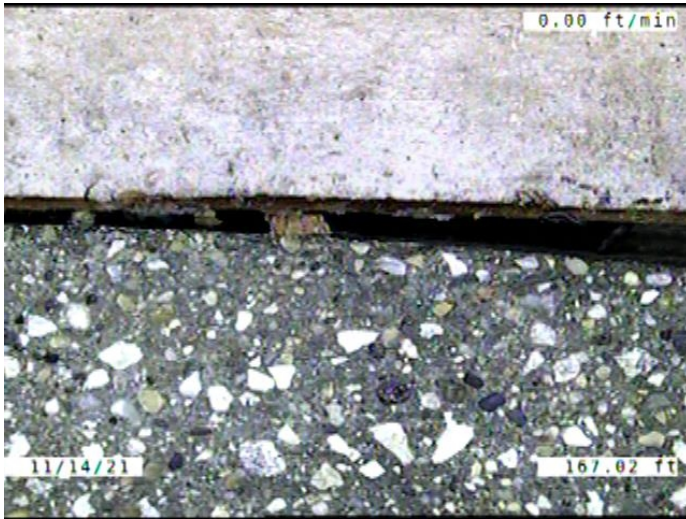
Code: **MMC**  
 Description: **Miscellaneous Material Change**

Distance (ft): **167.0**  
 Structural Grade: **0**  
 O&M Grade: **0**  
 Clock Start/From:  
 Clock To:  
 1st Value:  
 2nd Value:  
 Value Percent:  
 Continuous Index:  
 Within 8" of Joint: **NO**  
 Remarks: **VCP TO CONCRETE**

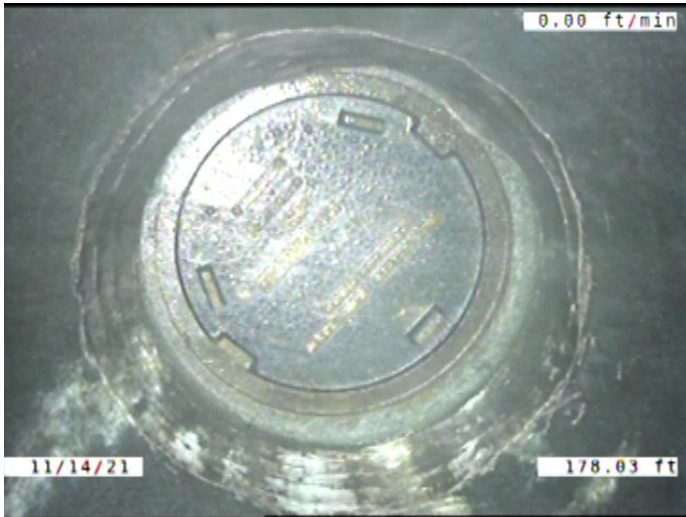
Code:	AMH
Description:	Manhole
Distance (ft):	178.0
Structural Grade:	0
O&M Grade:	0
Clock Start/From:	
Clock To:	
1st Value:	
2nd Value:	
Value Percent:	
Continuous Index:	
Within 8" of Joint:	NO
Remarks:	M-604-001
