Profile/Photo Observation Report

Date:	11/14/2021	Weather:		Coding:	PACP 7.0
Pipe Length (ft):	273.0	Owner:	City of Hobart	Pre Clean:	Heavy Cleaning
P.O.#:	YES502259	Surveyor:	S. Bucklin	PSR:	P-604-003-002
Customer:	City of Hobart	Clean Date:	11/13/2021	Shape:	C

Street:	West Cleveland Avenue	Flow Control:	Not Controlled
City:	Hobart, IN	Year Renewed:	
Location:	Local rural streets with light traffic, t	Tape/Media #:	
Purpose:	Routine Assessment	Dia/Height:	10"
Use:	Sanitary Sewage Pipe	Material:	VCP
Drain Area:		Lining:	None
Category:	NA		
Comment:			
Location Details:		Direction of Survey:	Upstream
US MH:	M-604-003	DS MH:	M-604-002
		Total Length Surveyed (ft):	186.6

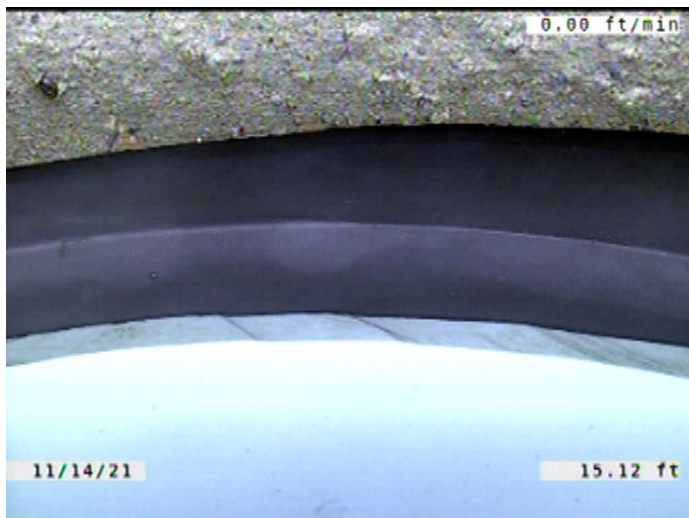
Code: **MMC**
 Description: **Miscellaneous Material Change**

Distance (ft): **15.1**
 Structural Grade: **0**
 O&M Grade: **0**
 Clock Start/From:
 Clock To:
 1st Value:
 2nd Value:
 Value Percent:
 Continuous Index:
 Within 8" of Joint: **NO**
 Remarks: **VCP TO PVC**
