Profile/Photo Observation Report

Date:	11/14/2021	Weather:		Coding:	PACP 7.0
Pipe Length (ft):	273.0	Owner:	City of Hobart	Pre Clean:	Heavy Cleaning
P.O.#:	YES502259	Surveyor:	S. Bucklin	PSR:	P-604-003-002
Customer:	City of Hobart	Clean Date:	11/13/2021	Shape:	C

Street:	West Cleveland Avenue	Flow Control:	Not Controlled
City:	Hobart, IN	Year Renewed:	
Location:	Local rural streets with light traffic, t	Tape/Media #:	
Purpose:	Routine Assessment	Dia/Height:	10"
Use:	Sanitary Sewage Pipe	Material:	VCP
Drain Area:		Lining:	None
Category:	NA		
Comment:			
Location Details:		Direction of Survey:	Upstream
US MH:	M-604-003	DS MH:	M-604-002
		Total Length Surveyed (ft):	186.6

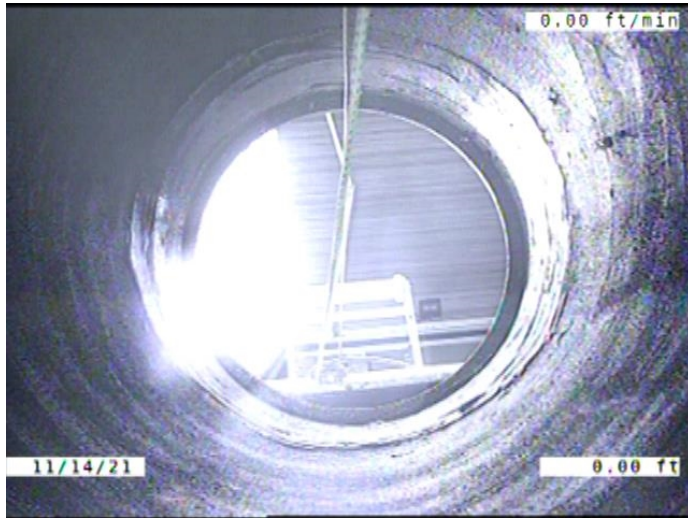
Code: **AMH**
 Description: **Manhole**

Distance (ft): **.0**
 Structural Grade: **0**
 O&M Grade: **0**
 Clock Start/From:
 Clock To:
 1st Value:
 2nd Value:
 Value Percent:
 Continuous Index:
 Within 8" of Joint: **NO**
 Remarks: **M-604-002**

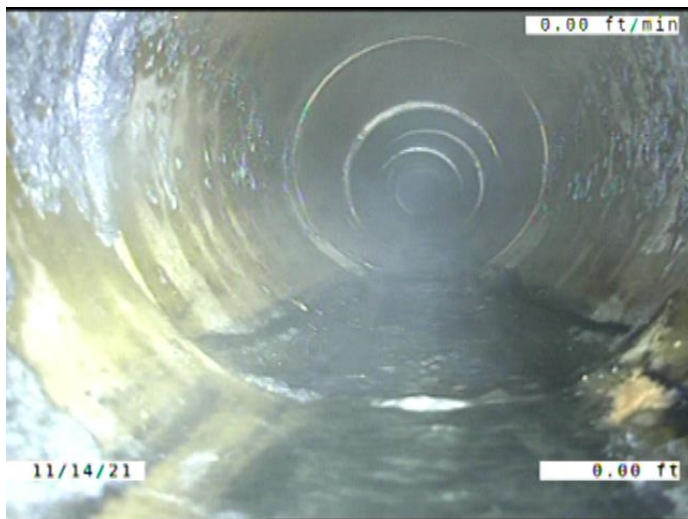
Code: **MWL**
 Description: **Miscellaneous Water Level**

Distance (ft): **.0**
 Structural Grade: **0**
 O&M Grade: **0**
 Clock Start/From:
 Clock To:
 1st Value:
 2nd Value:
 Value Percent: **5.000**
 Continuous Index:
 Within 8" of Joint: **NO**
 Remarks:

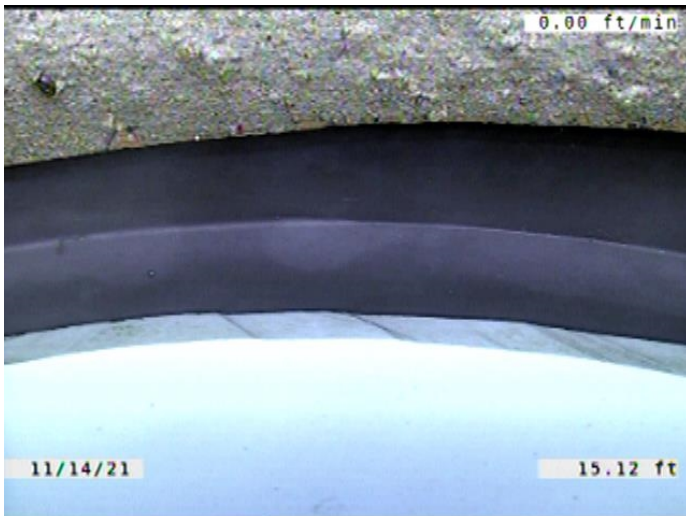
Code: **MMC**
Description: **Miscellaneous Material Change**

Distance (ft): **15.1**
Structural Grade: **0**
O&M Grade: **0**
Clock Start/From:
Clock To:
1st Value:
2nd Value:
Value Percent:
Continuous Index:
Within 8" of Joint: **NO**
Remarks: **VCP TO PVC**

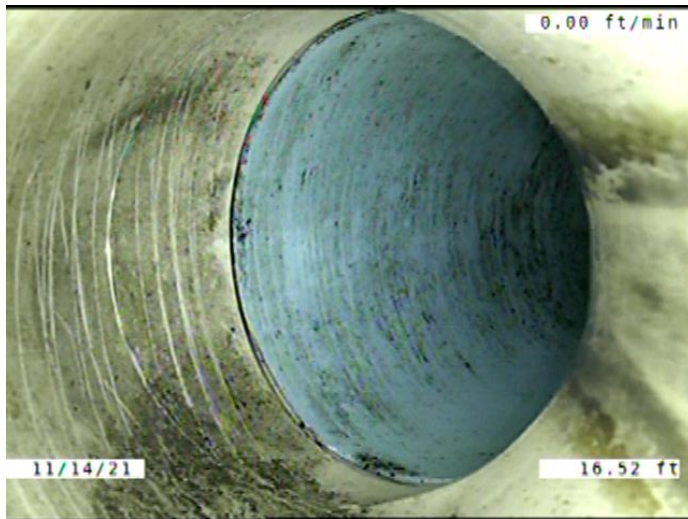
Code: **TF**
 Description: **Tap Factory**

Distance (ft): **16.5**
 Structural Grade: **0**
 O&M Grade: **0**
 Clock Start/From: **2**
 Clock To:
 1st Value: **4.000**
 2nd Value:
 Value Percent:
 Continuous Index:
 Within 8" of Joint: **YES**
 Remarks:

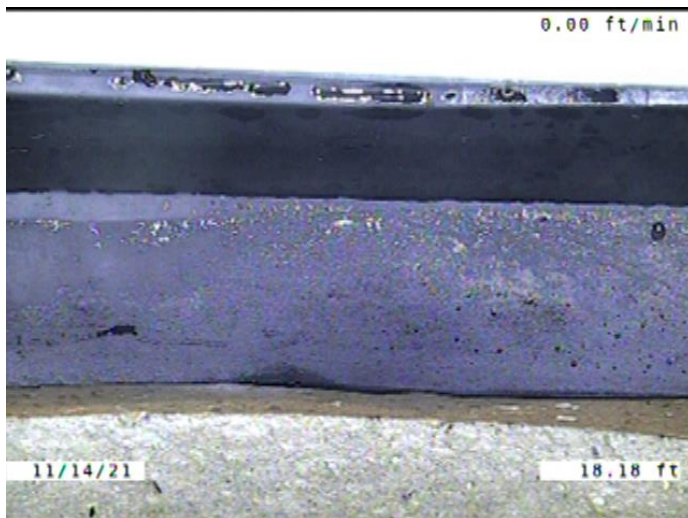
Code: **MMC**
 Description: **Miscellaneous Material Change**

Distance (ft): **18.2**
 Structural Grade: **0**
 O&M Grade: **0**
 Clock Start/From:
 Clock To:
 1st Value:
 2nd Value:
 Value Percent:
 Continuous Index:
 Within 8" of Joint: **NO**
 Remarks: **PVC TO VCP**
