RedZone  
ROBOTICS

Street:	Beverly Boulevard		Flow Control:	Not Controlled	
City:	City of Hobart		Year Renewed:		
Location:	Local rural streets with light traffic, t		Tape/Media #:		
Purpose:	Routine Assessment		Dia/Height:	12"	
Use:	Sanitary Sewage Pipe		Material:	CP	
Drain Area:			Lining:	None	
Category:	NA				
Comment:					
Location Details:			Direction of Survey:	Downstream	
US MH:	M-604-006	DS MH:	M-605-067	Total Length Surveyed (ft):	238.5

O&M Index:	<b>2.06</b>	O&M Quick:	<b>4133</b>	O&M Rating:	<b>33.00</b>
Structural Index:	<b>2.75</b>	Structural Quick:	<b>4731</b>	Structural Rating:	<b>55.00</b>
Overall Index:	<b>2.44</b>	Overall Quick:	<b>4834</b>	Overall Rating:	<b>88.00</b>

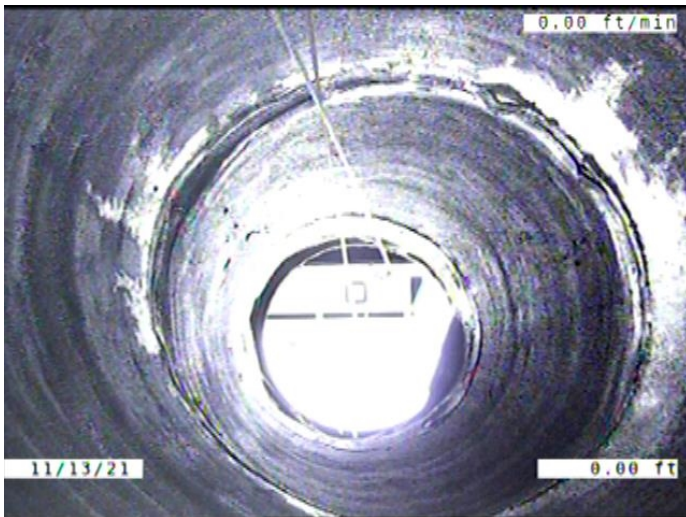
Code: **AMH**  
Description: **Manhole**

Distance (ft): **.0**  
Structural Grade: **0**  
O&M Grade: **0**  
Clock Start/From:  
Clock To:  
1st Value:  
2nd Value:  
Value Percent:  
Continuous Index:  
Within 8" of Joint: **NO**  
Remarks: **M-604-006**

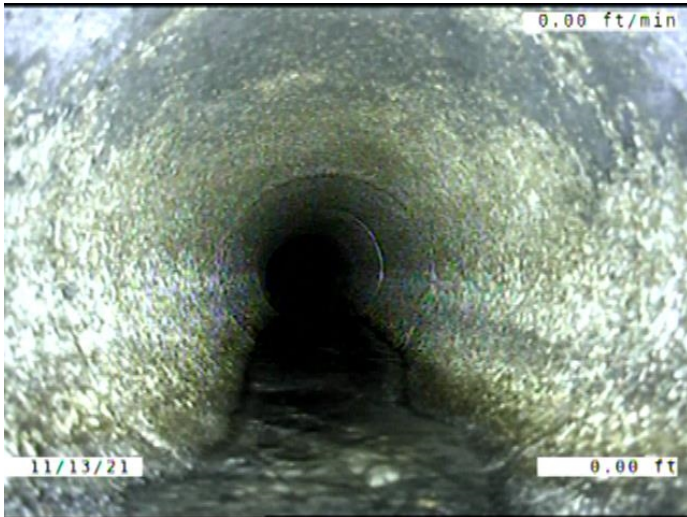
Code: **MWL**  
 Description: **Miscellaneous Water Level**

Distance (ft): **.0**  
 Structural Grade: **0**  
 O&M Grade: **0**  
 Clock Start/From:  
 Clock To:  
 1st Value:  
 2nd Value:  
 Value Percent: **5.000**  
 Continuous Index:  
 Within 8" of Joint: **NO**  
 Remarks:

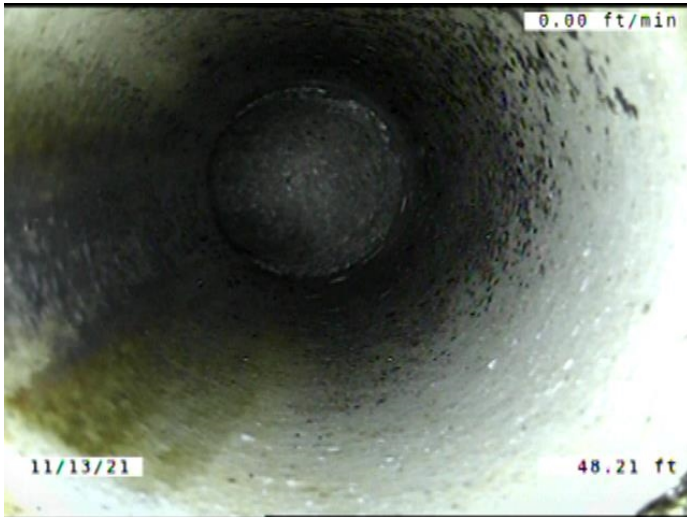
Code: **TB**  
Description: **Tap Break-in/Hammer**

Distance (ft): **48.2**  
Structural Grade: **0**  
O&M Grade: **0**  
Clock Start/From: **11**  
Clock To:  
1st Value: **6.000**  
2nd Value:  
Value Percent:  
Continuous Index:  
Within 8" of Joint: **YES**  
Remarks:

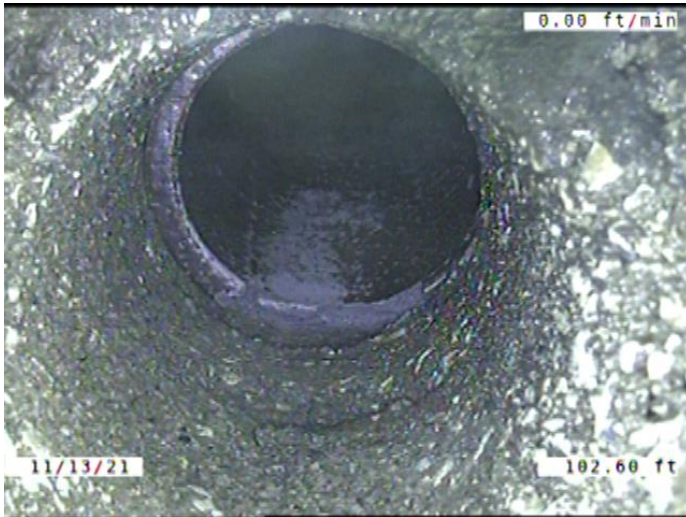
Code: **TF**  
Description: **Tap Factory**

Distance (ft): **102.6**  
Structural Grade: **0**  
O&M Grade: **0**  
Clock Start/From: **1**  
Clock To:  
1st Value: **6.000**  
2nd Value:  
Value Percent:  
Continuous Index:  
Within 8" of Joint: **YES**  
Remarks:

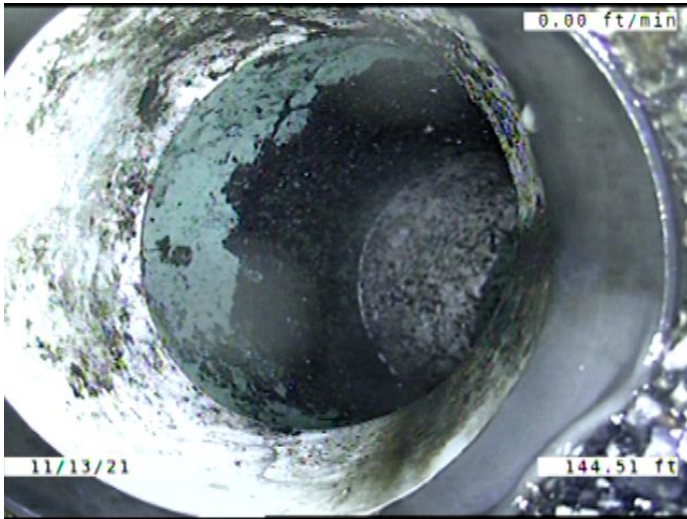
Code: **TB**  
Description: **Tap Break-in/Hammer**

Distance (ft): **144.5**  
Structural Grade: **0**  
O&M Grade: **0**  
Clock Start/From: **12**  
Clock To:  
1st Value: **4.000**  
2nd Value:  
Value Percent:  
Continuous Index:  
Within 8" of Joint: **NO**  
Remarks:

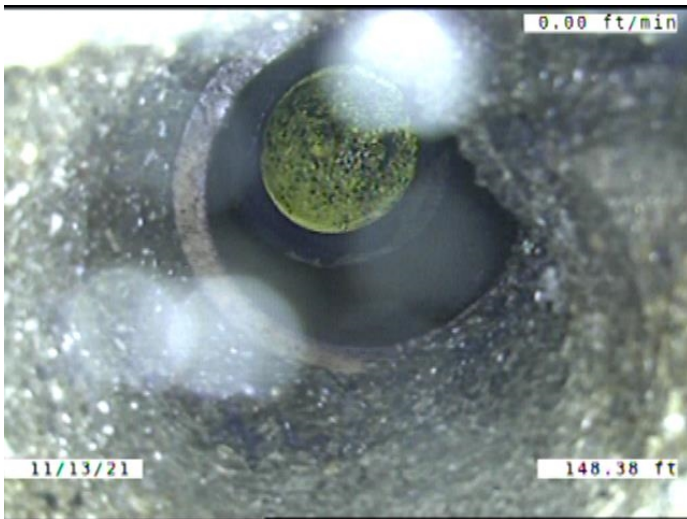
Code: **TFC**  
Description: **Tap Factory Capped**

Distance (ft): **148.4**  
Structural Grade: **0**  
O&M Grade: **0**  
Clock Start/From: **1**  
Clock To:  
1st Value: **6.000**  
2nd Value:  
Value Percent:  
Continuous Index:  
Within 8" of Joint: **YES**  
Remarks:

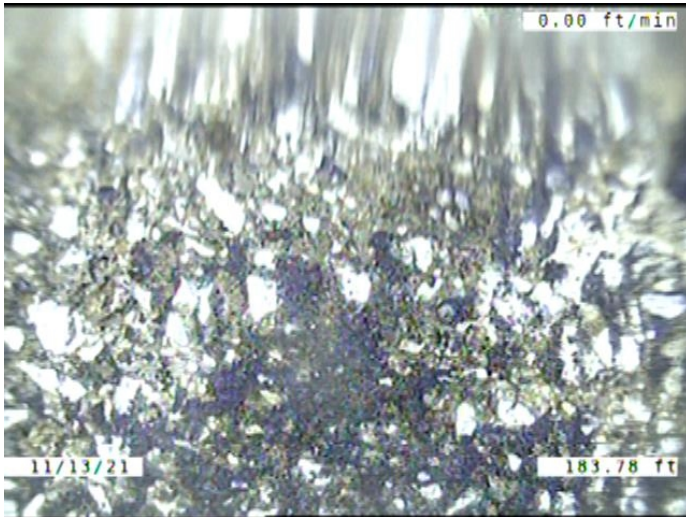
Code: **MWL**  
 Description: **Miscellaneous Water Level**

Distance (ft): **183.8**  
 Structural Grade: **0**  
 O&M Grade: **0**  
 Clock Start/From:  
 Clock To:  
 1st Value:  
 2nd Value:  
 Value Percent: **35.000**  
 Continuous Index:  
 Within 8" of Joint: **NO**  
 Remarks:

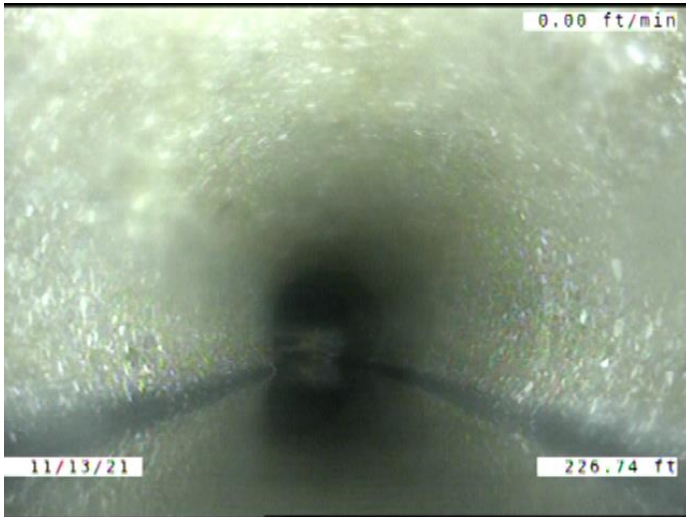
Code: **MWL**  
 Description: **Miscellaneous Water Level**

Distance (ft): **226.7**  
 Structural Grade: **0**  
 O&M Grade: **0**  
 Clock Start/From:  
 Clock To:  
 1st Value:  
 2nd Value:  
 Value Percent: **5.000**  
 Continuous Index:  
 Within 8" of Joint: **NO**  
 Remarks:

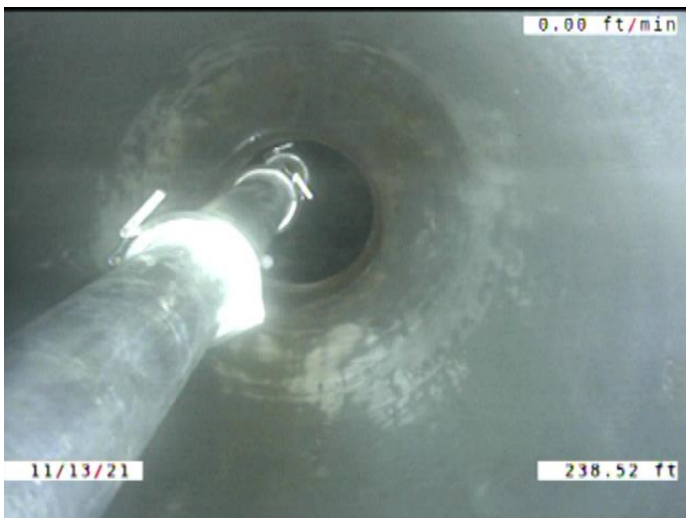
Code: **AMH**  
 Description: **Manhole**

Distance (ft): **238.5**  
 Structural Grade: **0**  
 O&M Grade: **0**  
 Clock Start/From:  
 Clock To:  
 1st Value:  
 2nd Value:  
 Value Percent:  
 Continuous Index:  
 Within 8" of Joint: **NO**  
 Remarks: **M-605-067**
