## Profile/Photo Observation Report

Street:	<b>Beverly Blvd.</b>	Flow Control:	<b>Not Controlled</b>
City:	<b>Hobart, IN</b>	Year Renewed:	
Location:	<b>Other</b>	Tape/Media #:	
Purpose:	<b>Not Known</b>	Dia/Height:	<b>10"</b>
Use:	<b>Sanitary</b>	Material:	<b>VCP</b>
Drain Area:	<b>NA</b>	Lining:	
Category:	<b>NA</b>		
Comment:

Location Details:		Direction of Survey:	<b>Upstream</b>
US MH:	<b>M-604-007</b>	DS MH:	<b>M-604-008</b>
		Total Length Surveyed (ft):	<b>129.4</b>

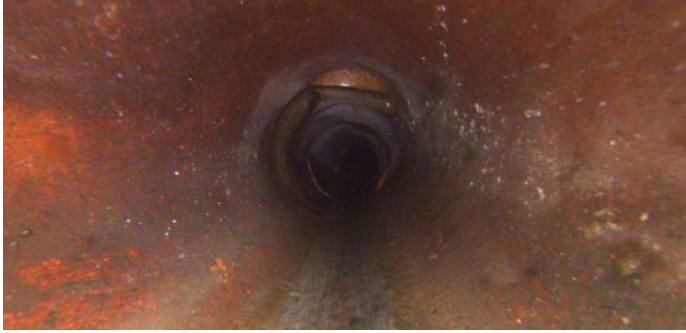
Code: **AMH**  
Description: **Manhole**

Distance (ft): **.0**  
Structural Grade: **0**  
O&M Grade: **0**  
Clock Start/From:  
Clock To:  
1st Value:  
2nd Value:  
Value Percent:  
Continuous Index:  
Within 8" of Joint: **NO**  
Remarks: **M-604-008**

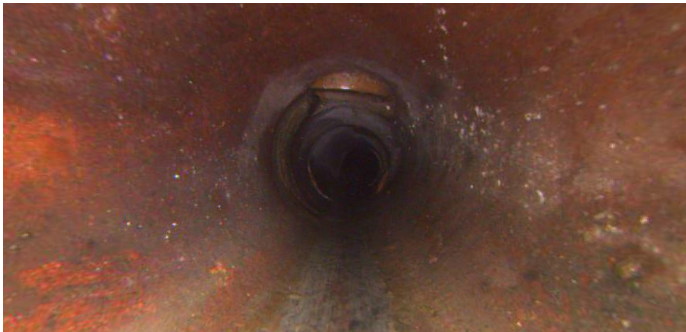
Code: **MWL**  
Description: **Water Level**

Distance (ft): **.0**  
Structural Grade: **0**  
O&M Grade: **0**  
Clock Start/From:  
Clock To:  
1st Value:  
2nd Value:  
Value Percent: **5.000**  
Continuous Index:  
Within 8" of Joint: **NO**  
Remarks:

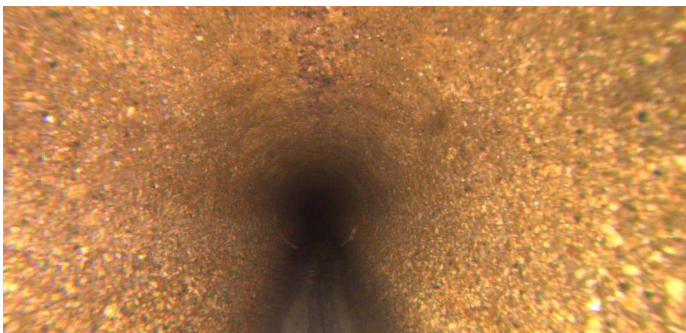
Code: **MMC**  
Description: **Material Change**

Distance (ft): **40.3**  
Structural Grade: **0**  
O&M Grade: **0**  
Clock Start/From:  
Clock To:  
1st Value:  
2nd Value:  
Value Percent:  
Continuous Index:  
Within 8" of Joint: **NO**  
Remarks: **cp**

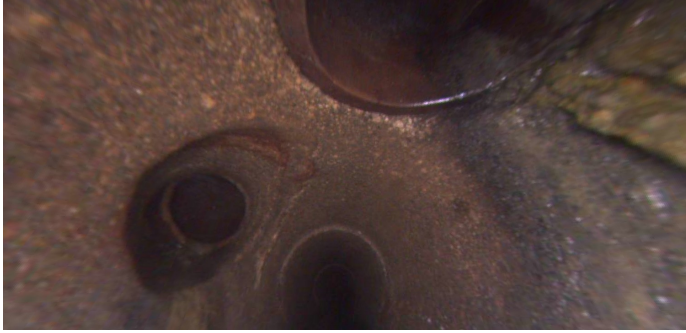
Code: **TF**  
Description: **Tap Factory**

Distance (ft): **53.6**  
Structural Grade: **0**  
O&M Grade: **0**  
Clock Start/From: **2**  
Clock To:  
1st Value: **4.000**  
2nd Value:  
Value Percent:  
Continuous Index:  
Within 8" of Joint:  
Remarks:

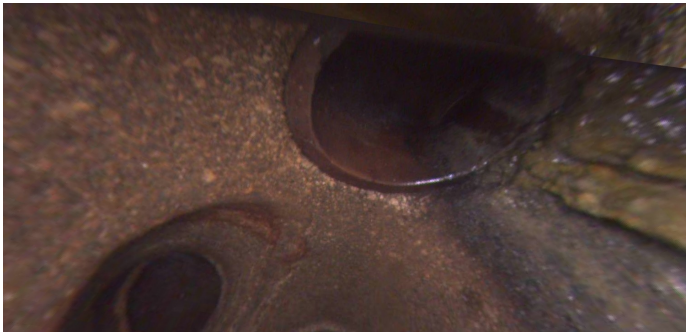
Code: **TB**  
Description: **Tap Break-in**

Distance (ft): **53.6**  
Structural Grade: **0**  
O&M Grade: **0**  
Clock Start/From: **12**  
Clock To:  
1st Value: **4.000**  
2nd Value:  
Value Percent:  
Continuous Index:  
Within 8" of Joint:  
Remarks:

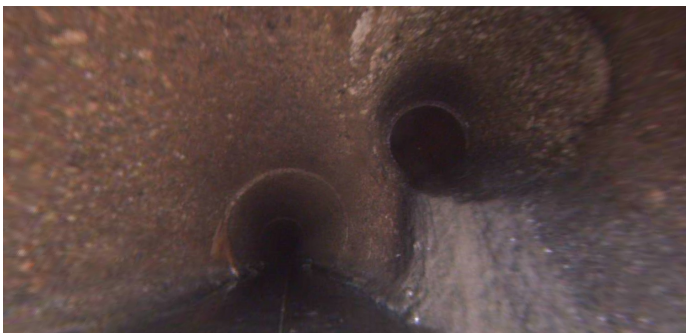
Code: **TFA**  
Description: **Tap Factory Active**

Distance (ft): **125.4**  
Structural Grade: **0**  
O&M Grade: **0**  
Clock Start/From: **10**  
Clock To:  
1st Value: **4.000**  
2nd Value:  
Value Percent:  
Continuous Index:  
Within 8" of Joint:  
Remarks:
