RedZone
ROBOTICS

Street:	Beverly Boulevard		Flow Control:	Not Controlled	
City:	City of Hobart		Year Renewed:		
Location:	Local rural streets with light traffic, t		Tape/Media #:		
Purpose:	Routine Assessment		Dia/Height:	10"	
Use:	Sanitary Sewage Pipe		Material:	CP	
Drain Area:			Lining:	None	
Category:	NA				
Comment:					
Location Details:			Direction of Survey:	Downstream	
US MH:	M-604-007	DS MH:	M-604-008	Total Length Surveyed (ft):	282.3

Tuesday, April 25, 2023

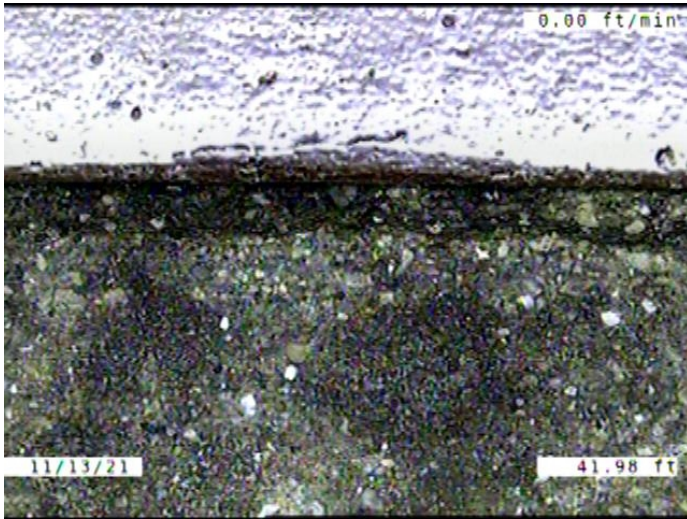
Code: **MMC**
 Description: **Miscellaneous Material Change**

Distance (ft): **42.0**
 Structural Grade: **0**
 O&M Grade: **0**
 Clock Start/From:
 Clock To:
 1st Value:
 2nd Value:
 Value Percent:
 Continuous Index:
 Within 8" of Joint: **NO**
 Remarks: **VCP TO CONCRETE**

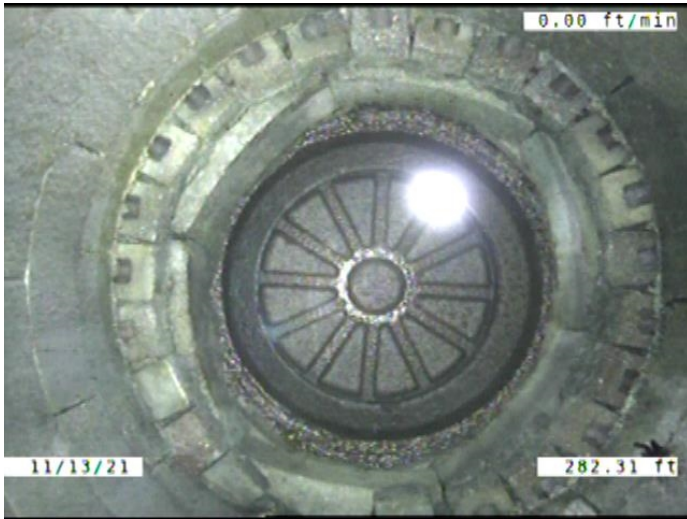
Code:	AMH
Description:	Manhole
Distance (ft):	282.3
Structural Grade:	0
O&M Grade:	0
Clock Start/From:	
Clock To:	
1st Value:	
2nd Value:	
Value Percent:	
Continuous Index:	
Within 8" of Joint:	NO
Remarks:	M-604-008
