Profile/Photo Observation Report

Date:	11/13/2021	Weather:		Coding:	PACP 7.0
Pipe Length (ft):	282.3	Owner:	City of Hobart	Pre Clean:	Heavy Cleaning
P.O.#:	YES502259	Surveyor:	Steven Bucklin	PSR:	P-604-008-007
Customer:	City of Hobart, IN (Red	Clean Date:	11/13/2021	Shape:	C

Street:	Beverly Boulevard	Flow Control:	Not Controlled
City:	City of Hobart	Year Renewed:	
Location:	Local rural streets with light traffic, t	Tape/Media #:	
Purpose:	Routine Assessment	Dia/Height:	10"
Use:	Sanitary Sewage Pipe	Material:	CP
Drain Area:		Lining:	None
Category:	NA		
Comment:			
Location Details:		Direction of Survey:	Downstream
US MH:	M-604-007	DS MH:	M-604-008
		Total Length Surveyed (ft):	282.3

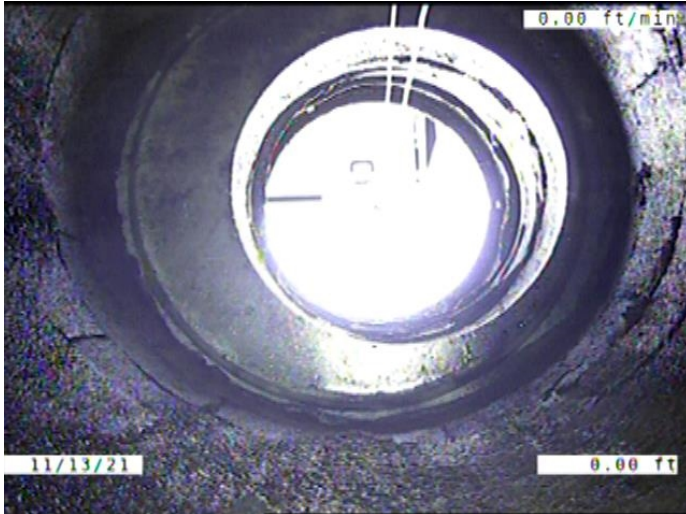
Code: **AMH**
 Description: **Manhole**

Distance (ft): **.0**
 Structural Grade: **0**
 O&M Grade: **0**
 Clock Start/From:
 Clock To:
 1st Value:
 2nd Value:
 Value Percent:
 Continuous Index:
 Within 8" of Joint: **NO**
 Remarks: **M-604-007**

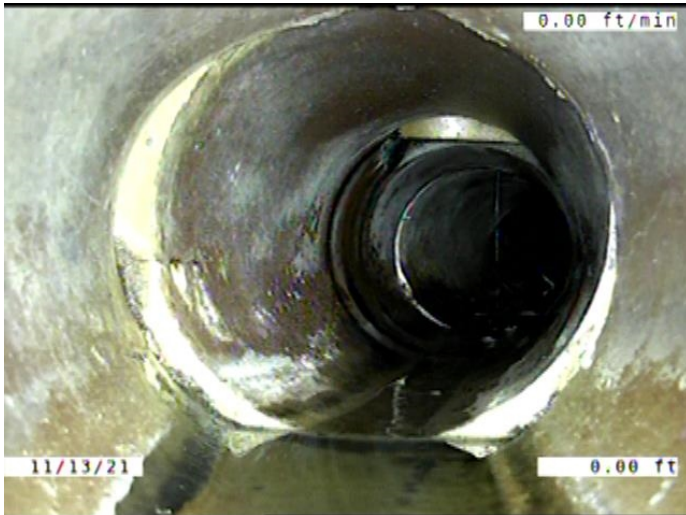
Code: **MWL**
 Description: **Miscellaneous Water Level**

Distance (ft): **.0**
 Structural Grade: **0**
 O&M Grade: **0**
 Clock Start/From:
 Clock To:
 1st Value:
 2nd Value:
 Value Percent: **5.000**
 Continuous Index:
 Within 8" of Joint: **NO**
 Remarks:

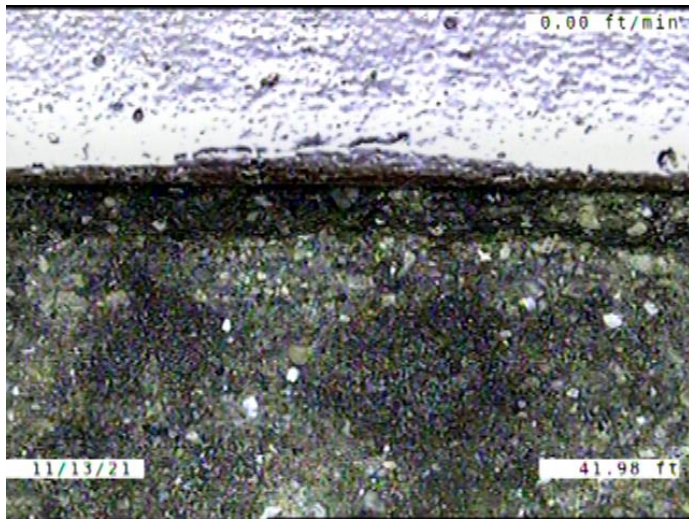
Code: **MMC**
 Description: **Miscellaneous Material Change**

Distance (ft): **42.0**
 Structural Grade: **0**
 O&M Grade: **0**
 Clock Start/From:
 Clock To:
 1st Value:
 2nd Value:
 Value Percent:
 Continuous Index:
 Within 8" of Joint: **NO**
 Remarks: **VCP TO CONCRETE**

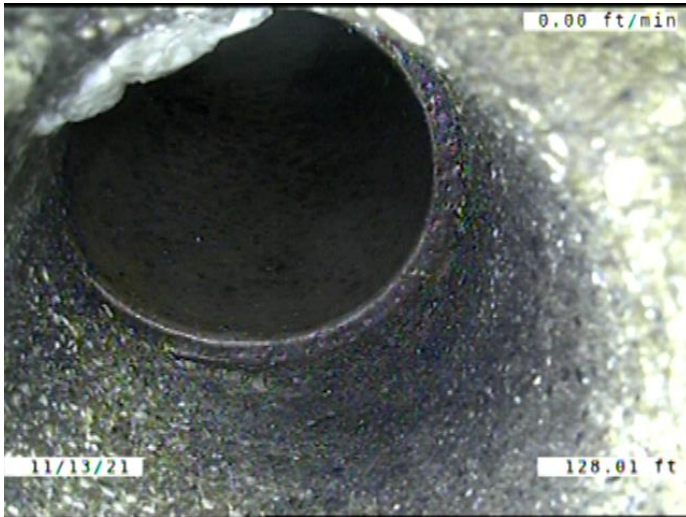
Code: **TF**
 Description: **Tap Factory**

Distance (ft): **128.0**
 Structural Grade: **0**
 O&M Grade: **0**
 Clock Start/From: **10**
 Clock To:
 1st Value: **4.000**
 2nd Value:
 Value Percent:
 Continuous Index:
 Within 8" of Joint: **YES**
 Remarks:

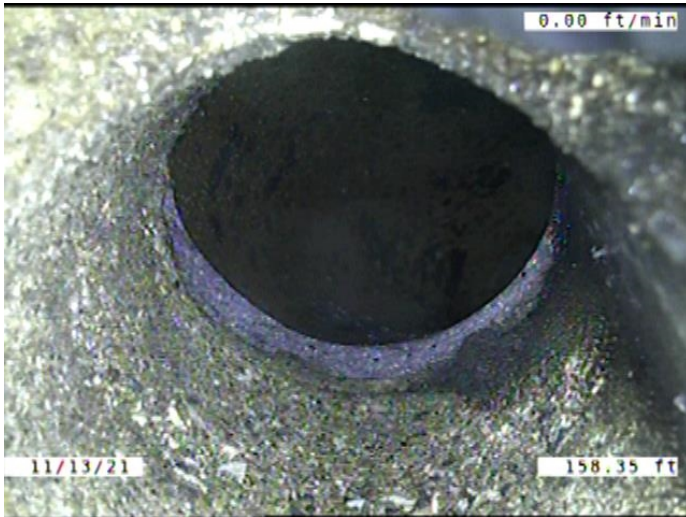
Code: **TF**
 Description: **Tap Factory**

Distance (ft): **158.4**
 Structural Grade: **0**
 O&M Grade: **0**
 Clock Start/From: **2**
 Clock To:
 1st Value: **6.000**
 2nd Value:
 Value Percent:
 Continuous Index:
 Within 8" of Joint: **YES**
 Remarks:

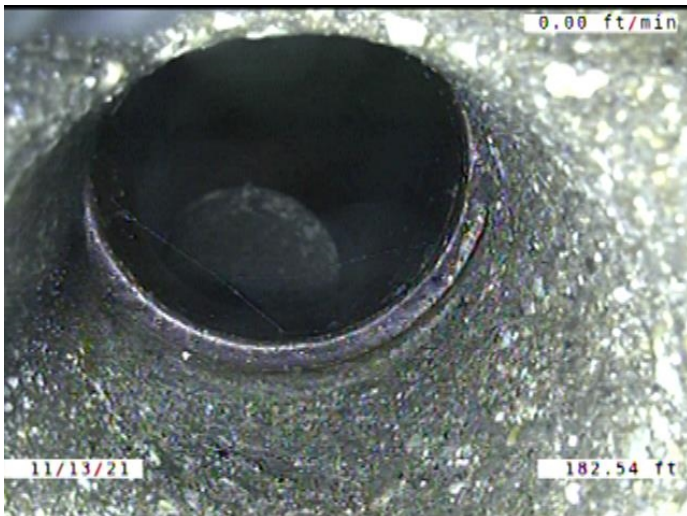
Code: **TF**
 Description: **Tap Factory**

Distance (ft): **182.5**
 Structural Grade: **0**
 O&M Grade: **0**
 Clock Start/From: **10**
 Clock To:
 1st Value: **6.000**
 2nd Value:
 Value Percent:
 Continuous Index:
 Within 8" of Joint: **YES**
 Remarks:

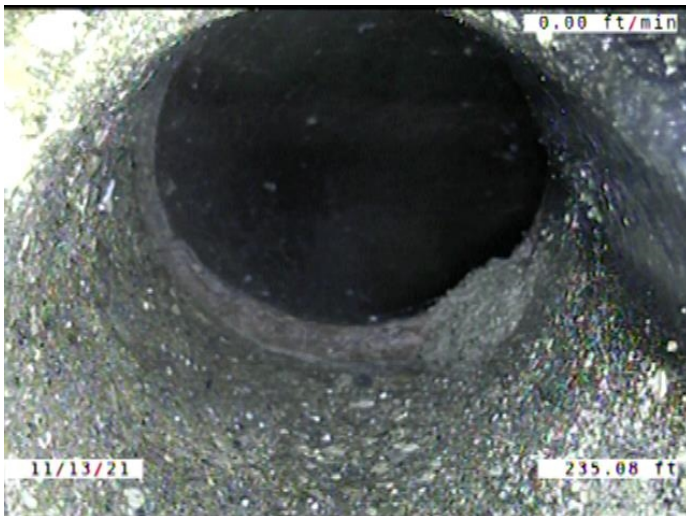
Code: **TF**
 Description: **Tap Factory**

Distance (ft): **235.1**
 Structural Grade: **0**
 O&M Grade: **0**
 Clock Start/From: **2**
 Clock To:
 1st Value: **6.000**
 2nd Value:
 Value Percent:
 Continuous Index:
 Within 8" of Joint: **YES**
 Remarks:

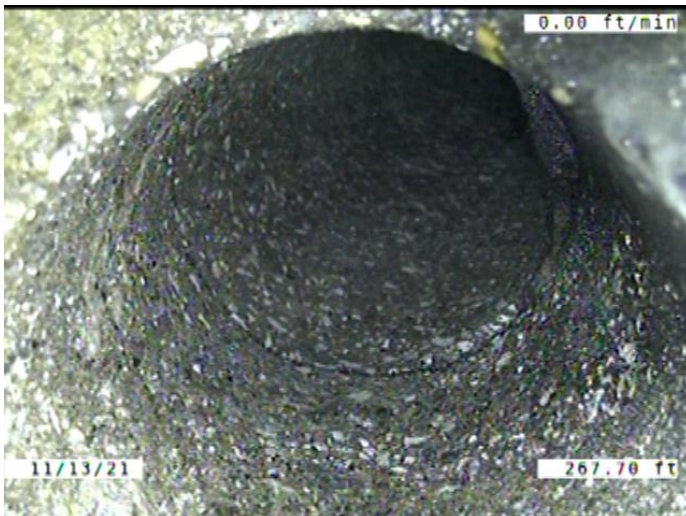
Code: **TF**
 Description: **Tap Factory**

Distance (ft): **267.7**
 Structural Grade: **0**
 O&M Grade: **0**
 Clock Start/From: **1**
 Clock To:
 1st Value: **6.000**
 2nd Value:
 Value Percent:
 Continuous Index:
 Within 8" of Joint: **YES**
 Remarks:

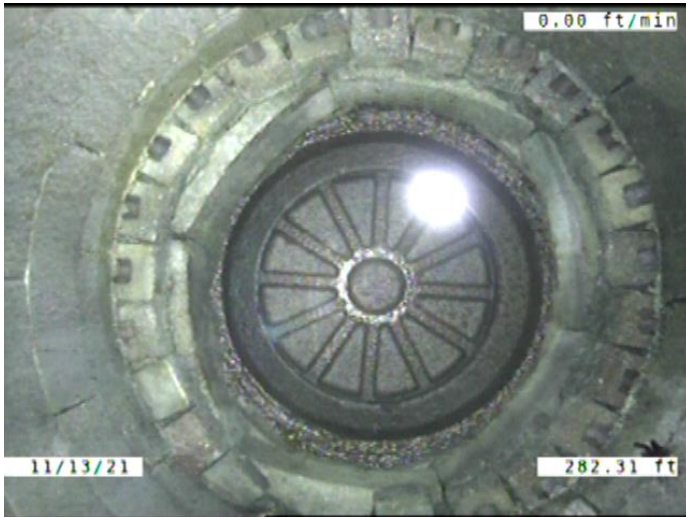
Code:	AMH
Description:	Manhole
Distance (ft):	282.3
Structural Grade:	0
O&M Grade:	0
Clock Start/From:	
Clock To:	
1st Value:	
2nd Value:	
Value Percent:	
Continuous Index:	
Within 8" of Joint:	NO
Remarks:	M-604-008
