Profile/Photo Observation Report

Date:	04/23/2018	Weather:		Coding:	PACP 6.0
Pipe Length (ft):	303.1	Owner:	NA	Pre Clean:	Not Known
P.O.#:		Surveyor:	Jen Costello	PSR:	P-604-030-028
Customer:		Clean Date:	01/01/1900	Shape:	C

Street:	Summerlin	Flow Control:	Not Controlled
City:	Hobart, IN	Year Renewed:	
Location:	Light Highway	Tape/Media #:	
Purpose:	Not Known	Dia/Height:	10"
Use:	Sanitary	Material:	VCP
Drain Area:	NA	Lining:	
Category:	NA		
Comment:

Location Details:		Direction of Survey:	Downstream
US MH:	M-604-028	DS MH:	M-604-030
		Total Length Surveyed (ft):	277.8

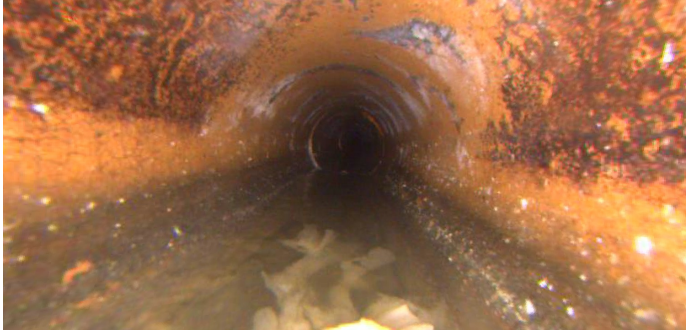
Code: **AMH**
Description: **Manhole**

Distance (ft): **.0**
Structural Grade: **0**
O&M Grade: **0**
Clock Start/From:
Clock To:
1st Value:
2nd Value:
Value Percent:
Continuous Index:
Within 8" of Joint: **NO**
Remarks: **M-604-028**

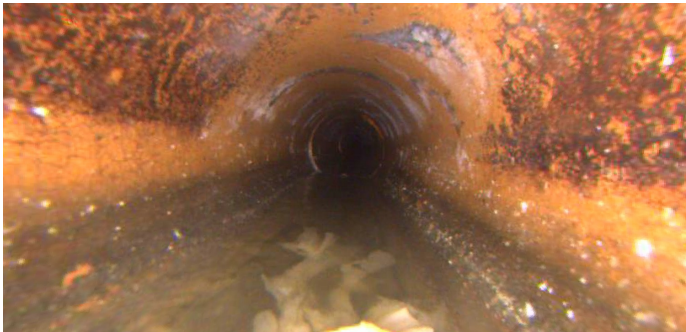
Code: **MWL**
Description: **Water Level**

Distance (ft): **.0**
Structural Grade: **0**
O&M Grade: **0**
Clock Start/From:
Clock To:
1st Value:
2nd Value:
Value Percent: **10.000**
Continuous Index:
Within 8" of Joint: **NO**
Remarks:

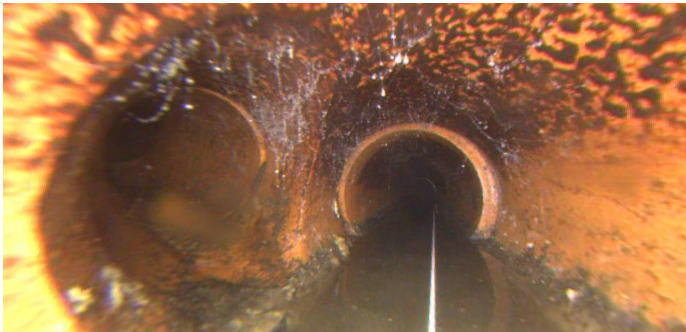
Code: **TFA**
Description: **Tap Factory Active**

Distance (ft): **161.5**
Structural Grade: **0**
O&M Grade: **0**
Clock Start/From: **3**
Clock To:
1st Value: **4.000**
2nd Value:
Value Percent:
Continuous Index:
Within 8" of Joint:
Remarks:

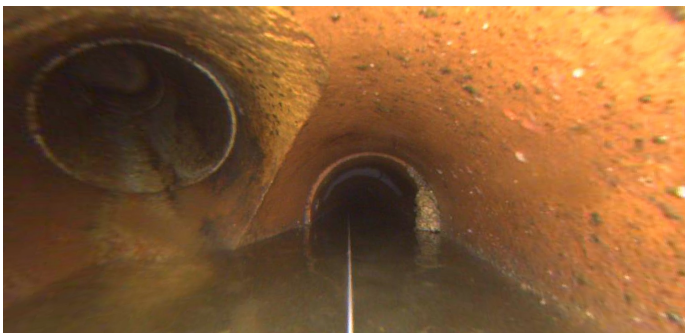
Code: **TFA**
Description: **Tap Factory Active**

Distance (ft): **271.9**
Structural Grade: **0**
O&M Grade: **0**
Clock Start/From: **2**
Clock To:
1st Value: **4.000**
2nd Value:
Value Percent:
Continuous Index:
Within 8" of Joint:
Remarks:
