Profile/Photo Observation Report

Date:	04/12/2018	Weather:		Coding:	PACP 6.0
Pipe Length (ft):		Owner:	City of Hobart	Pre Clean:	Not Known
P.O.#:	240	Surveyor:	B. Helbling	PSR:	P-604-044-043
Customer:	City of Hobart	Clean Date:		Shape:	C

Street:	North Ash Street	Flow Control:	Not Controlled
City:	Hobart, IN	Year Renewed:	
Location:	Light Highway	Tape/Media #:	DEP240
Purpose:	Routine Assessment	Dia/Height:	15"
Use:	Sanitary	Material:	VCP
Drain Area:		Lining:	
Category:	NA		
Comment:	YES501824 Submittal 2		
Location Details:		Direction of Survey:	Downstream
US MH:	M-604-043	DS MH:	M-604-044
		Total Length Surveyed (ft):	44.3

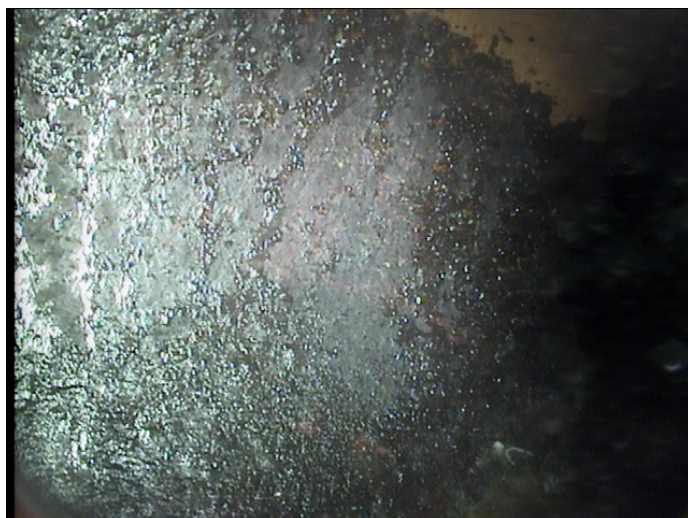
Code: **AMH**
Description: **Manhole**

Distance (ft): **.0**
Structural Grade: **0**
O&M Grade: **0**
Clock Start/From:
Clock To:
1st Value:
2nd Value:
Value Percent:
Continuous Index:
Within 8" of Joint: **NO**
Remarks: **M-604-043**

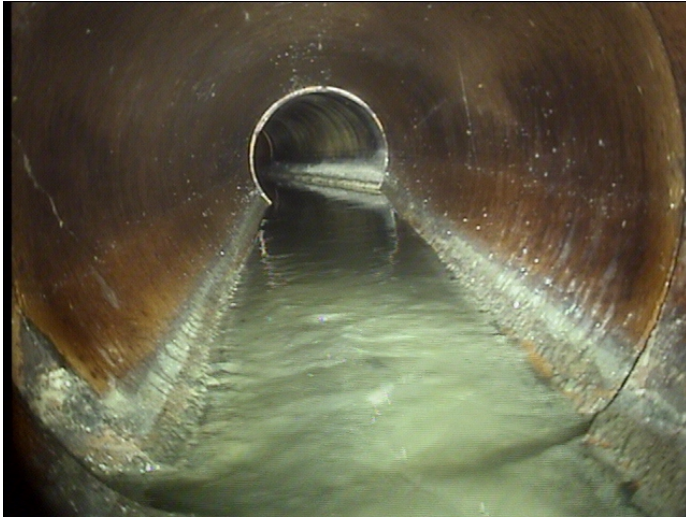
Code: **MWL**
Description: **Water Level**

Distance (ft): **.0**
Structural Grade: **0**
O&M Grade: **0**
Clock Start/From:
Clock To:
1st Value:
2nd Value:
Value Percent: **10.000**
Continuous Index:
Within 8" of Joint: **NO**
Remarks:
