## Profile/Photo Observation Report

Date:	<b>08/10/2022</b>	Weather:		Coding:	<b>PACP 7.0</b>
Pipe Length (ft):	<b>176.0</b>	Owner:	<b>City of Hobart</b>	Pre Clean:	<b>Heavy Cleaning</b>
P.O.#:	<b>YES502259</b>	Surveyor:	<b>S. Bucklin</b>	PSR:	<b>P-604-056-057</b>
Customer:	<b>City of Hobart</b>	Clean Date:	<b>08/03/2022</b>	Shape:	<b>C</b>

Street:	<b>North Connecticut Street</b>	Flow Control:	<b>Not Controlled</b>
City:	<b>Hobart, IN</b>	Year Renewed:	
Location:	<b>Local rural streets with light traffic, t</b>	Tape/Media #:	
Purpose:	<b>Routine Assessment</b>	Dia/Height:	<b>18"</b>
Use:	<b>Sanitary Sewage Pipe</b>	Material:	<b>VCP</b>
Drain Area:		Lining:	<b>None</b>
Category:	<b>NA</b>		
Comment:			
Location Details:		Direction of Survey:	<b>Downstream</b>
US MH:	<b>M-604-056</b>	DS MH:	<b>M-604-057</b>
		Total Length Surveyed (ft):	<b>173.7</b>

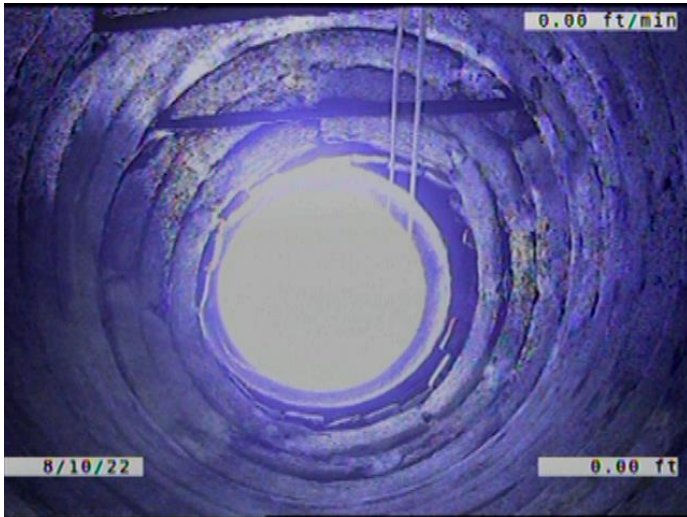
Code: **AMH**  
 Description: **Manhole**

Distance (ft): **.0**  
 Structural Grade: **0**  
 O&M Grade: **0**  
 Clock Start/From:  
 Clock To:  
 1st Value:  
 2nd Value:  
 Value Percent:  
 Continuous Index:  
 Within 8" of Joint: **NO**  
 Remarks: **M-604-056**

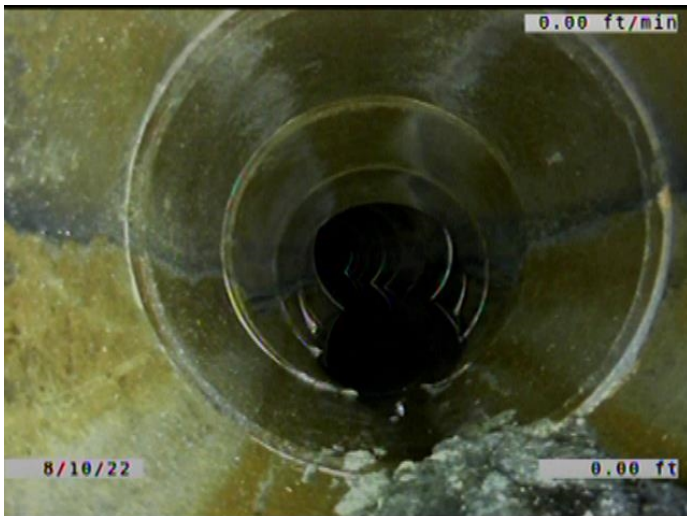
Code: **MWL**  
 Description: **Miscellaneous Water Level**

Distance (ft): **.0**  
 Structural Grade: **0**  
 O&M Grade: **0**  
 Clock Start/From:  
 Clock To:  
 1st Value:  
 2nd Value:  
 Value Percent: **5.000**  
 Continuous Index:  
 Within 8" of Joint: **NO**  
 Remarks:

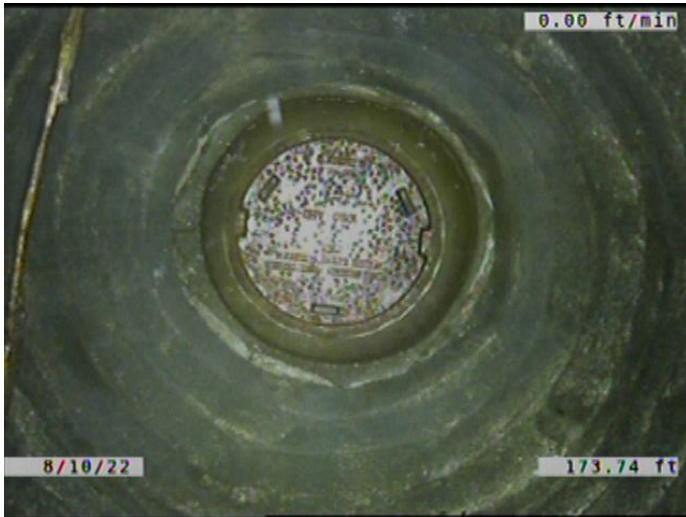
Code:	AMH
Description:	Manhole
Distance (ft):	173.7
Structural Grade:	0
O&M Grade:	0
Clock Start/From:	
Clock To:	
1st Value:	
2nd Value:	
Value Percent:	
Continuous Index:	
Within 8" of Joint:	NO
Remarks:	M-604-057
