Profile/Photo Observation Report

| Street: | N CONNECTICUT ST | Flow Control: | Not Controlled |
| City: | Hobart, IN | Year Renewed: | |

| US MH: | M-604-057 | DS MH: | M-604-109 |

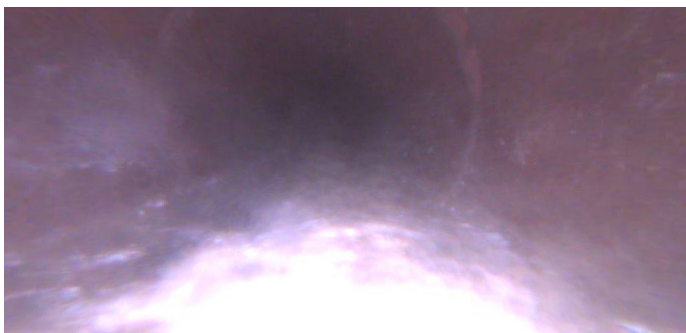
Code: **AMH**
Description: **Manhole**

Distance (ft): **.0**
Structural Grade: **0**
O&M Grade: **0**
Clock Start/From:
Clock To:
1st Value:
2nd Value:
Value Percent:
Continuous Index:
Within 8" of Joint: **NO**
Remarks: **M-604-057**

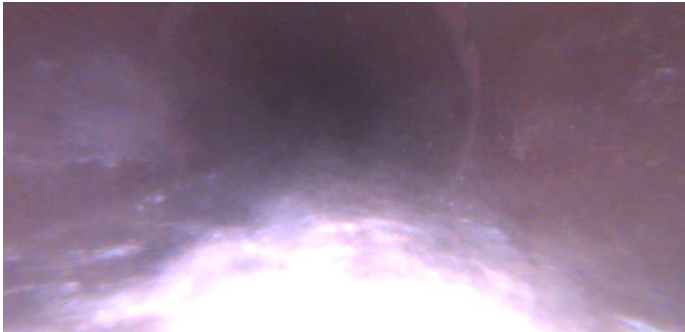
| Code: | MWL |
| Description: | Water Level |

| Value Percent: | 5.000 |

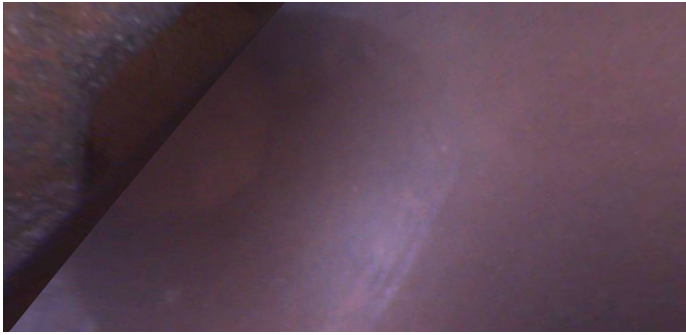
Code: **TFC**
Description: **Tap Factory Capped**

Distance (ft): **29.7**
Structural Grade: **0**
O&M Grade: **0**
Clock Start/From: **10**
Clock To:
1st Value: **4.000**
2nd Value:
Value Percent:
Continuous Index:
Within 8" of Joint: **YES**
Remarks:

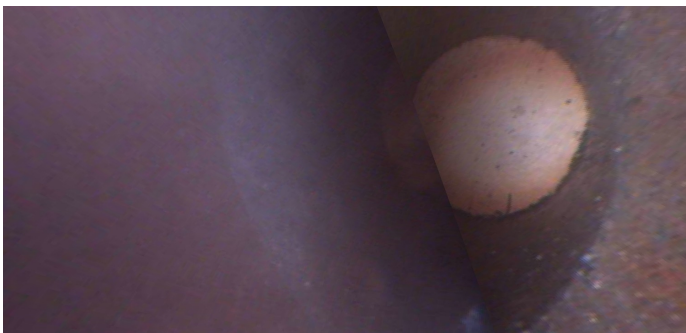
Code: **TFC**
Description: **Tap Factory Capped**

Distance (ft): **39.7**
Structural Grade: **0**
O&M Grade: **0**
Clock Start/From: **2**
Clock To:
1st Value: **4.000**
2nd Value:
Value Percent:
Continuous Index:
Within 8" of Joint: **YES**
Remarks:

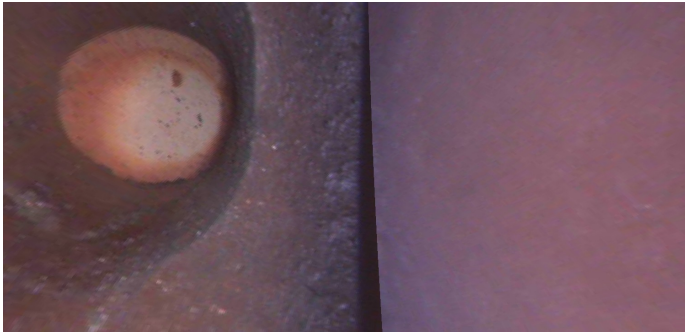
Code: **TFC**
Description: **Tap Factory Capped**

Distance (ft): **52.3**
Structural Grade: **0**
O&M Grade: **0**
Clock Start/From: **10**
Clock To:
1st Value: **4.000**
2nd Value:
Value Percent:
Continuous Index:
Within 8" of Joint: **YES**
Remarks:

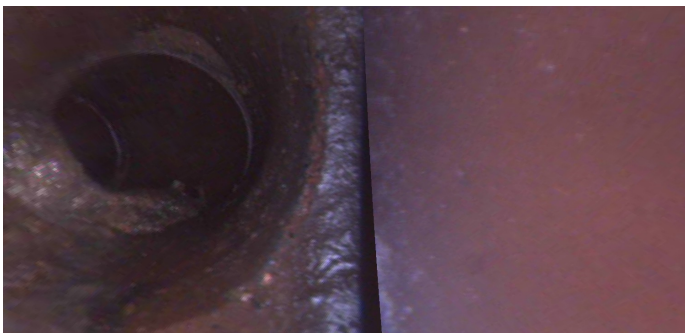
Code: **TF**
Description: **Tap Factory**

Distance (ft): **77.9**
Structural Grade: **0**
O&M Grade: **0**
Clock Start/From: **10**
Clock To:
1st Value: **4.000**
2nd Value:
Value Percent:
Continuous Index:
Within 8" of Joint: **YES**
Remarks:

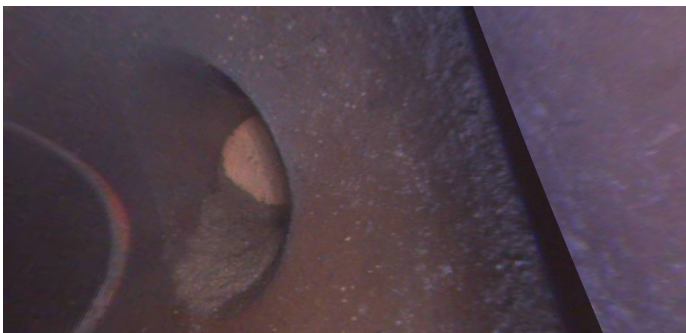
Code: **TFC**
Description: **Tap Factory Capped**

Distance (ft): **102.4**
Structural Grade: **0**
O&M Grade: **0**
Clock Start/From: **10**
Clock To:
1st Value: **4.000**
2nd Value:
Value Percent:
Continuous Index:
Within 8" of Joint: **YES**
Remarks:

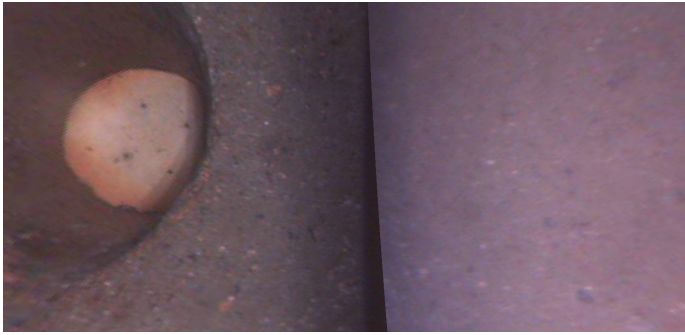
Code: **TFC**
Description: **Tap Factory Capped**

Distance (ft): **128.6**
Structural Grade: **0**
O&M Grade: **0**
Clock Start/From: **10**
Clock To:
1st Value: **4.000**
2nd Value:
Value Percent:
Continuous Index:
Within 8" of Joint: **YES**
Remarks:

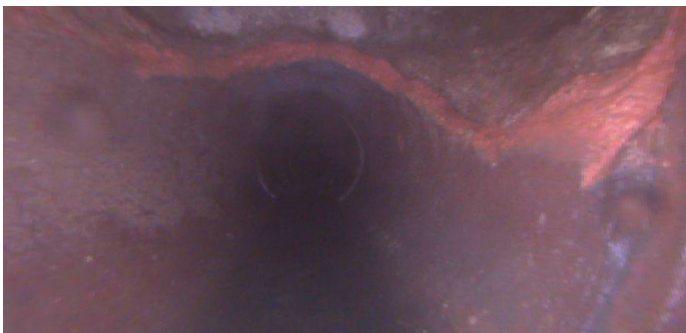
Code: **AMH**
Description: **Manhole**

Distance (ft): **137.4**
Structural Grade: **0**
O&M Grade: **0**
Clock Start/From:
Clock To:
1st Value:
2nd Value:
Value Percent:
Continuous Index:
Within 8" of Joint: **NO**
Remarks: **M-604-109**
