Profile/Photo Observation Report

Date:	11/10/2021	Weather:		Coding:	PACP 7.0
Pipe Length (ft):	164.5	Owner:	City of Hobart	Pre Clean:	Heavy Cleaning
P.O.#:	YES502259	Surveyor:	Steven Bucklin	PSR:	P-604-107-058
Customer:	City of Hobart, IN (Red	Clean Date:	11/10/2021	Shape:	C

Street:	West Home Avenue	Flow Control:	Not Controlled
City:	City of Hobart	Year Renewed:	
Location:	Local rural streets with light traffic, t	Tape/Media #:	
Purpose:	Routine Assessment	Dia/Height:	10"
Use:	Sanitary Sewage Pipe	Material:	VCP
Drain Area:		Lining:	None
Category:	NA		
Comment:			
Location Details:		Direction of Survey:	Downstream
US MH:	M-604-058	DS MH:	M-604-107
		Total Length Surveyed (ft):	164.5

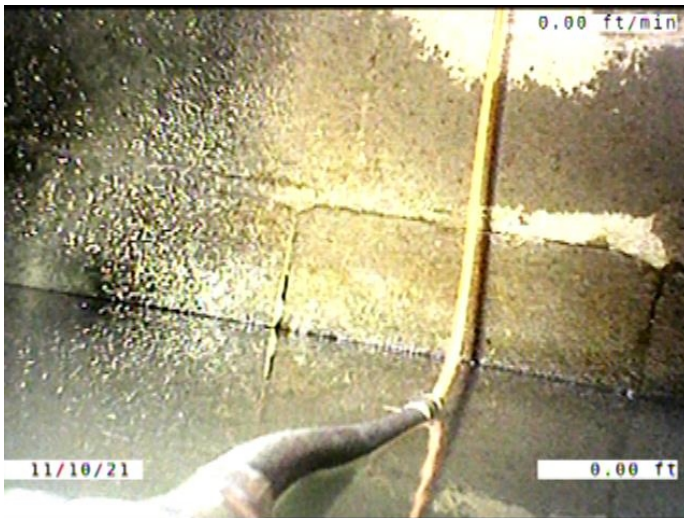
Code: **AMH**
Description: **Manhole**

Distance (ft): **.0**
Structural Grade: **0**
O&M Grade: **0**
Clock Start/From:
Clock To:
1st Value:
2nd Value:
Value Percent:
Continuous Index:
Within 8" of Joint: **NO**
Remarks: **M-604-058**
