## Profile/Photo Observation Report

Date:	<b>11/08/2021</b>	Weather:		Coding:	<b>PACP 7.0</b>
Pipe Length (ft):	<b>218.0</b>	Owner:	<b>City of Hobart</b>	Pre Clean:	<b>Heavy Cleaning</b>
P.O.#:	<b>YES502259</b>	Surveyor:	<b>Steven Bucklin</b>	PSR:	<b>P-604-065-064</b>
Customer:	<b>City of Hobart, IN (Red</b>	Clean Date:	<b>11/08/2021</b>	Shape:	<b>C</b>

Street:	<b>North Pennsylvania Street</b>	Flow Control:	<b>Not Controlled</b>
City:	<b>City of Hobart</b>	Year Renewed:	
Location:	<b>Local rural streets with light traffic, t</b>	Tape/Media #:	
Purpose:	<b>Routine Assessment</b>	Dia/Height:	<b>12"</b>
Use:	<b>Sanitary Sewage Pipe</b>	Material:	<b>VCP</b>
Drain Area:		Lining:	<b>None</b>
Category:	<b>NA</b>		
Comment:			
Location Details:		Direction of Survey:	<b>Upstream</b>
US MH:	<b>M-604-065</b>	DS MH:	<b>M-604-064</b>
		Total Length Surveyed (ft):	<b>218.0</b>

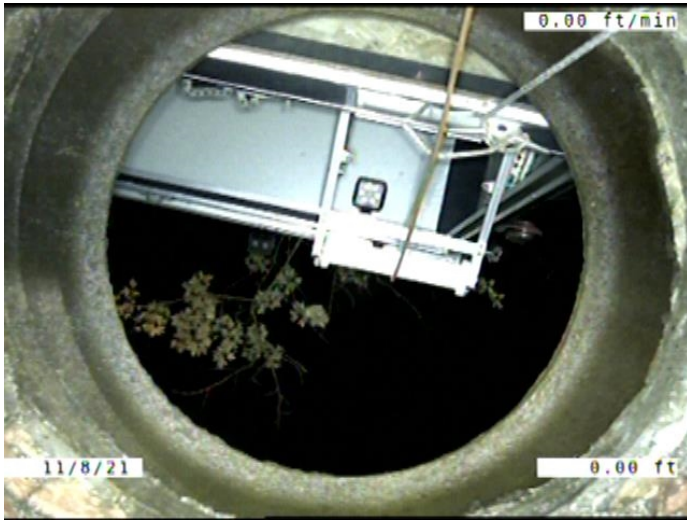
Code: **AMH**  
Description: **Manhole**

Distance (ft): **.0**  
Structural Grade: **0**  
O&M Grade: **0**  
Clock Start/From:  
Clock To:  
1st Value:  
2nd Value:  
Value Percent:  
Continuous Index:  
Within 8" of Joint: **NO**  
Remarks: **M-604-064**

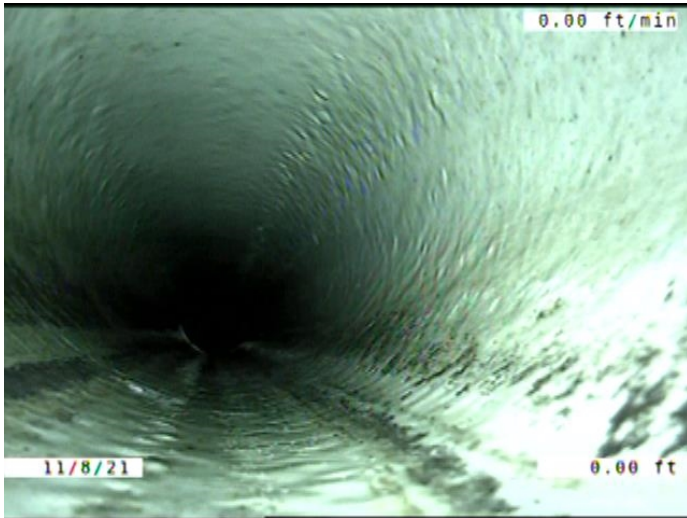
Code: **MWL**  
Description: **Miscellaneous Water Level**

Distance (ft): **.0**  
Structural Grade: **0**  
O&M Grade: **0**  
Clock Start/From:  
Clock To:  
1st Value:  
2nd Value:  
Value Percent: **5.000**  
Continuous Index:  
Within 8" of Joint: **NO**  
Remarks:

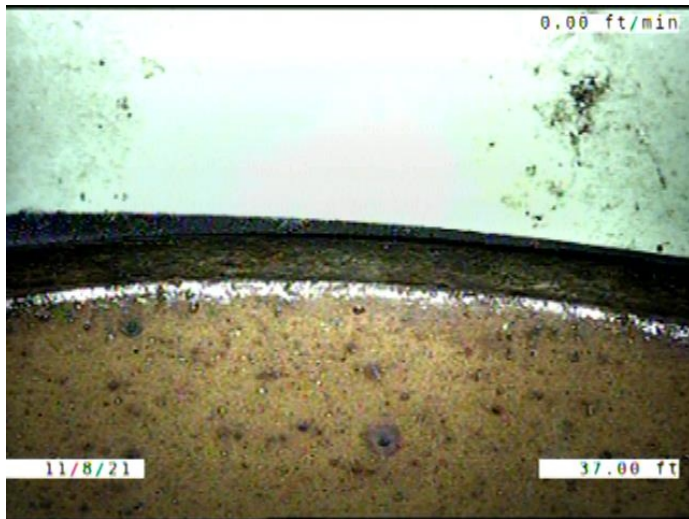
Code: **MMC**  
 Description: **Miscellaneous Material Change**

Distance (ft): **37.0**  
 Structural Grade: **0**  
 O&M Grade: **0**  
 Clock Start/From:  
 Clock To:  
 1st Value:  
 2nd Value:  
 Value Percent:  
 Continuous Index:  
 Within 8" of Joint: **NO**  
 Remarks: **PVC TO VCP**

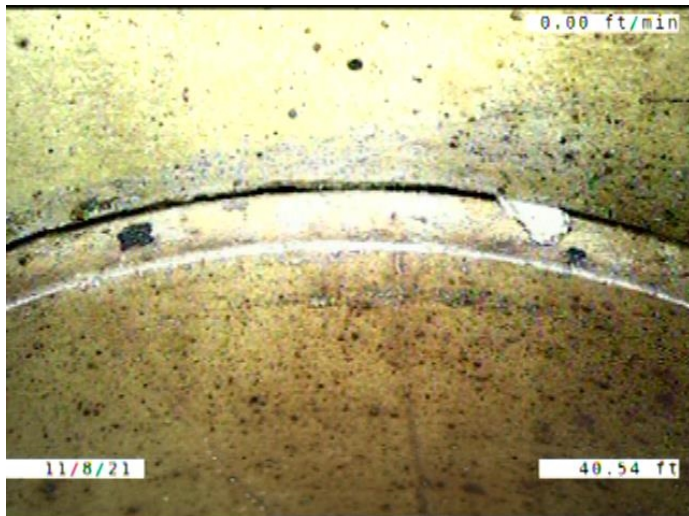
Code: **MWL**  
 Description: **Miscellaneous Water Level**

Distance (ft): **40.5**  
 Structural Grade: **0**  
 O&M Grade: **0**  
 Clock Start/From:  
 Clock To:  
 1st Value:  
 2nd Value:  
 Value Percent: **30.000**  
 Continuous Index:  
 Within 8" of Joint: **NO**  
 Remarks:

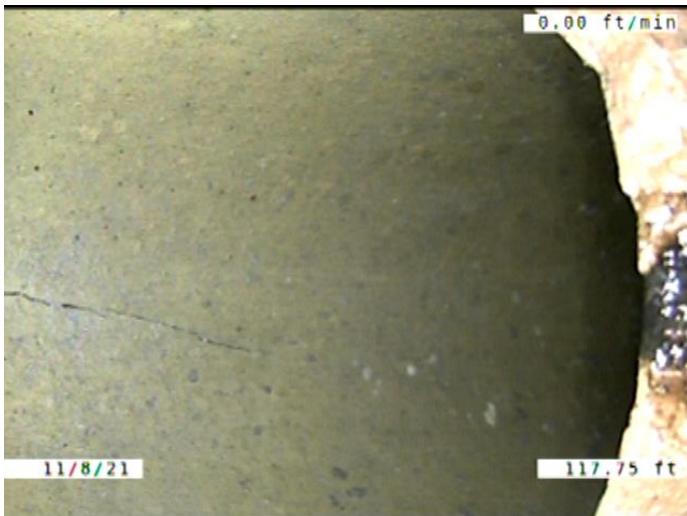
Code: **TB**  
Description: **Tap Break-in/Hammer**

Distance (ft): **117.7**  
Structural Grade: **0**  
O&M Grade: **0**  
Clock Start/From: **1**  
Clock To:  
1st Value: **4.000**  
2nd Value:  
Value Percent:  
Continuous Index:  
Within 8" of Joint: **YES**  
Remarks:

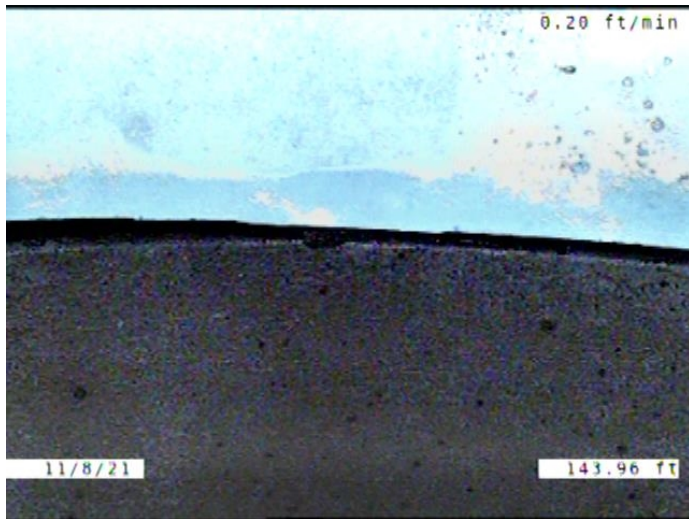
Code:	<b>MMC</b>
Description:	<b>Miscellaneous Material Change</b>
Distance (ft):	<b>144.0</b>
Structural Grade:	<b>0</b>
O&M Grade:	<b>0</b>
Clock Start/From:	
Clock To:	
1st Value:	
2nd Value:	
Value Percent:	
Continuous Index:	
Within 8" of Joint:	<b>NO</b>
Remarks:	<b>PVC TO VCP</b>

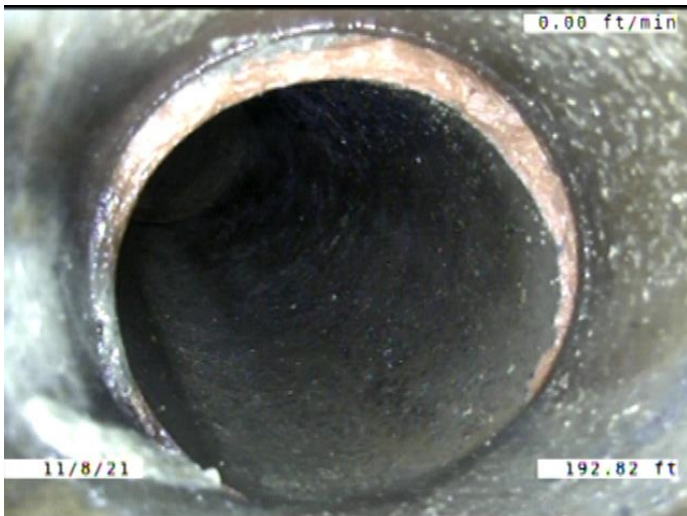
Code: **TF**  
Description: **Tap Factory**

Distance (ft): **192.8**  
Structural Grade: **0**  
O&M Grade: **0**  
Clock Start/From: **10**  
Clock To:  
1st Value: **4.000**  
2nd Value:  
Value Percent:  
Continuous Index:  
Within 8" of Joint: **YES**  
Remarks:

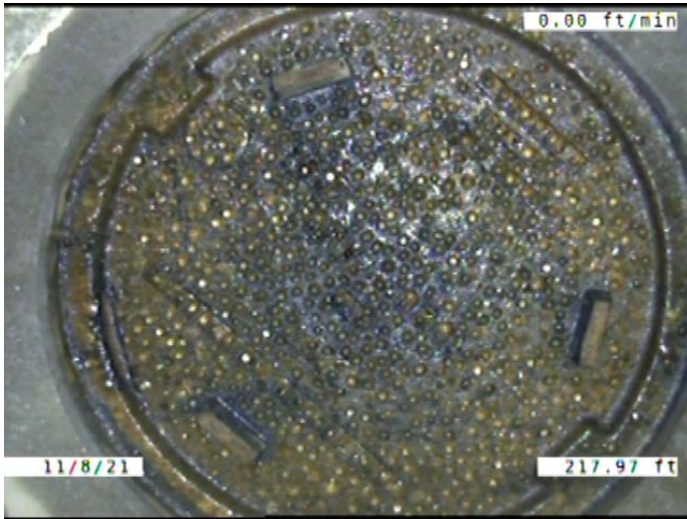
Code:	AMH
Description:	Manhole
Distance (ft):	218.0
Structural Grade:	0
O&M Grade:	0
Clock Start/From:	
Clock To:	
1st Value:	
2nd Value:	
Value Percent:	
Continuous Index:	
Within 8" of Joint:	NO
Remarks:	M-604-065
