Profile/Photo Observation Report

| Street: | S Pennsylvania St. | Flow Control: | Not Controlled |
| City: | Hobart, IN | Year Renewed: | |

| US MH: | M-604-067 | DS MH: | M-604-066 |

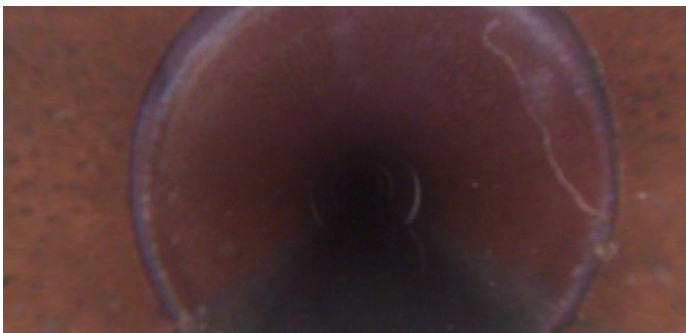
Code: **MWL**
Description: **Water Level**

Distance (ft): **.0**
Structural Grade: **0**
O&M Grade: **0**
Clock Start/From:
Clock To:
1st Value:
2nd Value:
Value Percent: **5.000**
Continuous Index:
Within 8" of Joint: **NO**
Remarks:

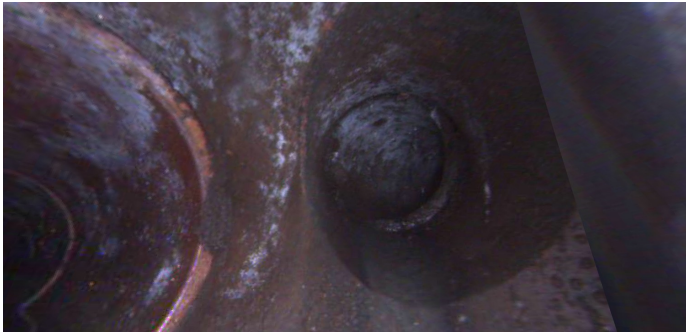
Code: **TF**
Description: **Tap Factory**

Distance (ft): **69.8**
Structural Grade: **0**
O&M Grade: **0**
Clock Start/From: **9**
Clock To:
1st Value: **4.000**
2nd Value:
Value Percent:
Continuous Index:
Within 8" of Joint:
Remarks:

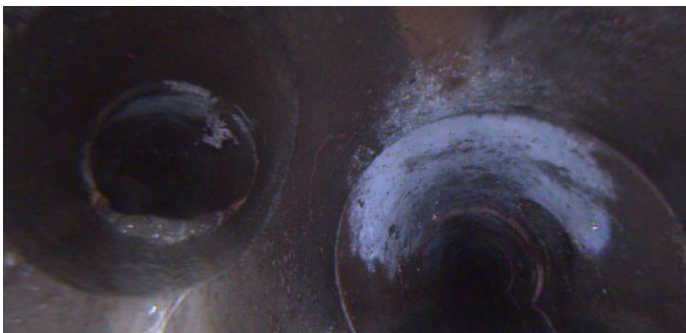
Code: **TFA**
Description: **Tap Factory Active**

Distance (ft): **72.2**
Structural Grade: **0**
O&M Grade: **0**
Clock Start/From: **2**
Clock To:
1st Value: **4.000**
2nd Value:
Value Percent:
Continuous Index:
Within 8" of Joint:
Remarks:

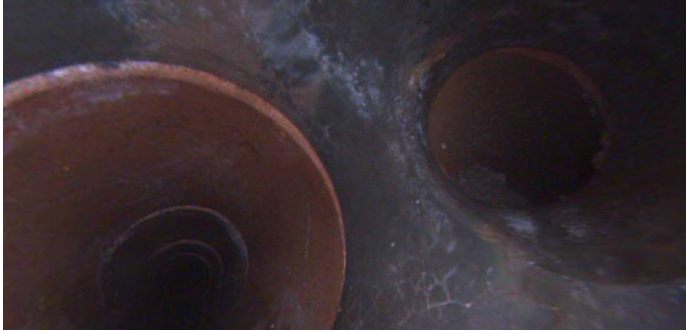
Code: **TF**
Description: **Tap Factory**

Distance (ft): **111.9**
Structural Grade: **0**
O&M Grade: **0**
Clock Start/From: **10**
Clock To:
1st Value: **4.000**
2nd Value:
Value Percent:
Continuous Index:
Within 8" of Joint:
Remarks:

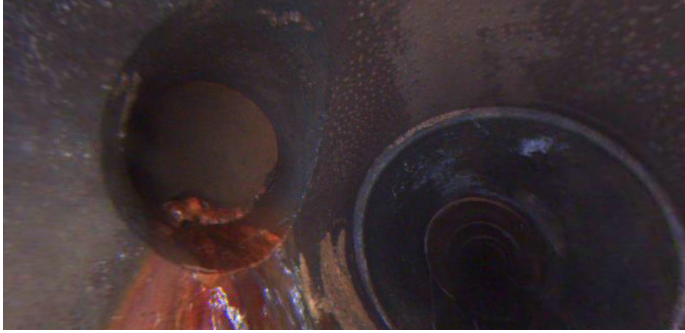
Code: **TFA**
Description: **Tap Factory Active**

Distance (ft): **114.3**
Structural Grade: **0**
O&M Grade: **0**
Clock Start/From: **2**
Clock To:
1st Value: **4.000**
2nd Value:
Value Percent:
Continuous Index:
Within 8" of Joint:
Remarks:

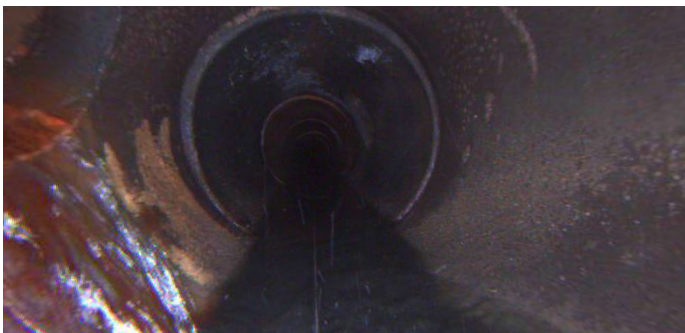
Code: **MGO**
Description: **General Observation**

Distance (ft): **114.3**
Structural Grade: **0**
O&M Grade: **0**
Clock Start/From:
Clock To:
1st Value:
2nd Value:
Value Percent:
Continuous Index:
Within 8" of Joint: **NO**
Remarks: **rear camera**

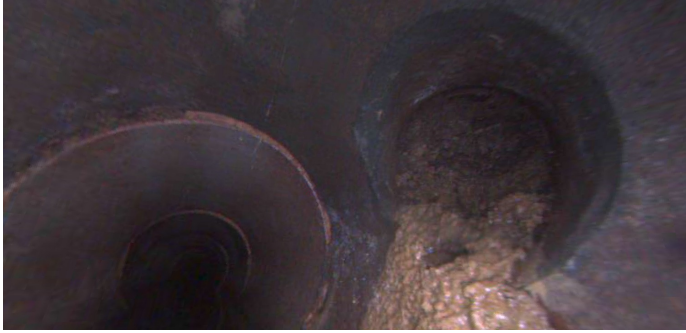
Code: **TFC**
Description: **Tap Factory Capped**

Distance (ft): **152.1**
Structural Grade: **0**
O&M Grade: **0**
Clock Start/From: **9**
Clock To:
1st Value: **4.000**
2nd Value:
Value Percent:
Continuous Index:
Within 8" of Joint:
Remarks: **dae**

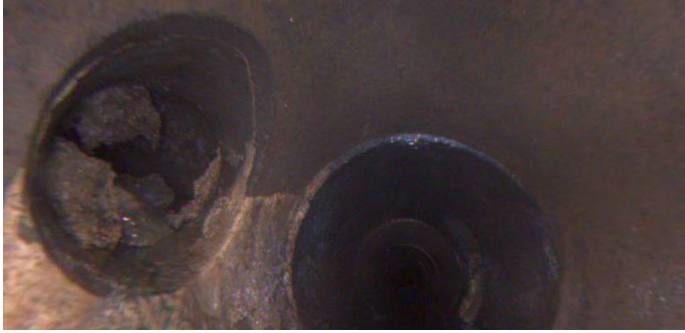
Code: **TF**
Description: **Tap Factory**

Distance (ft): **154.2**
Structural Grade: **0**
O&M Grade: **0**
Clock Start/From: **3**
Clock To:
1st Value: **4.000**
2nd Value:
Value Percent:
Continuous Index:
Within 8" of Joint:
Remarks:

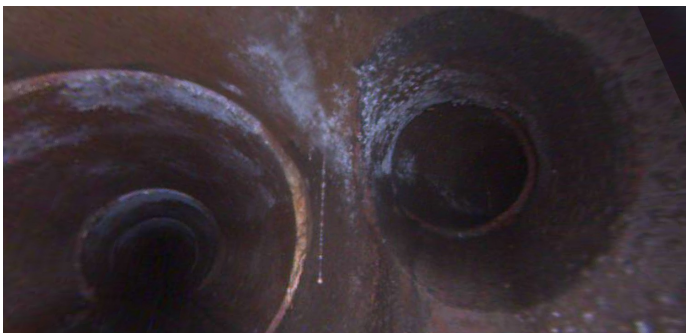
Code: **TF**
Description: **Tap Factory**

Distance (ft): **191.7**
Structural Grade: **0**
O&M Grade: **0**
Clock Start/From: **9**
Clock To:
1st Value: **4.000**
2nd Value:
Value Percent:
Continuous Index:
Within 8" of Joint:
Remarks:

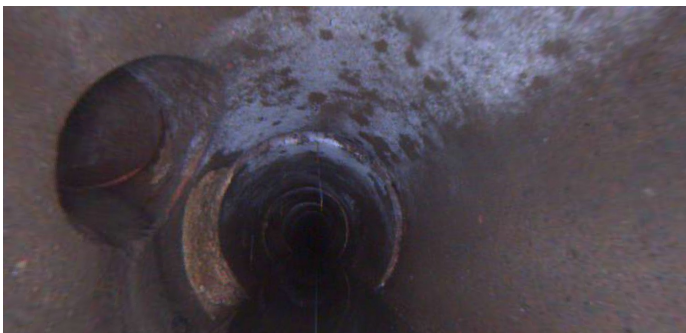
Code: **TFA**
Description: **Tap Factory Active**

Distance (ft): **194.3**
Structural Grade: **0**
O&M Grade: **0**
Clock Start/From: **2**
Clock To:
1st Value: **4.000**
2nd Value:
Value Percent:
Continuous Index:
Within 8" of Joint:
Remarks:

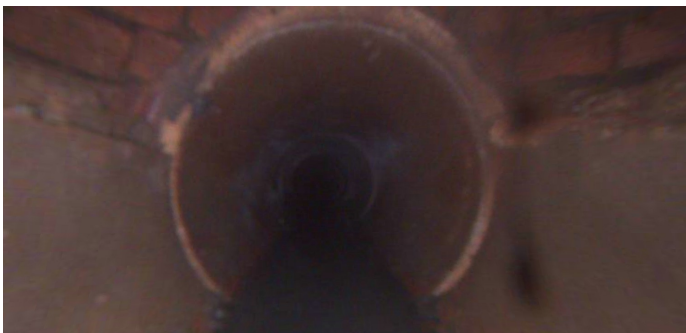
Code: **AMH**
Description: **Manhole**

Distance (ft): **227.3**
Structural Grade: **0**
O&M Grade: **0**
Clock Start/From:
Clock To:
1st Value:
2nd Value:
Value Percent:
Continuous Index:
Within 8" of Joint: **NO**
Remarks: **M-604-066**
