Profile/Photo Observation Report

Date:	04/20/2018	Weather:		Coding:	PACP 6.0
Pipe Length (ft):	270.1	Owner:	NA	Pre Clean:	Not Known
P.O.#:		Surveyor:	Byrd Fitzgerald	PSR:	P-604-069-068
Customer:		Clean Date:	01/01/1900	Shape:	C

Street:	Summerlin	Flow Control:	Not Controlled
City:	Hobart, IN	Year Renewed:	
Location:	Light Highway	Tape/Media #:	
Purpose:	Not Known	Dia/Height:	10"
Use:	Sanitary	Material:	VCP
Drain Area:	NA	Lining:	
Category:	NA		
Comment:

Location Details:		Direction of Survey:	Downstream
US MH:	M-604-068	DS MH:	M-604-069
		Total Length Surveyed (ft):	58.1

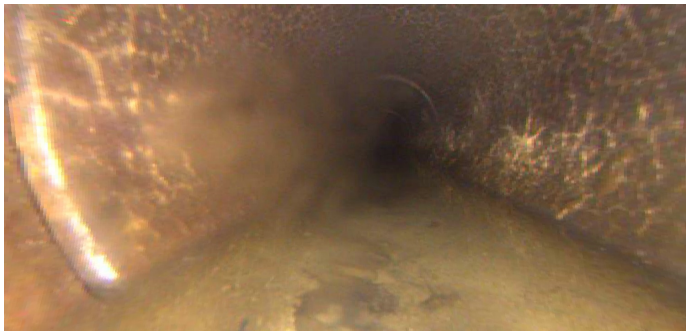
Code: **AMH**
Description: **Manhole**

Distance (ft): **.0**
Structural Grade: **0**
O&M Grade: **0**
Clock Start/From:
Clock To:
1st Value:
2nd Value:
Value Percent:
Continuous Index:
Within 8" of Joint: **NO**
Remarks: **M-604-068**
