Profile/Photo Observation Report

Date:	11/17/2021	Weather:		Coding:	PACP 7.0
Pipe Length (ft):	223.5	Owner:	City of Hobart	Pre Clean:	Heavy Cleaning
P.O.#:	YES502259	Surveyor:	S. Bucklin	PSR:	P-604-074-073
Customer:	City of Hobart	Clean Date:	11/17/2021	Shape:	C

Street:	North Washington Street	Flow Control:	Not Controlled
City:	Hobart, IN	Year Renewed:	
Location:	Easement/Right of Way	Tape/Media #:	
Purpose:	Routine Assessment	Dia/Height:	12"
Use:	Sanitary Sewage Pipe	Material:	VCP
Drain Area:		Lining:	None
Category:	NA		
Comment:			
Location Details:		Direction of Survey:	Downstream
US MH:	M-604-074	DS MH:	M-604-073
		Total Length Surveyed (ft):	223.5

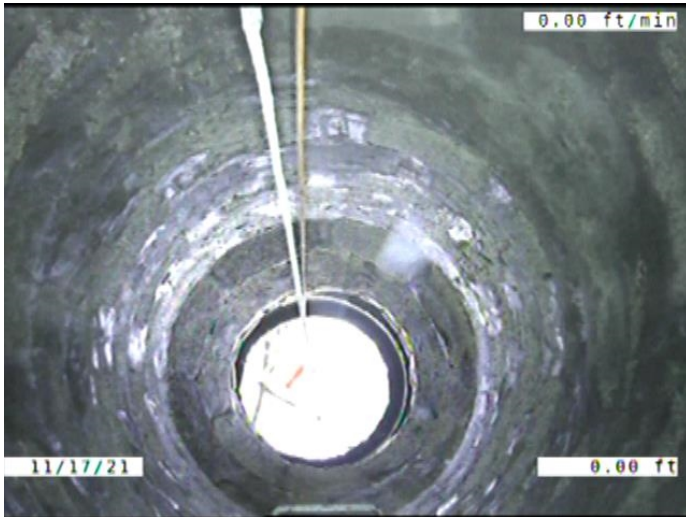
Code: **AMH**
Description: **Manhole**

Distance (ft): **.0**
Structural Grade: **0**
O&M Grade: **0**
Clock Start/From:
Clock To:
1st Value:
2nd Value:
Value Percent:
Continuous Index:
Within 8" of Joint: **NO**
Remarks: **M-604-074**

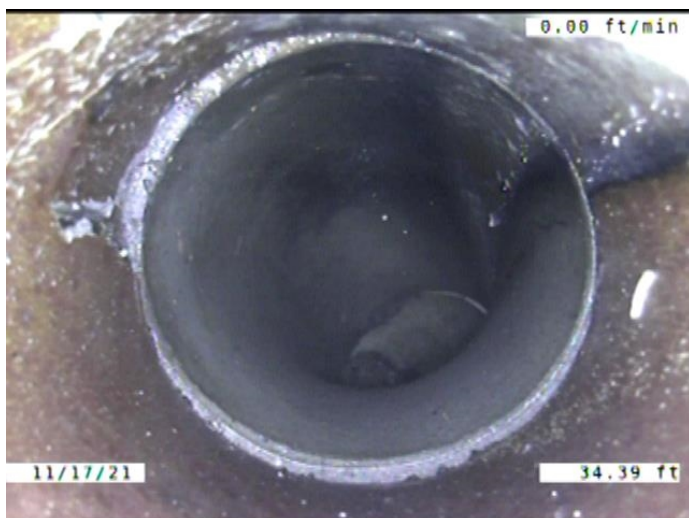
Code: **FM**
 Description: **Fracture Multiple**

Distance (ft): **33.6**
 Structural Grade: **4**
 O&M Grade: **0**
 Clock Start/From: **12**
 Clock To: **12**
 1st Value:
 2nd Value:
 Value Percent:
 Continuous Index: **S02**
 Within 8" of Joint: **YES**
 Remarks:

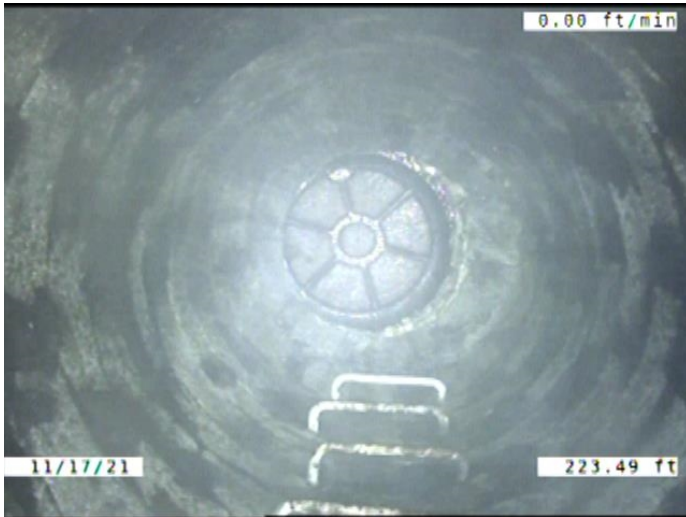
Code: **DAE**
 Description: **Deposits Attached Encrustation**

Distance (ft): **222.6**
 Structural Grade: **0**
 O&M Grade: **2**
 Clock Start/From: **8**
 Clock To: **4**
 1st Value:
 2nd Value:
 Value Percent: **5.000**
 Continuous Index: **F01**
 Within 8" of Joint: **YES**
 Remarks:
