Profile/Photo Observation Report

| Pipe Length (ft): | 223.5 | Owner: | City of Hobart | Pre Clean: | Heavy Cleaning |

| Street: | North Washington Street | Flow Control: | Not Controlled |
| US MH: | M-604-074 | DS MH: | M-604-073 |

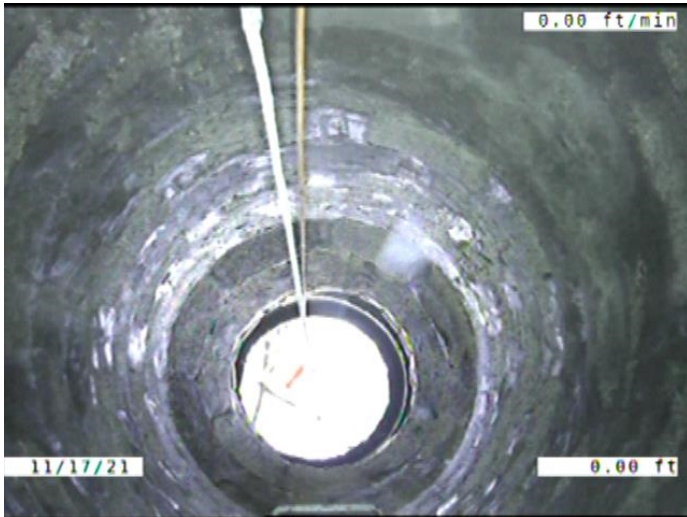
Code: **AMH**
Description: **Manhole**

Distance (ft): **.0**
Structural Grade: **0**
O&M Grade: **0**
Clock Start/From:
Clock To:
1st Value:
2nd Value:
Value Percent:
Continuous Index:
Within 8" of Joint: **NO**
Remarks: **M-604-074**

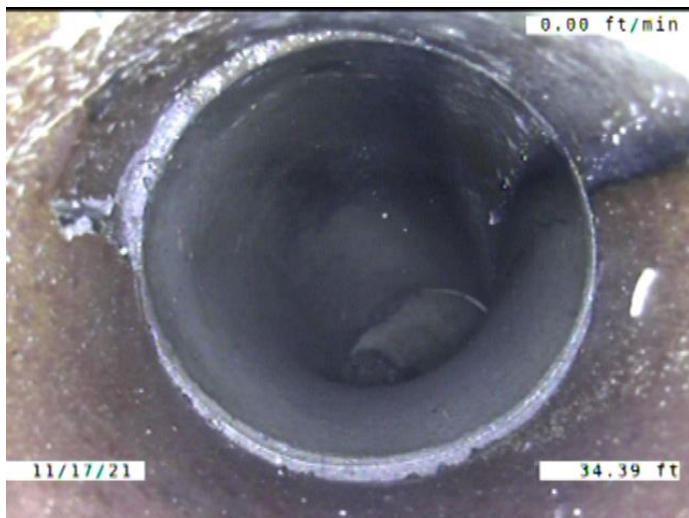
Code: **FM**
Description: **Fracture Multiple**

Distance (ft): **33.6**
Structural Grade: **4**
O&M Grade: **0**
Clock Start/From: **12**
Clock To: **12**
1st Value:
2nd Value:
Value Percent:
Continuous Index: **S02**
Within 8" of Joint: **YES**
Remarks:
