Profile/Photo Observation Report

Street:	N WASHINGTON ST	Flow Control:	Not Controlled
City:	Hobart, IN	Year Renewed:	
Location:	Light Highway	Tape/Media #:	
Purpose:	Not Known	Dia/Height:	12"
Use:	Sanitary	Material:	VCP
Drain Area:	NA	Lining:	
Category:	NA		
Comment:

Location Details:		Direction of Survey:	Upstream
US MH:	M-604-075	DS MH:	M-604-074
		Total Length Surveyed (ft):	153.3

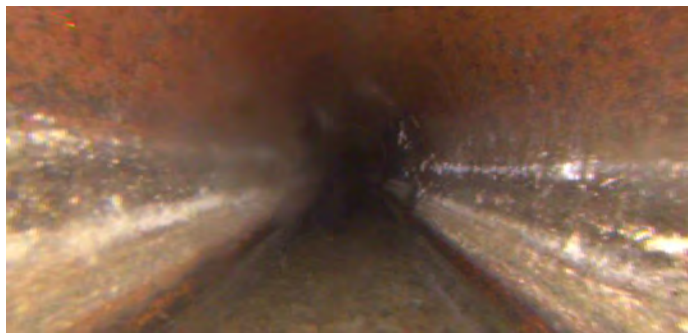
Code: **AMH**
 Description: **Manhole**

Distance (ft): **.0**
 Structural Grade: **0**
 O&M Grade: **0**
 Clock Start/From:
 Clock To:
 1st Value:
 2nd Value:
 Value Percent:
 Continuous Index:
 Within 8" of Joint: **NO**
 Remarks: **M-604-075**

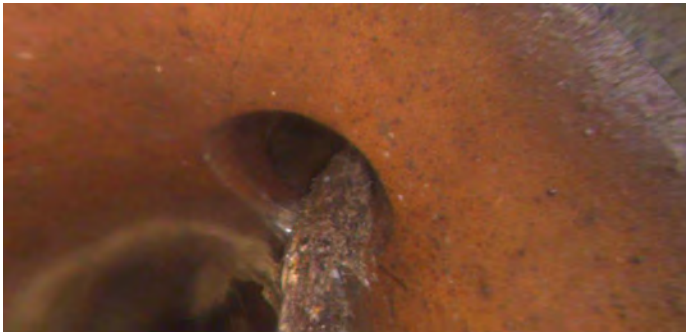
Code: **TF**
Description: **Tap Factory**

Distance (ft): **19.6**
Structural Grade: **0**
O&M Grade: **0**
Clock Start/From: **1**
Clock To:
1st Value: **4.000**
2nd Value:
Value Percent:
Continuous Index:
Within 8" of Joint: **YES**
Remarks:

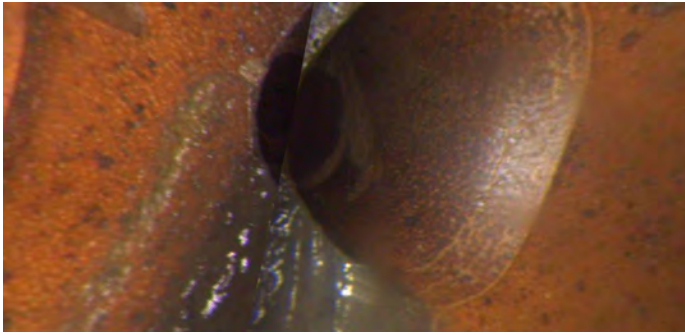
Code: **TF**
Description: **Tap Factory**

Distance (ft): **55.1**
Structural Grade: **0**
O&M Grade: **0**
Clock Start/From: **1**
Clock To:
1st Value: **4.000**
2nd Value:
Value Percent:
Continuous Index:
Within 8" of Joint: **YES**
Remarks:

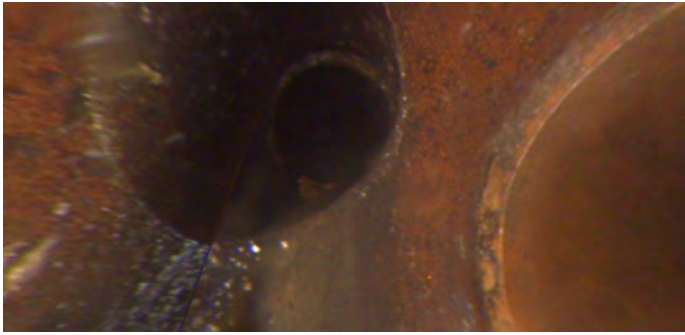
Code: **TF**
Description: **Tap Factory**

Distance (ft): **56.9**
Structural Grade: **0**
O&M Grade: **0**
Clock Start/From: **10**
Clock To:
1st Value: **4.000**
2nd Value:
Value Percent:
Continuous Index:
Within 8" of Joint: **YES**
Remarks:
