Profile/Photo Observation Report

Street:	Summerlin	Flow Control:	Not Controlled
City:	Hobart, IN	Year Renewed:	
Location:	Light Highway	Tape/Media #:	
Purpose:	Not Known	Dia/Height:	12"
Use:	Sanitary	Material:	VCP
Drain Area:	NA	Lining:	
Category:	NA		
Comment:

Location Details:		Direction of Survey:	Upstream
US MH:	M-604-088	DS MH:	M-604-087
		Total Length Surveyed (ft):	40.4

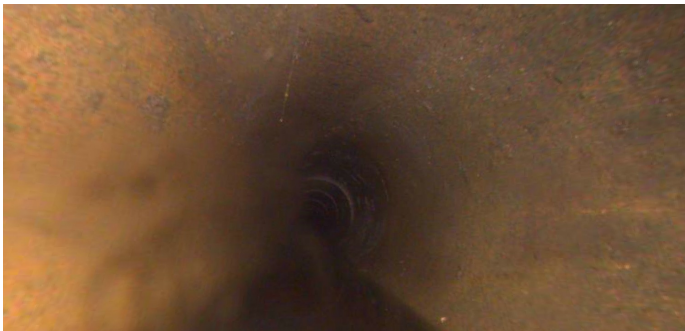
Code: **AMH**
Description: **Manhole**

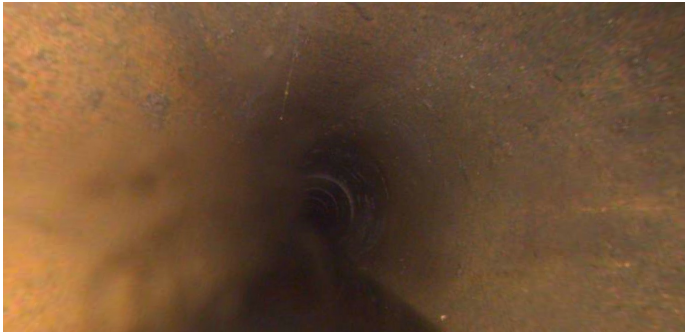
Code:	MWL
Description:	Water Level

Distance (ft):	.0
Structural Grade:	0
O&M Grade:	0
Clock Start/From:	
Clock To:	
1st Value:	
2nd Value:	
Value Percent:	5.000
Continuous Index:	
Within 8" of Joint:	NO
Remarks:
