# Profile/Photo Observation Report

Date:	<b>11/20/2021</b>	Weather:		Coding:	<b>PACP 7.0</b>
Pipe Length (ft):	<b>170.0</b>	Owner:	<b>City of Hobart</b>	Pre Clean:	<b>Heavy Cleaning</b>
P.O.#:	<b>YES502259</b>	Surveyor:	<b>S. Bucklin</b>	PSR:	<b>P-604-095-094</b>
Customer:	<b>City of Hobart</b>	Clean Date:	<b>11/20/2021</b>	Shape:	<b>C</b>

Street:	<b>North Pennsylvania Street</b>	Flow Control:	<b>Not Controlled</b>
City:	<b>Hobart, IN</b>	Year Renewed:	
Location:	<b>Local rural streets with light traffic, t</b>	Tape/Media #:	
Purpose:	<b>Routine Assessment</b>	Dia/Height:	<b>12"</b>
Use:	<b>Sanitary Sewage Pipe</b>	Material:	<b>VCP</b>
Drain Area:		Lining:	<b>None</b>
Category:	<b>NA</b>		
Comment:			
Location Details:		Direction of Survey:	<b>Downstream</b>
US MH:	<b>M-604-094</b>	DS MH:	<b>M-604-095</b>
		Total Length Surveyed (ft):	<b>170.0</b>

O&M Index:	<b>1.86</b>	O&M Quick:	<b>352D</b>	O&M Rating:	<b>78.00</b>
Structural Index:	<b>2.92</b>	Structural Quick:	<b>4B34</b>	Structural Rating:	<b>108.00</b>
Overall Index:	<b>2.35</b>	Overall Quick:	<b>4B39</b>	Overall Rating:	<b>186.00</b>

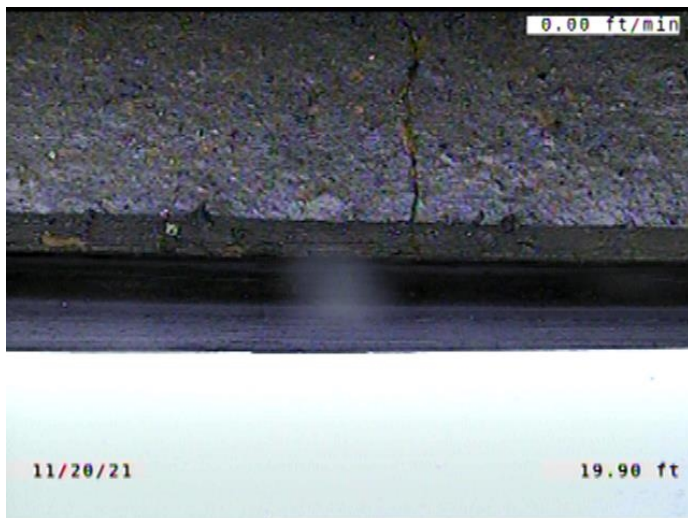
Code: **MMC**  
Description: **Miscellaneous Material Change**

Distance (ft): **19.9**  
Structural Grade: **0**  
O&M Grade: **0**  
Clock Start/From:  
Clock To:  
1st Value:  
2nd Value:  
Value Percent:  
Continuous Index:  
Within 8" of Joint: **NO**  
Remarks: **VCP TO PVC**

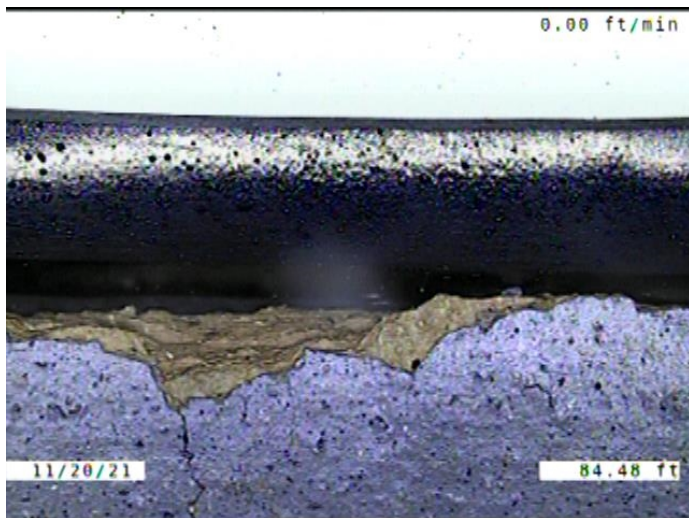
Code: **MMC**  
 Description: **Miscellaneous Material Change**

Distance (ft): **84.5**  
 Structural Grade: **0**  
 O&M Grade: **0**  
 Clock Start/From:  
 Clock To:  
 1st Value:  
 2nd Value:  
 Value Percent:  
 Continuous Index:  
 Within 8" of Joint: **NO**  
 Remarks: **PVC TO VCP**

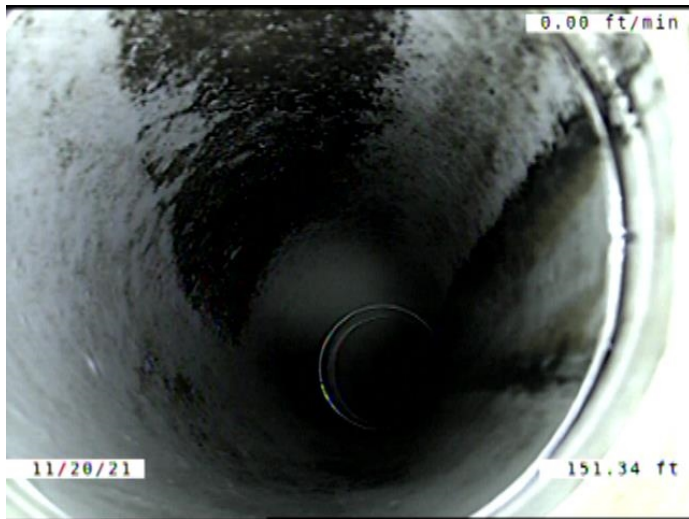
Code: **TFA**  
 Description: **Tap Factory Activity**

Distance (ft): **151.3**  
 Structural Grade: **0**  
 O&M Grade: **0**  
 Clock Start/From: **1**  
 Clock To:  
 1st Value: **4.000**  
 2nd Value:  
 Value Percent:  
 Continuous Index:  
 Within 8" of Joint: **YES**  
 Remarks:

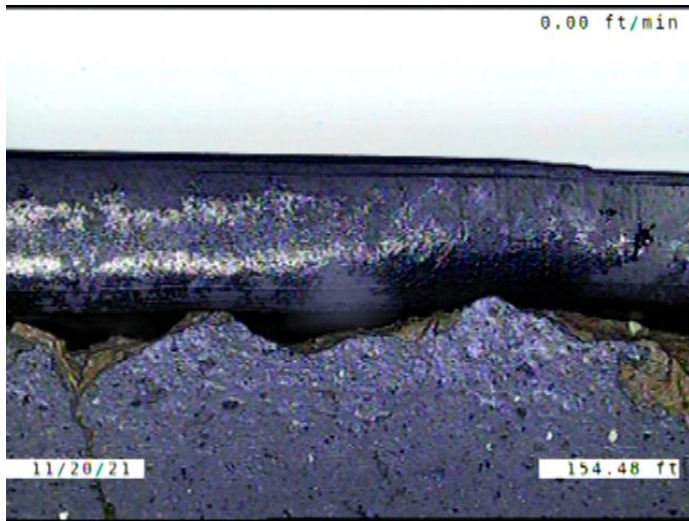
Code: **MMC**  
Description: **Miscellaneous Material Change**

Distance (ft): **154.5**  
Structural Grade: **0**  
O&M Grade: **0**  
Clock Start/From:  
Clock To:  
1st Value:  
2nd Value:  
Value Percent:  
Continuous Index:  
Within 8" of Joint: **NO**  
Remarks: **PVC TO VCP**
