Profile/Photo Observation Report

Date:	11/20/2021	Weather:		Coding:	PACP 7.0
Pipe Length (ft):	170.0	Owner:	City of Hobart	Pre Clean:	Heavy Cleaning
P.O.#:	YES502259	Surveyor:	S. Bucklin	PSR:	P-604-095-094
Customer:	City of Hobart	Clean Date:	11/20/2021	Shape:	C

Street:	North Pennsylvania Street	Flow Control:	Not Controlled
City:	Hobart, IN	Year Renewed:	
Location:	Local rural streets with light traffic, t	Tape/Media #:	
Purpose:	Routine Assessment	Dia/Height:	12"
Use:	Sanitary Sewage Pipe	Material:	VCP
Drain Area:		Lining:	None
Category:	NA		
Comment:			
Location Details:		Direction of Survey:	Downstream
US MH:	M-604-094	DS MH:	M-604-095
		Total Length Surveyed (ft):	170.0

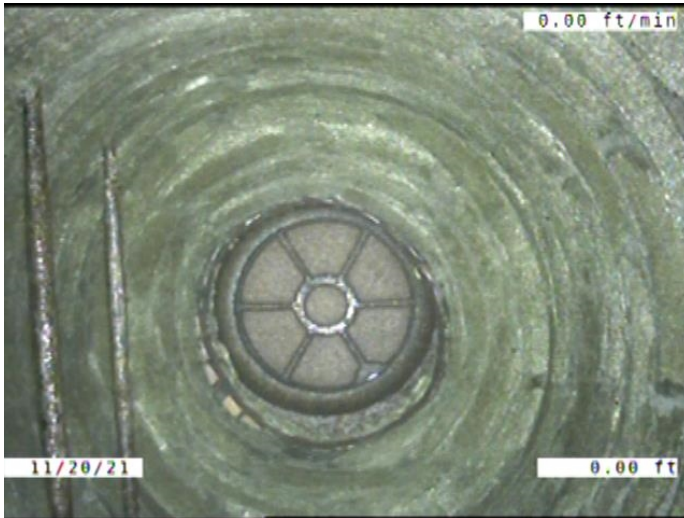
Code: **AMH**
Description: **Manhole**

Distance (ft): **.0**
Structural Grade: **0**
O&M Grade: **0**
Clock Start/From:
Clock To:
1st Value:
2nd Value:
Value Percent:
Continuous Index:
Within 8" of Joint: **NO**
Remarks: **M-604-094**

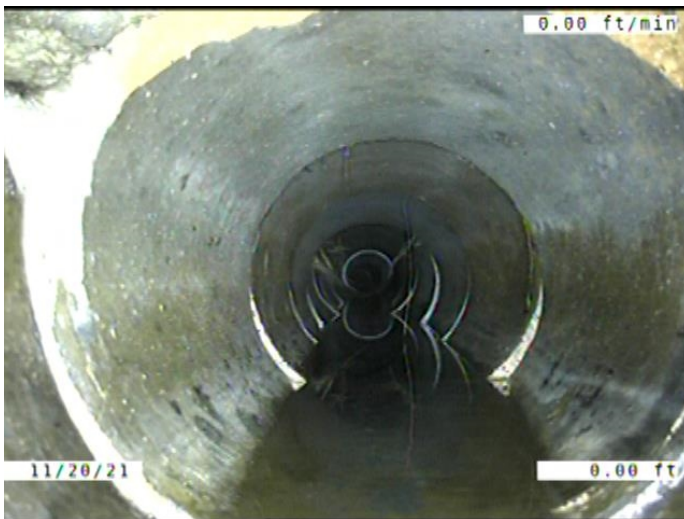
Code: **MWL**
Description: **Miscellaneous Water Level**

Distance (ft): **.0**
Structural Grade: **0**
O&M Grade: **0**
Clock Start/From:
Clock To:
1st Value:
2nd Value:
Value Percent: **5.000**
Continuous Index:
Within 8" of Joint: **NO**
Remarks:

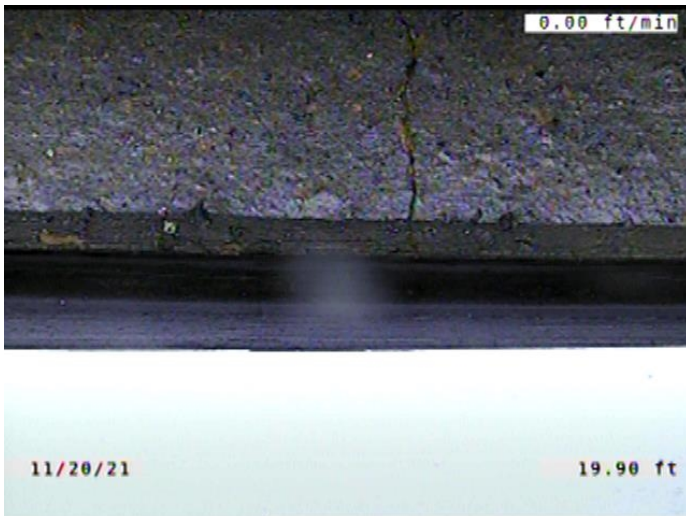
Code: **MMC**
 Description: **Miscellaneous Material Change**

Distance (ft): **19.9**
 Structural Grade: **0**
 O&M Grade: **0**
 Clock Start/From:
 Clock To:
 1st Value:
 2nd Value:
 Value Percent:
 Continuous Index:
 Within 8" of Joint: **NO**
 Remarks: **VCP TO PVC**

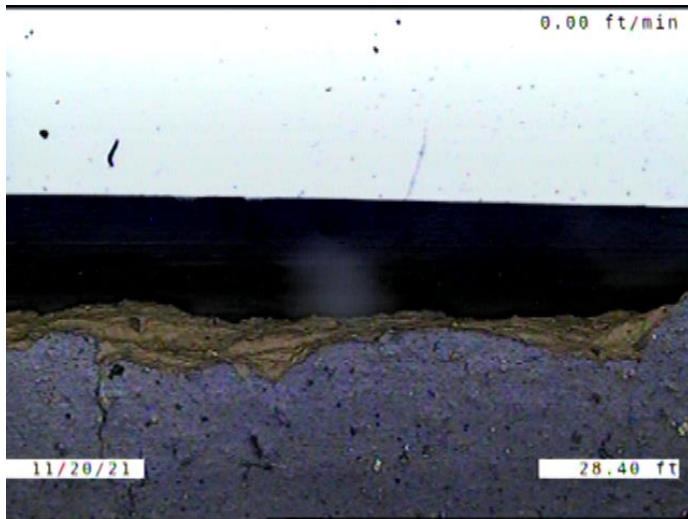
Code: **MMC**
 Description: **Miscellaneous Material Change**

Distance (ft): **28.4**
 Structural Grade: **0**
 O&M Grade: **0**
 Clock Start/From:
 Clock To:
 1st Value:
 2nd Value:
 Value Percent:
 Continuous Index:
 Within 8" of Joint: **NO**
 Remarks: **PVC TO VCP**

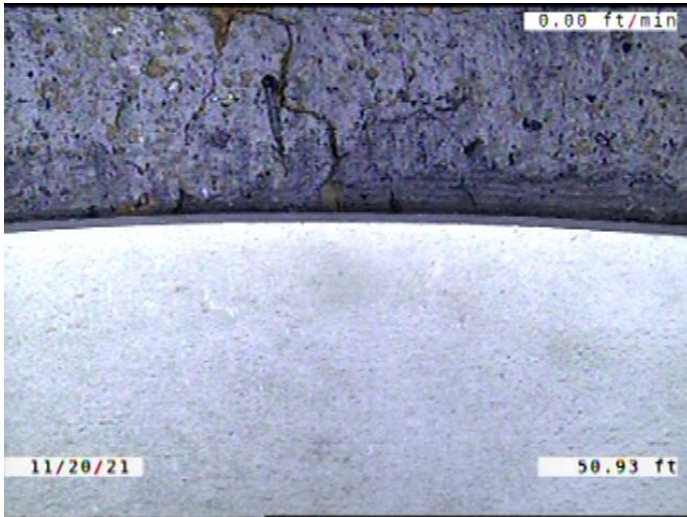
Code: **MMC**
 Description: **Miscellaneous Material Change**

Distance (ft): **50.9**
 Structural Grade: **0**
 O&M Grade: **0**
 Clock Start/From:
 Clock To:
 1st Value:
 2nd Value:
 Value Percent:
 Continuous Index:
 Within 8" of Joint: **NO**
 Remarks: **VCP TO PVC**

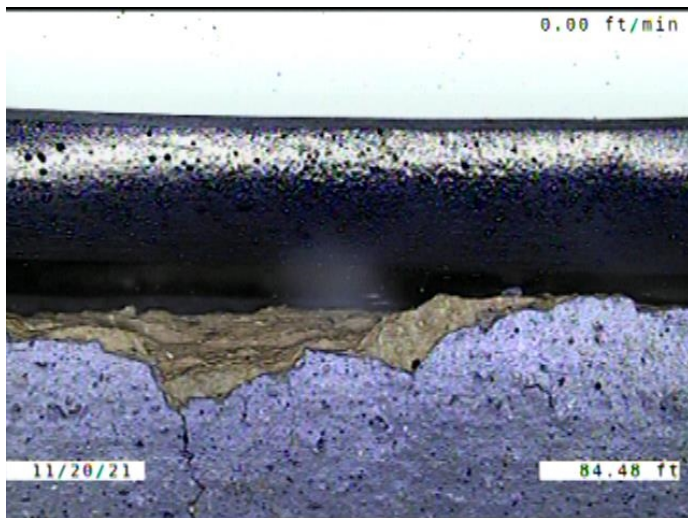
Code:	MMC
Description:	Miscellaneous Material Change
Distance (ft):	84.5
Structural Grade:	0
O&M Grade:	0
Clock Start/From:	
Clock To:	
1st Value:	
2nd Value:	
Value Percent:	
Continuous Index:	
Within 8" of Joint:	NO
Remarks:	PVC TO VCP

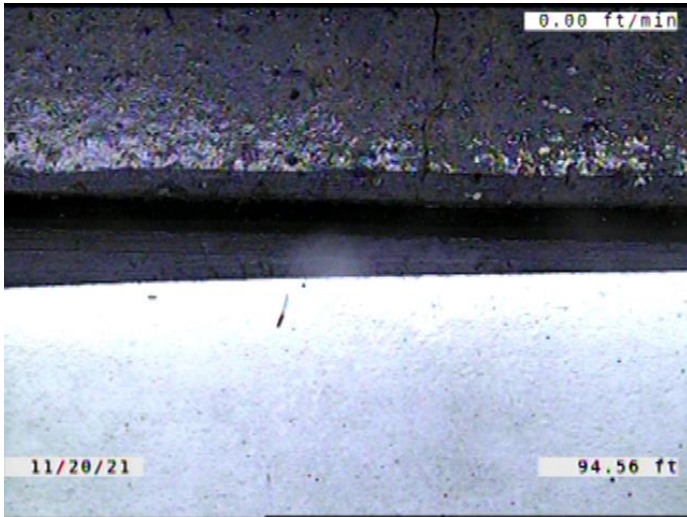
Code: **MMC**
Description: **Miscellaneous Material Change**

Distance (ft): **94.6**
Structural Grade: **0**
O&M Grade: **0**
Clock Start/From:
Clock To:
1st Value:
2nd Value:
Value Percent:
Continuous Index:
Within 8" of Joint: **NO**
Remarks: **VCP TO PVC**

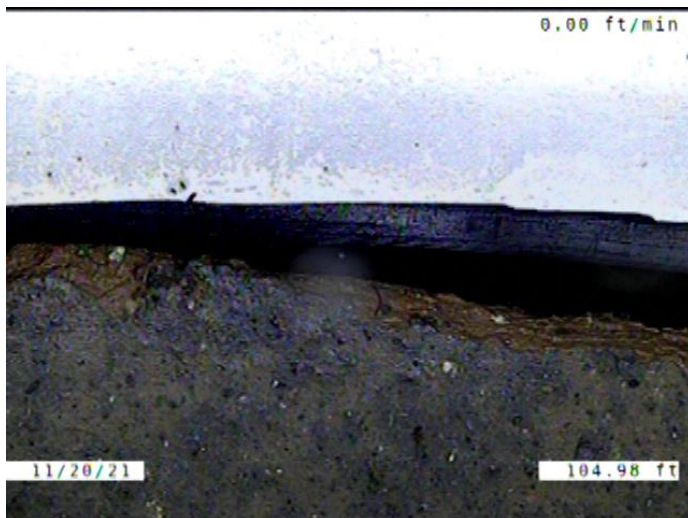
Code: **MMC**
Description: **Miscellaneous Material Change**

Distance (ft): **105.0**
Structural Grade: **0**
O&M Grade: **0**
Clock Start/From:
Clock To:
1st Value:
2nd Value:
Value Percent:
Continuous Index:
Within 8" of Joint: **NO**
Remarks: **PVC TO VCP**

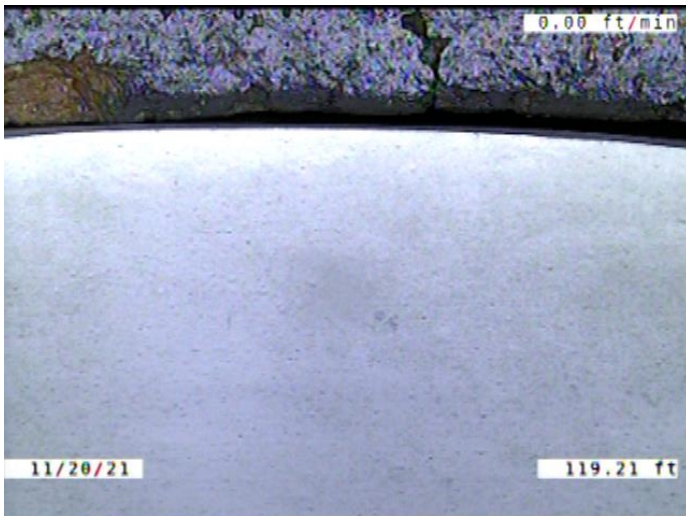
Code: **MMC**
 Description: **Miscellaneous Material Change**

Distance (ft): **119.2**
 Structural Grade: **0**
 O&M Grade: **0**
 Clock Start/From:
 Clock To:
 1st Value:
 2nd Value:
 Value Percent:
 Continuous Index:
 Within 8" of Joint: **NO**
 Remarks: **VCP TO PVC**

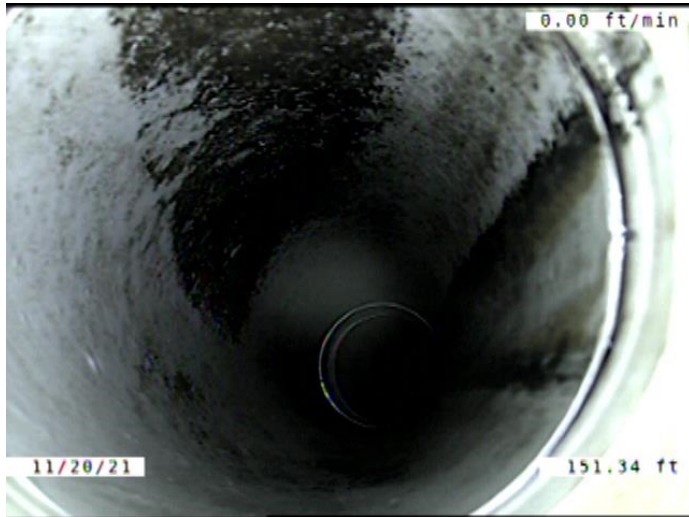
Code:	TFA
Description:	Tap Factory Activity
Distance (ft):	151.3
Structural Grade:	0
O&M Grade:	0
Clock Start/From:	1
Clock To:	
1st Value:	4.000
2nd Value:	
Value Percent:	
Continuous Index:	
Within 8" of Joint:	YES
Remarks:

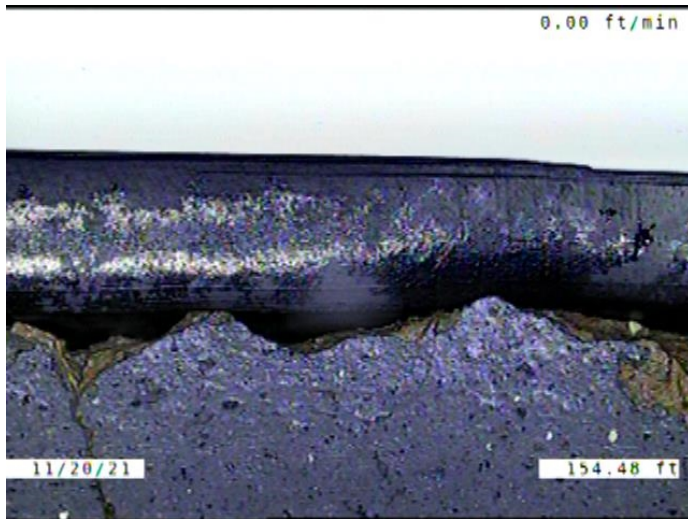
Code: **MMC**
 Description: **Miscellaneous Material Change**

Distance (ft): **154.5**
 Structural Grade: **0**
 O&M Grade: **0**
 Clock Start/From:
 Clock To:
 1st Value:
 2nd Value:
 Value Percent:
 Continuous Index:
 Within 8" of Joint: **NO**
 Remarks: **PVC TO VCP**

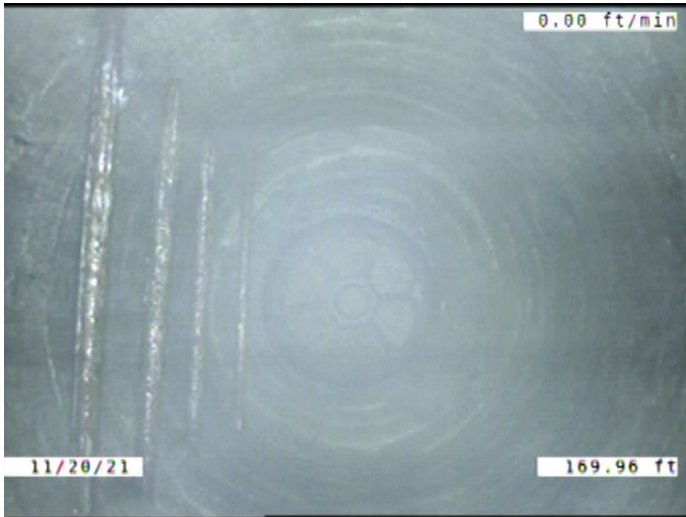
Code:	AMH
Description:	Manhole
Distance (ft):	170.0
Structural Grade:	0
O&M Grade:	0
Clock Start/From:	
Clock To:	
1st Value:	
2nd Value:	
Value Percent:	
Continuous Index:	
Within 8" of Joint:	NO
Remarks:	M-604-095
