Profile/Photo Observation Report

Date:	11/20/2021	Weather:		Coding:	PACP 7.0
Pipe Length (ft):	166.7	Owner:	City of Hobart	Pre Clean:	Heavy Cleaning
P.O.#:	YES502259	Surveyor:	S. Bucklin	PSR:	P-604-096-095
Customer:	City of Hobart	Clean Date:	11/20/2021	Shape:	C

Street:	North Pennsylvania Street	Flow Control:	Not Controlled
City:	Hobart, IN	Year Renewed:	
Location:	Local rural streets with light traffic, t	Tape/Media #:	
Purpose:	Routine Assessment	Dia/Height:	12"
Use:	Sanitary Sewage Pipe	Material:	VCP
Drain Area:		Lining:	None
Category:	NA		
Comment:			
Location Details:		Direction of Survey:	Downstream
US MH:	M-604-095	DS MH:	M-604-096
		Total Length Surveyed (ft):	166.7

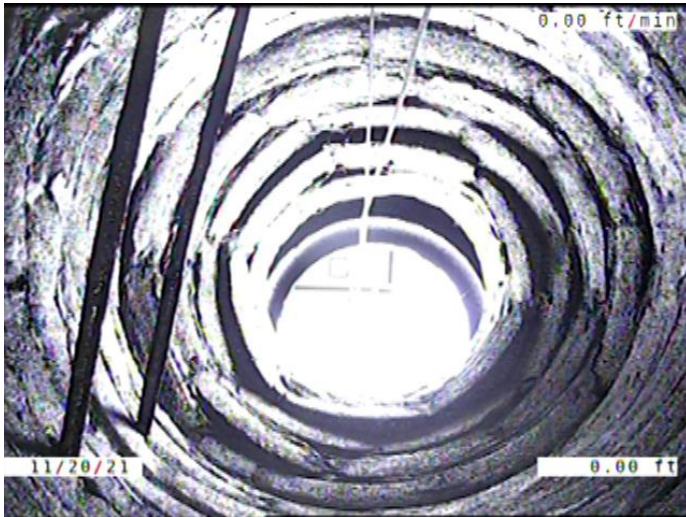
Code: **AMH**
Description: **Manhole**

Distance (ft): **.0**
Structural Grade: **0**
O&M Grade: **0**
Clock Start/From:
Clock To:
1st Value:
2nd Value:
Value Percent:
Continuous Index:
Within 8" of Joint: **NO**
Remarks: **M-604-095**

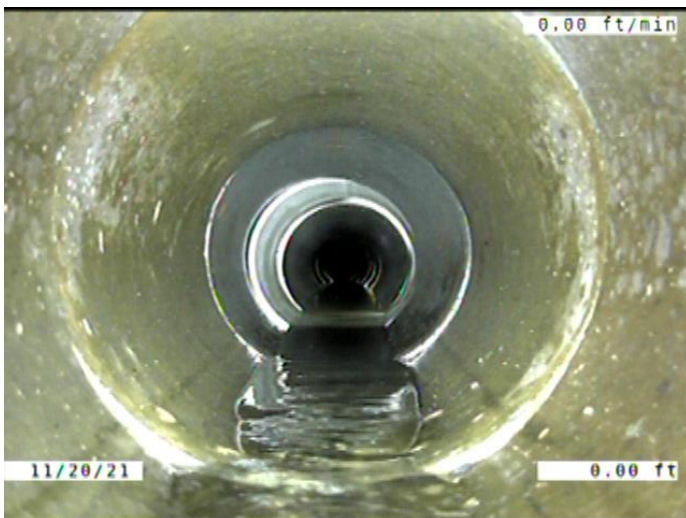
Code: **MWL**
Description: **Miscellaneous Water Level**

Distance (ft): **.0**
Structural Grade: **0**
O&M Grade: **0**
Clock Start/From:
Clock To:
1st Value:
2nd Value:
Value Percent: **5.000**
Continuous Index:
Within 8" of Joint: **NO**
Remarks:

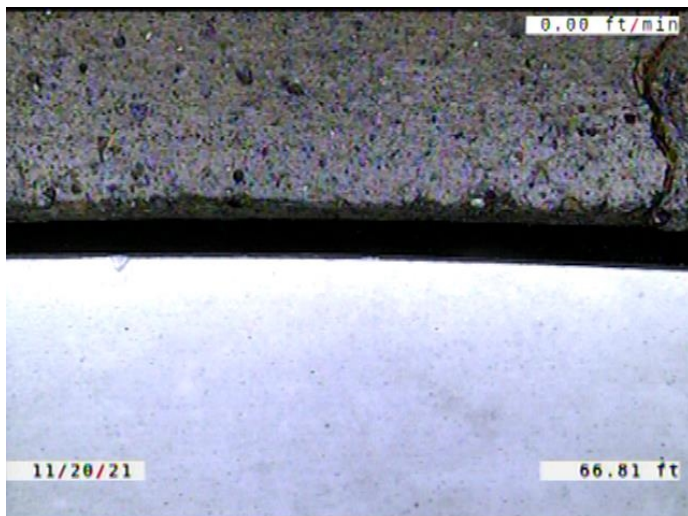
Code: **MMC**
 Description: **Miscellaneous Material Change**

Distance (ft): **66.8**
 Structural Grade: **0**
 O&M Grade: **0**
 Clock Start/From:
 Clock To:
 1st Value:
 2nd Value:
 Value Percent:
 Continuous Index:
 Within 8" of Joint: **NO**
 Remarks: **VCP TO PVC**

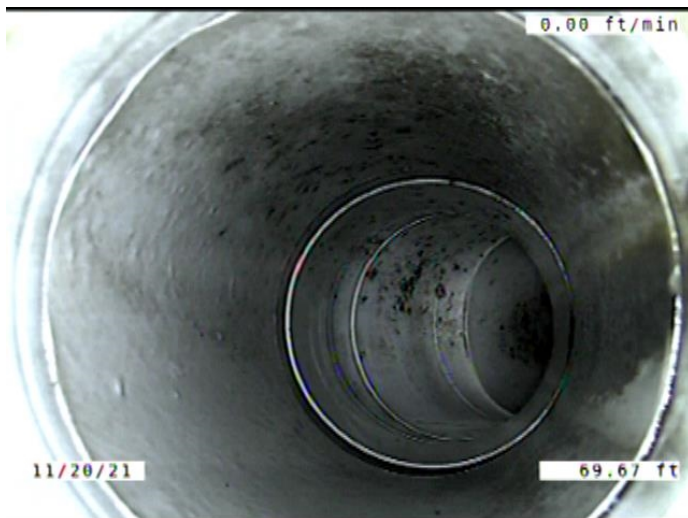
Code: **TF**
 Description: **Tap Factory**

Distance (ft): **69.7**
 Structural Grade: **0**
 O&M Grade: **0**
 Clock Start/From: **1**
 Clock To:
 1st Value: **4.000**
 2nd Value:
 Value Percent:
 Continuous Index:
 Within 8" of Joint: **YES**
 Remarks:

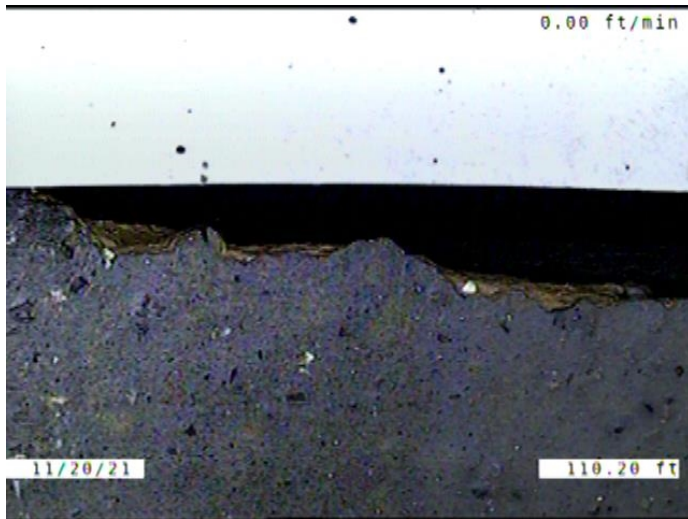
Code: **MMC**
 Description: **Miscellaneous Material Change**

Distance (ft): **110.2**
 Structural Grade: **0**
 O&M Grade: **0**
 Clock Start/From:
 Clock To:
 1st Value:
 2nd Value:
 Value Percent:
 Continuous Index:
 Within 8" of Joint: **NO**
 Remarks: **PVC TO VCP**

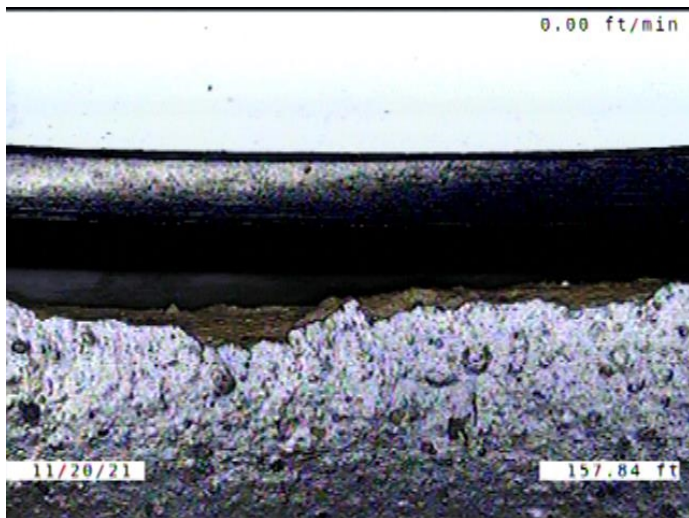
Code: **MMC**
Description: **Miscellaneous Material Change**

Distance (ft): **157.8**
Structural Grade: **0**
O&M Grade: **0**
Clock Start/From:
Clock To:
1st Value:
2nd Value:
Value Percent:
Continuous Index:
Within 8" of Joint: **NO**
Remarks: **PVC TO VCP**

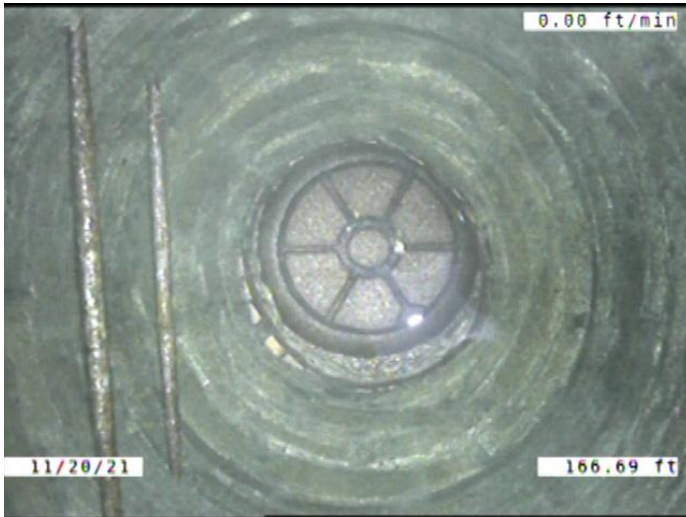
Code:	AMH
Description:	Manhole
Distance (ft):	166.7
Structural Grade:	0
O&M Grade:	0
Clock Start/From:	
Clock To:	
1st Value:	
2nd Value:	
Value Percent:	
Continuous Index:	
Within 8" of Joint:	NO
Remarks:	M-604-096
