# Profile/Photo Observation Report

Date:	11/20/2021	Weather:		Coding:	PACP 7.0
Pipe Length (ft):	166.7	Owner:	City of Hobart	Pre Clean:	Heavy Cleaning
P.O.#:	YES502259	Surveyor:	S. Bucklin	PSR:	P-604-096-095
Customer:	City of Hobart	Clean Date:	11/20/2021	Shape:	C

Street:	North Pennsylvania Street	Flow Control:	Not Controlled
City:	Hobart, IN	Year Renewed:	
Location:	Local rural streets with light traffic, t	Tape/Media #:	
Purpose:	Routine Assessment	Dia/Height:	12"
Use:	Sanitary Sewage Pipe	Material:	VCP
Drain Area:		Lining:	None
Category:	NA		
Comment:			
Location Details:		Direction of Survey:	Downstream
US MH:	M-604-095	DS MH:	M-604-096
		Total Length Surveyed (ft):	166.7

O&M Index:	1.83	O&M Quick:	4135	O&M Rating:	84.00
Structural Index:	3.29	Structural Quick:	514B	Structural Rating:	102.00
Overall Index:	2.42	Overall Quick:	514B	Overall Rating:	186.00

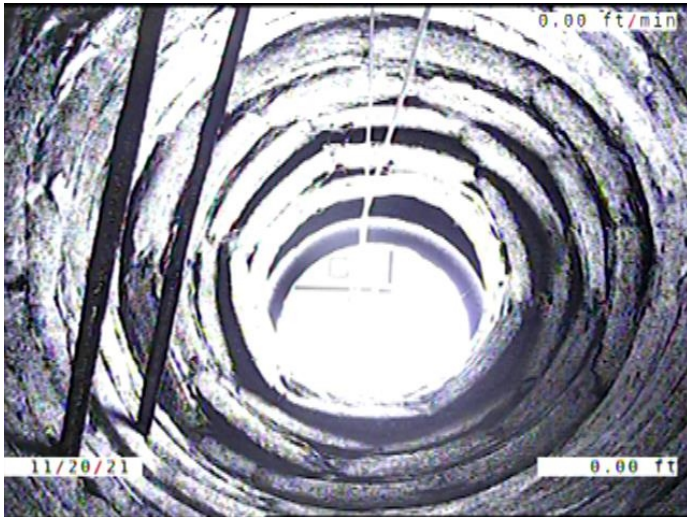
Code: **AMH**  
 Description: **Manhole**

Distance (ft): **.0**  
 Structural Grade: **0**  
 O&M Grade: **0**  
 Clock Start/From:  
 Clock To:  
 1st Value:  
 2nd Value:  
 Value Percent:  
 Continuous Index:  
 Within 8" of Joint: **NO**  
 Remarks: **M-604-095**

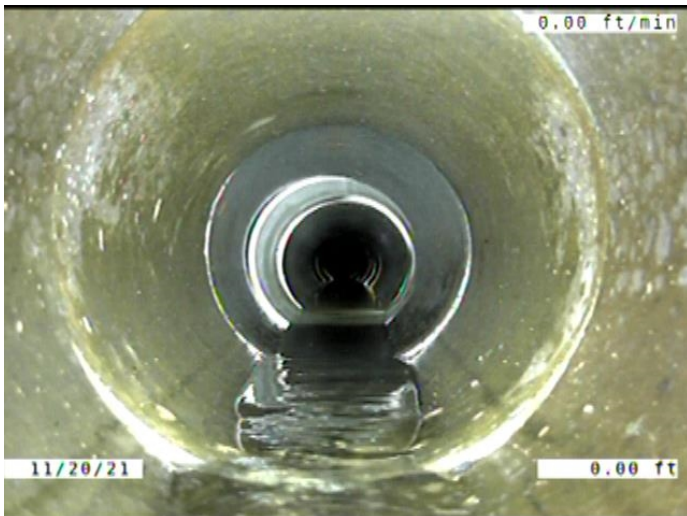
Code: **MWL**  
 Description: **Miscellaneous Water Level**

Distance (ft): **.0**  
 Structural Grade: **0**  
 O&M Grade: **0**  
 Clock Start/From:  
 Clock To:  
 1st Value:  
 2nd Value:  
 Value Percent: **5.000**  
 Continuous Index:  
 Within 8" of Joint: **NO**  
 Remarks:

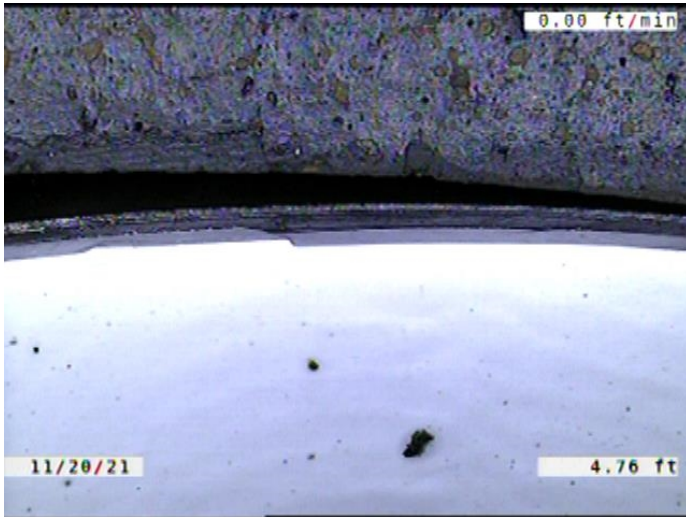
Code: **MMC**  
 Description: **Miscellaneous Material Change**

Distance (ft): **4.8**  
 Structural Grade: **0**  
 O&M Grade: **0**  
 Clock Start/From:  
 Clock To:  
 1st Value:  
 2nd Value:  
 Value Percent:  
 Continuous Index:  
 Within 8" of Joint: **NO**  
 Remarks: **VCP TO PVC**

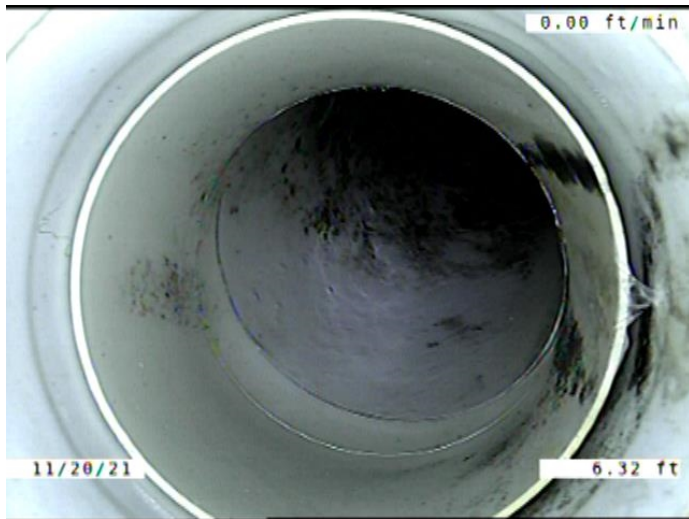
Code: **TFA**  
 Description: **Tap Factory Activity**

Distance (ft): **6.3**  
 Structural Grade: **0**  
 O&M Grade: **0**  
 Clock Start/From: **1**  
 Clock To:  
 1st Value: **4.000**  
 2nd Value:  
 Value Percent:  
 Continuous Index:  
 Within 8" of Joint: **YES**  
 Remarks:

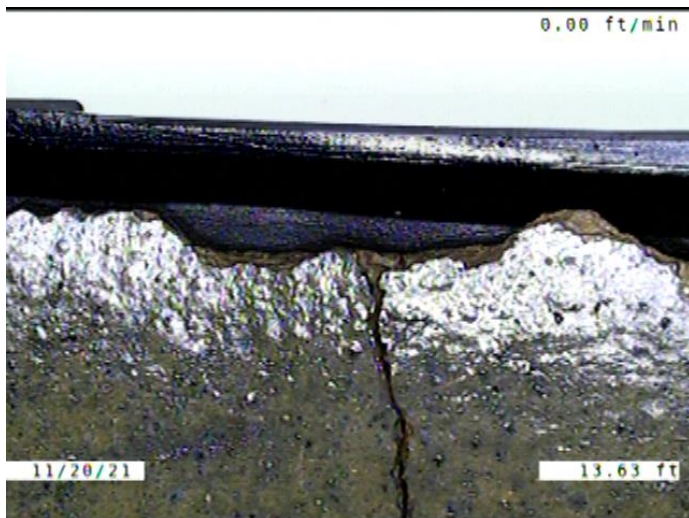
Code: **MMC**  
 Description: **Miscellaneous Material Change**

Distance (ft): **13.6**  
 Structural Grade: **0**  
 O&M Grade: **0**  
 Clock Start/From:  
 Clock To:  
 1st Value:  
 2nd Value:  
 Value Percent:  
 Continuous Index:  
 Within 8" of Joint: **NO**  
 Remarks: **PVC TO VCP**

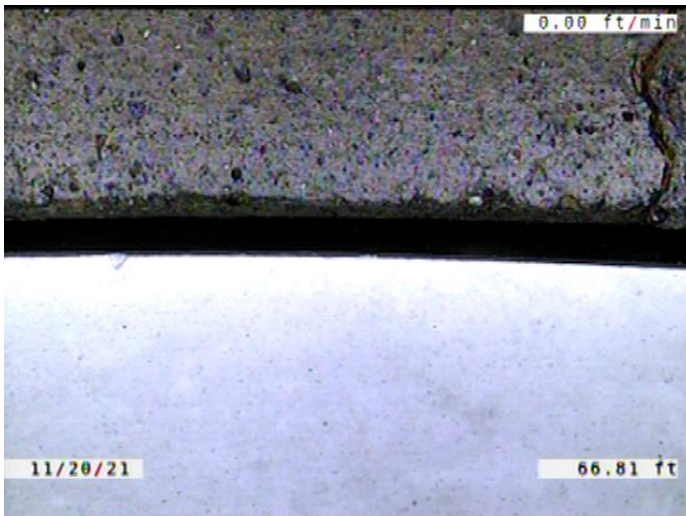
Code: **MMC**  
Description: **Miscellaneous Material Change**

Distance (ft): **66.8**  
Structural Grade: **0**  
O&M Grade: **0**  
Clock Start/From:  
Clock To:  
1st Value:  
2nd Value:  
Value Percent:  
Continuous Index:  
Within 8" of Joint: **NO**  
Remarks: **VCP TO PVC**

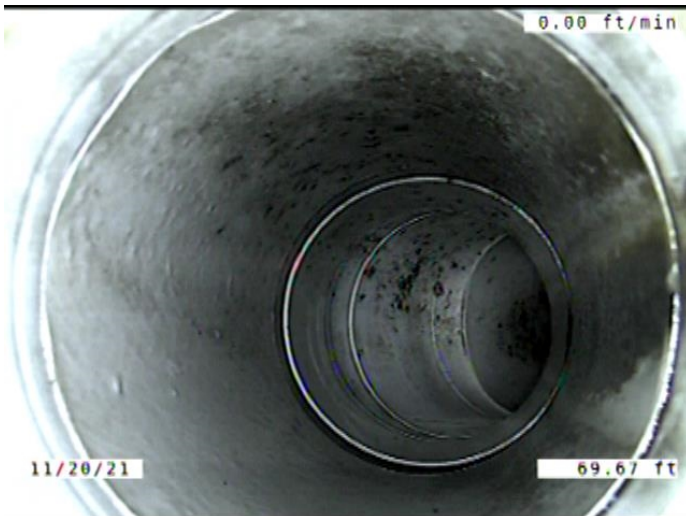
Code: **TF**  
 Description: **Tap Factory**

Distance (ft): **69.7**  
 Structural Grade: **0**  
 O&M Grade: **0**  
 Clock Start/From: **1**  
 Clock To:  
 1st Value: **4.000**  
 2nd Value:  
 Value Percent:  
 Continuous Index:  
 Within 8" of Joint: **YES**  
 Remarks:

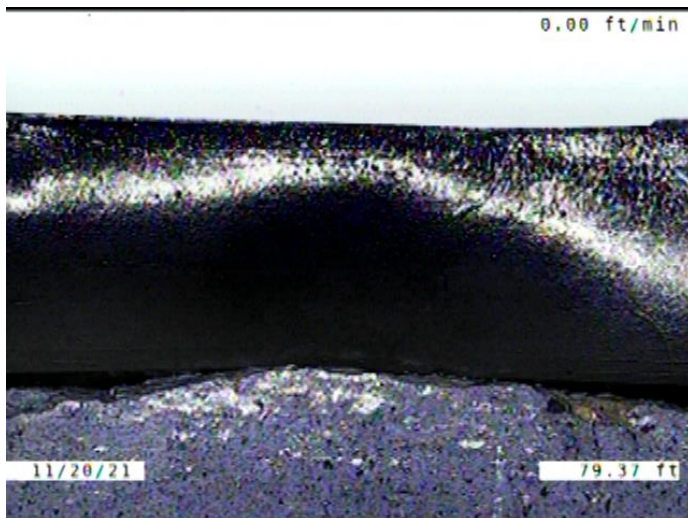
Code: **MMC**  
 Description: **Miscellaneous Material Change**

Distance (ft): **79.4**  
 Structural Grade: **0**  
 O&M Grade: **0**  
 Clock Start/From:  
 Clock To:  
 1st Value:  
 2nd Value:  
 Value Percent:  
 Continuous Index:  
 Within 8" of Joint: **NO**  
 Remarks: **PVC TO VCP**

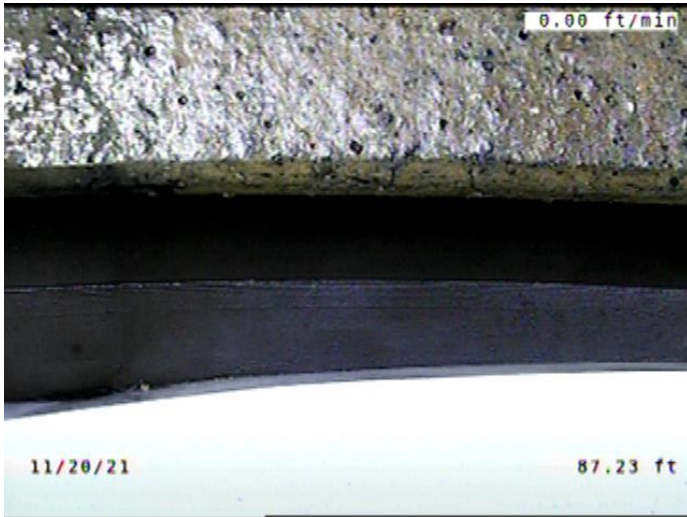
Code: **MMC**  
 Description: **Miscellaneous Material Change**

Distance (ft): **87.2**  
 Structural Grade: **0**  
 O&M Grade: **0**  
 Clock Start/From:  
 Clock To:  
 1st Value:  
 2nd Value:  
 Value Percent:  
 Continuous Index:  
 Within 8" of Joint: **NO**  
 Remarks: **VCP TO PVC**

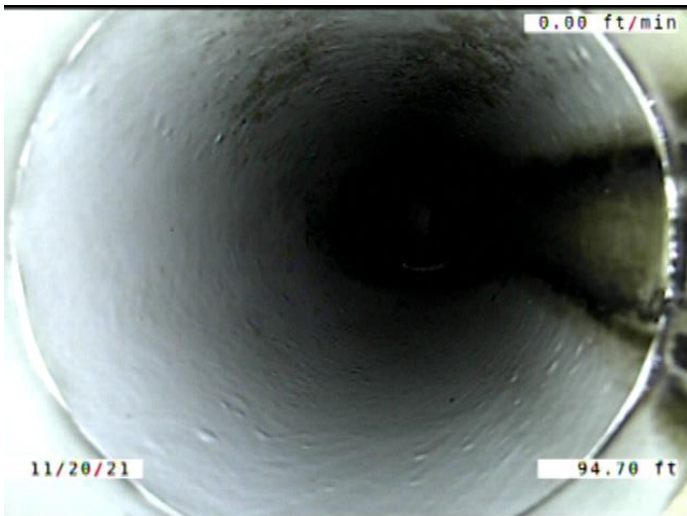
Code: **TF**  
 Description: **Tap Factory**

Distance (ft): **94.7**  
 Structural Grade: **0**  
 O&M Grade: **0**  
 Clock Start/From: **1**  
 Clock To:  
 1st Value: **4.000**  
 2nd Value:  
 Value Percent:  
 Continuous Index:  
 Within 8" of Joint: **YES**  
 Remarks:

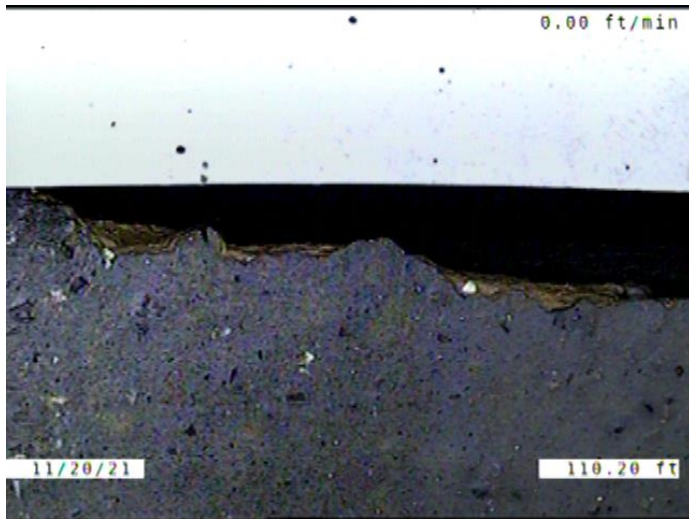
Code: **MMC**  
 Description: **Miscellaneous Material Change**

Distance (ft): **110.2**  
 Structural Grade: **0**  
 O&M Grade: **0**  
 Clock Start/From:  
 Clock To:  
 1st Value:  
 2nd Value:  
 Value Percent:  
 Continuous Index:  
 Within 8" of Joint: **NO**  
 Remarks: **PVC TO VCP**

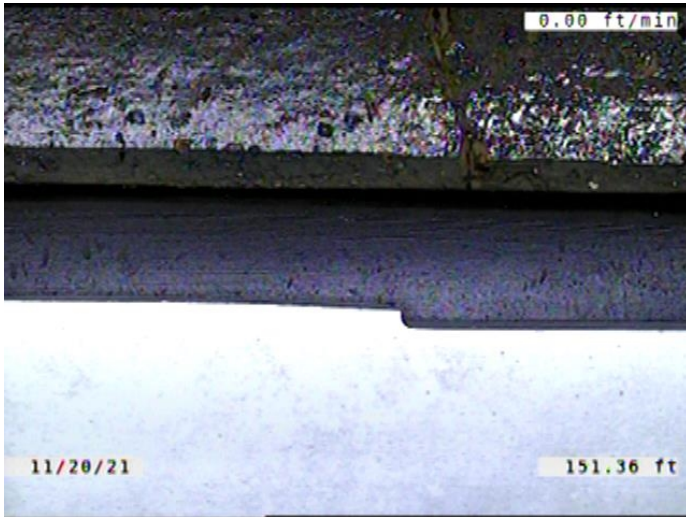
Code:	<b>MMC</b>
Description:	<b>Miscellaneous Material Change</b>
Distance (ft):	<b>151.4</b>
Structural Grade:	<b>0</b>
O&M Grade:	<b>0</b>
Clock Start/From:	
Clock To:	
1st Value:	
2nd Value:	
Value Percent:	
Continuous Index:	
Within 8" of Joint:	<b>NO</b>
Remarks:	<b>VCP TO PVC</b>

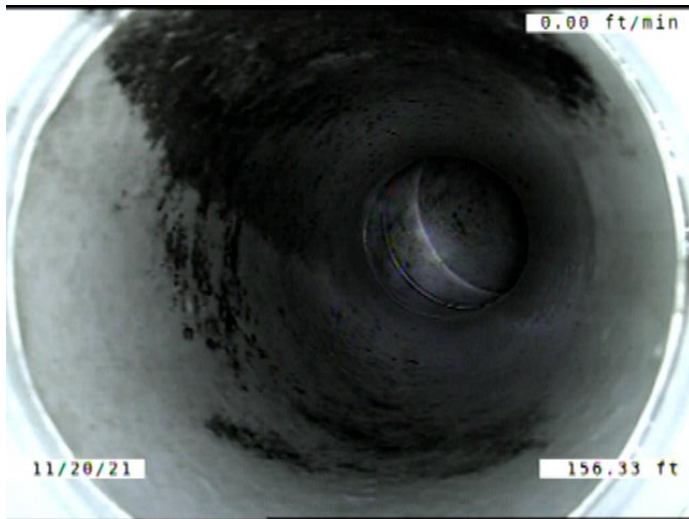
Code: **TF**  
Description: **Tap Factory**

Distance (ft): **156.3**  
Structural Grade: **0**  
O&M Grade: **0**  
Clock Start/From: **1**  
Clock To:  
1st Value: **4.000**  
2nd Value:  
Value Percent:  
Continuous Index:  
Within 8" of Joint: **YES**  
Remarks:

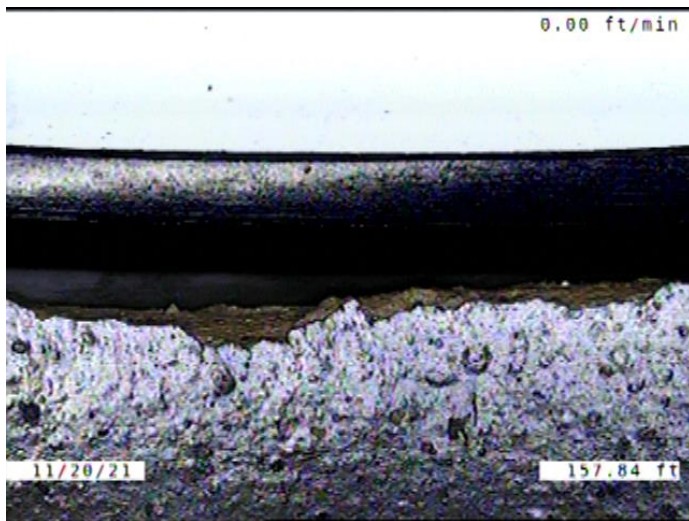
Code: **MMC**  
Description: **Miscellaneous Material Change**

Distance (ft): **157.8**  
Structural Grade: **0**  
O&M Grade: **0**  
Clock Start/From:  
Clock To:  
1st Value:  
2nd Value:  
Value Percent:  
Continuous Index:  
Within 8" of Joint: **NO**  
Remarks: **PVC TO VCP**

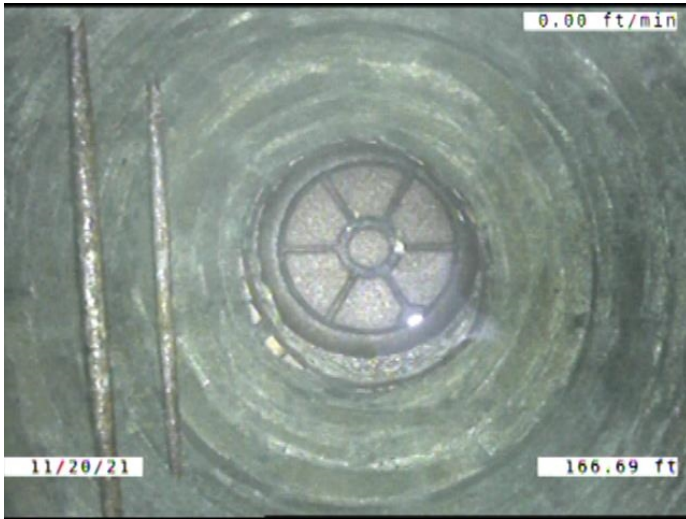
Code:	<b>AMH</b>
Description:	<b>Manhole</b>
Distance (ft):	<b>166.7</b>
Structural Grade:	<b>0</b>
O&M Grade:	<b>0</b>
Clock Start/From:	
Clock To:	
1st Value:	
2nd Value:	
Value Percent:	
Continuous Index:	
Within 8" of Joint:	<b>NO</b>
Remarks:	<b>M-604-096</b>
