Profile/Photo Observation Report

Date: **11/09/2021** Weather: _____ Coding: **PACP 7.0**
 Pipe Length (ft): **173.1** Owner: **City of Hobart** Pre Clean: **Heavy Cleaning**
 P.O.#: **YES502259** Surveyor: **Steven Bucklin** PSR: **P-604-111-107**
 Customer: **City of Hobart, IN (Red** Clean Date: **11/09/2021** Shape: **C**

Street: **North Ash Street** Flow Control: **Not Controlled**
 City: **City of Hobart** Year Renewed: _____
 Location: **Local rural streets with light traffic, t** Tape/Media #: _____
 Purpose: **Routine Assessment** Dia/Height: **10"**
 Use: **Sanitary Sewage Pipe** Material: **VCP**
 Drain Area: _____ Lining: **None**
 Category: **NA**
 Comment: _____
 Location Details: _____ Direction of Survey: **Upstream**
 US MH: **M-604-107** DS MH: **M-604-111** Total Length Surveyed (ft): **173.1**

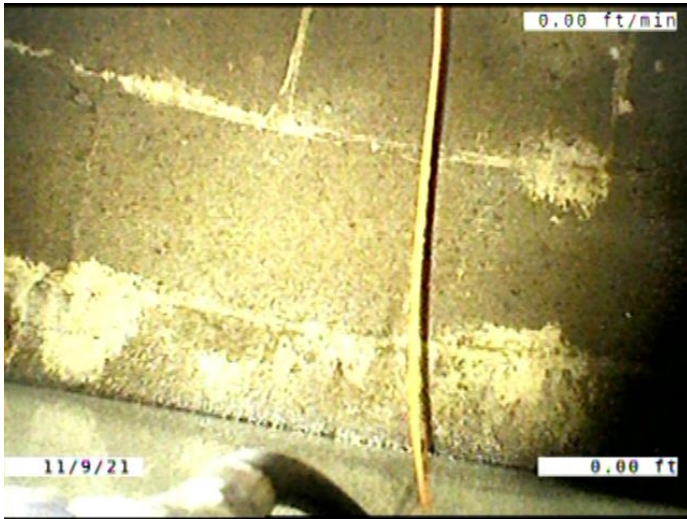
Code: **AMH**
Description: **Manhole**

Distance (ft): **.0**
Structural Grade: **0**
O&M Grade: **0**
Clock Start/From:
Clock To:
1st Value:
2nd Value:
Value Percent:
Continuous Index:
Within 8" of Joint: **NO**
Remarks: **M-604-111**

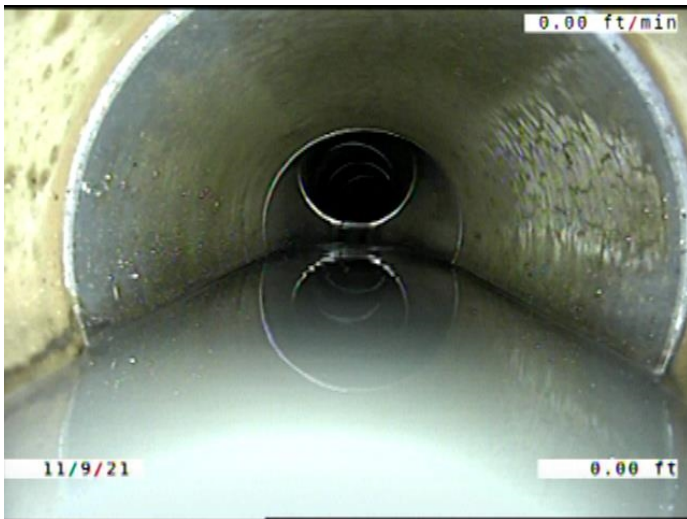
Code: **MWL**
Description: **Miscellaneous Water Level**

Distance (ft): **.0**
Structural Grade: **0**
O&M Grade: **0**
Clock Start/From:
Clock To:
1st Value:
2nd Value:
Value Percent: **10.000**
Continuous Index:
Within 8" of Joint: **NO**
Remarks:

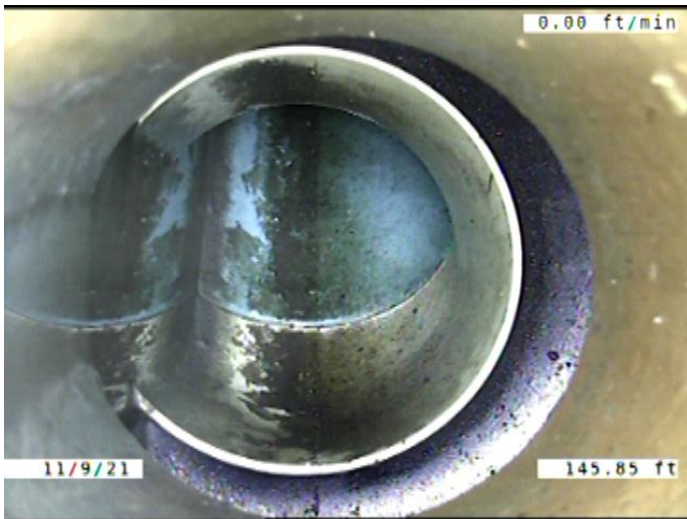
Code: **JOSD**
 Description: **Joint Offset Small Defective**

Distance (ft): **143.8**
 Structural Grade: **0**
 O&M Grade: **0**
 Clock Start/From:
 Clock To:
 1st Value:
 2nd Value:
 Value Percent:
 Continuous Index:
 Within 8" of Joint: **NO**
 Remarks: **SOIL VISIBLE**
