## **Profile/Photo Observation Report**

Customer: City of Hobart, IN (Red Clean Date: 11/09/2021 Shape: C

Street: North Ash Street Flow Control: Not Controlled

US MH: M-604-111 DS MH: M-604-108 Total Length Surveyed (ft): 175.9

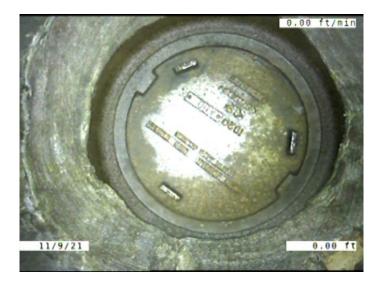
Code: AMH Description: Manhole

Distance (ft): .0 Structural Grade: 0 0 O&M Grade:

Remarks: M-604-108

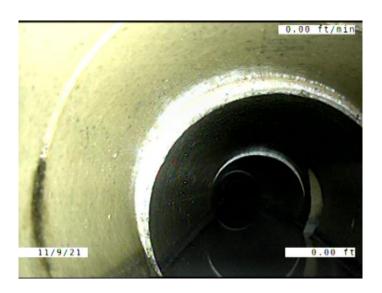
MWL Code:

Description: **Miscellaneous Water Level**

Distance (ft): .0 Structural Grade: 0 O&M Grade: 0

Value Percent: 5.000

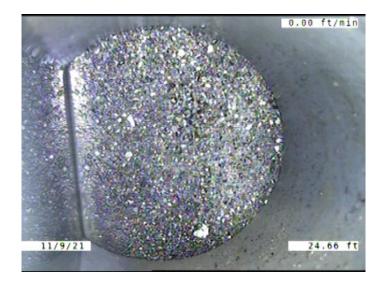
Code: TFC

Description: Tap Factory Capped

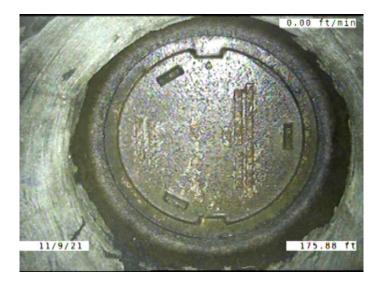
Remarks: Pipe floor missing in MH

Code: AMH
Description: Manhole

Distance (ft): 175.9
Structural Grade: 0
O&M Grade: 0
