RedZone  
ROBOTICS

Street:	North Ash Street		Flow Control:	Not Controlled	
City:	City of Hobart		Year Renewed:		
Location:	Local rural streets with light traffic, t		Tape/Media #:		
Purpose:	Routine Assessment		Dia/Height:	10"	
Use:	Sanitary Sewage Pipe		Material:	VCP	
Drain Area:			Lining:	None	
Category:	NA				
Comment:					
Location Details:			Direction of Survey:	Upstream	
US MH:	M-604-111	DS MH:	M-604-108	Total Length Surveyed (ft):	175.9

**Wednesday, January 19, 2022**

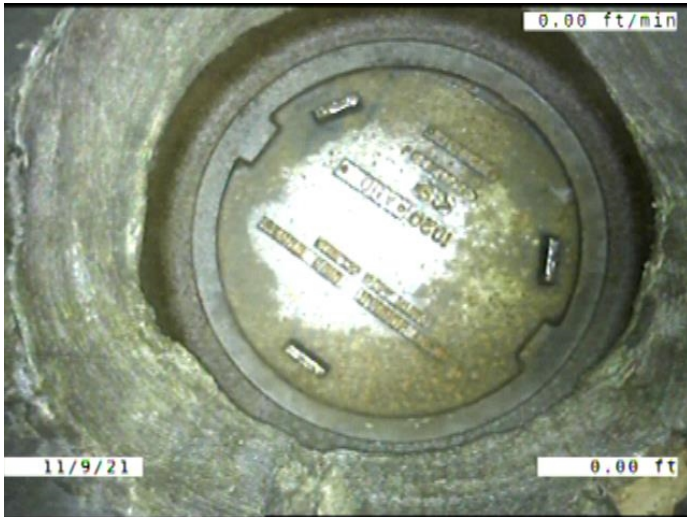
Code: **AMH**  
Description: **Manhole**

Distance (ft): **.0**  
Structural Grade: **0**  
O&M Grade: **0**  
Clock Start/From:  
Clock To:  
1st Value:  
2nd Value:  
Value Percent:  
Continuous Index:  
Within 8" of Joint: **NO**  
Remarks: **M-604-108**

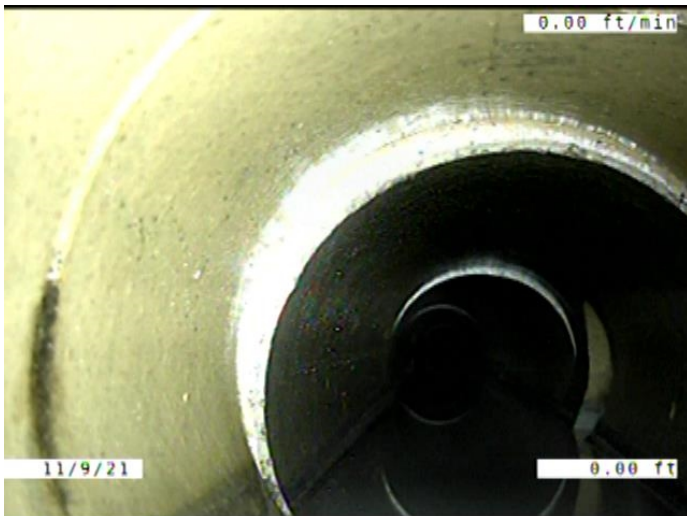
Code: **MWL**  
Description: **Miscellaneous Water Level**

Distance (ft): **.0**  
Structural Grade: **0**  
O&M Grade: **0**  
Clock Start/From:  
Clock To:  
1st Value:  
2nd Value:  
Value Percent: **5.000**  
Continuous Index:  
Within 8" of Joint: **NO**  
Remarks:

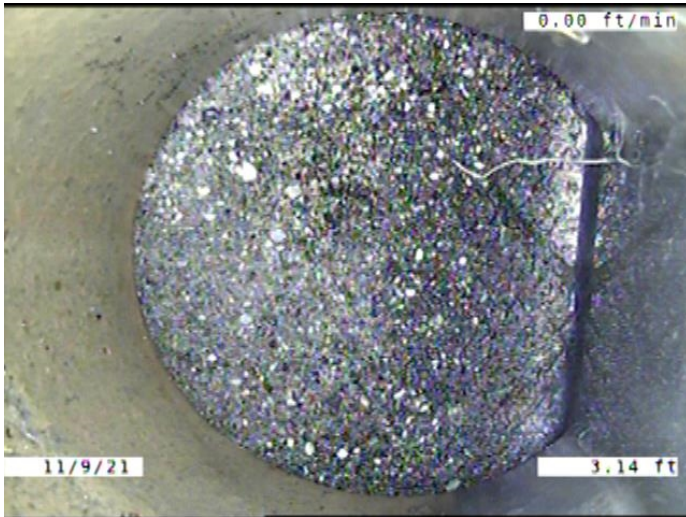
Code: **TFC**  
 Description: **Tap Factory Capped**

Distance (ft): **3.1**  
 Structural Grade: **0**  
 O&M Grade: **0**  
 Clock Start/From: **3**  
 Clock To:  
 1st Value: **4.000**  
 2nd Value:  
 Value Percent:  
 Continuous Index:  
 Within 8" of Joint: **YES**  
 Remarks:

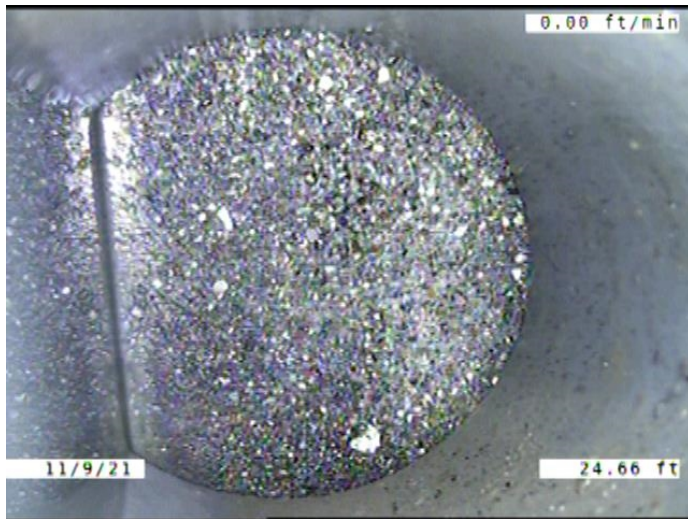
Code: **TFC**  
 Description: **Tap Factory Capped**

Distance (ft): **24.7**  
 Structural Grade: **0**  
 O&M Grade: **0**  
 Clock Start/From: **9**  
 Clock To:  
 1st Value: **4.000**  
 2nd Value:  
 Value Percent:  
 Continuous Index:  
 Within 8" of Joint: **YES**  
 Remarks:

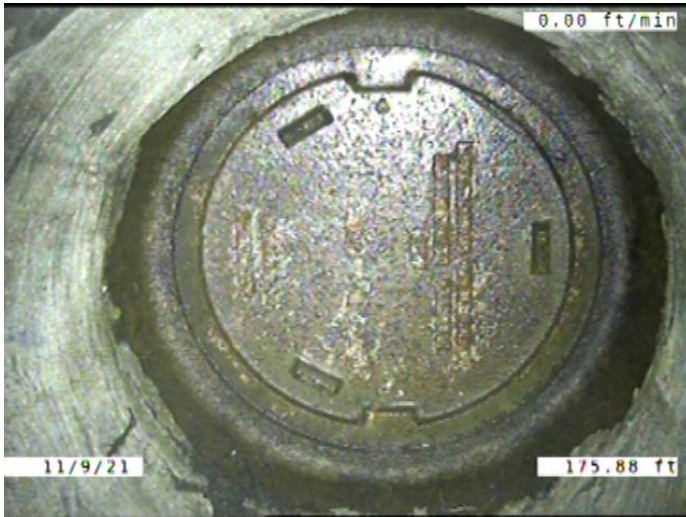
Code: **AMH**  
Description: **Manhole**

Distance (ft): **175.9**  
Structural Grade: **0**  
O&M Grade: **0**  
Clock Start/From:  
Clock To:  
1st Value:  
2nd Value:  
Value Percent:  
Continuous Index:  
Within 8" of Joint: **NO**  
Remarks: **M-604-111**
