Profile/Photo Observation Report

Date:	04/24/2018	Weather:		Coding:	PACP 6.0
Pipe Length (ft):	100.2	Owner:	NA	Pre Clean:	Not Known
P.O.#:		Surveyor:	Jen Costello	PSR:	P-604-UNK-116A
Customer:		Clean Date:	01/01/1900	Shape:	C

Street:	W CLEVELAND AVE	Flow Control:	Not Controlled
City:	Hobart, IN	Year Renewed:	
Location:	Other	Tape/Media #:	
Purpose:	Not Known	Dia/Height:	12"
Use:	Sanitary	Material:	CP
Drain Area:	NA	Lining:	
Category:	NA		
Comment:			
Location Details:		Direction of Survey:	Downstream
US MH:	M-604-116	DS MH:	M-604-116
		Total Length Surveyed (ft):	8.0

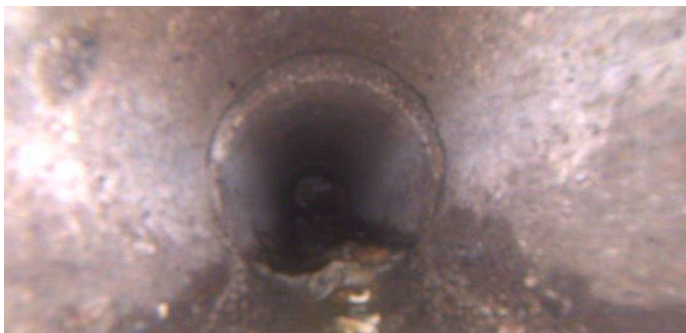
Code: **AMH**
Description: **Manhole**

Distance (ft): **.0**
Structural Grade: **0**
O&M Grade: **0**
Clock Start/From:
Clock To:
1st Value:
2nd Value:
Value Percent:
Continuous Index:
Within 8" of Joint: **NO**
Remarks: **M-604-116**

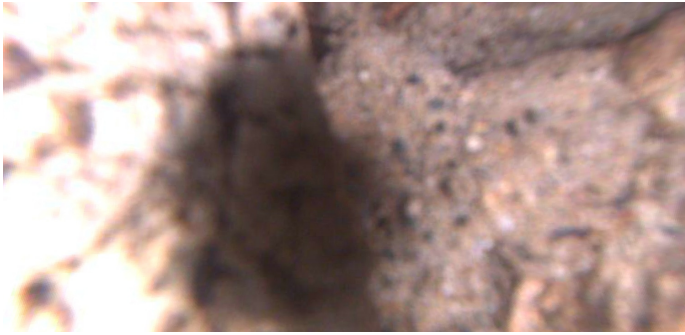
Code: **AEP**
Description: **End of Pipe**

Distance (ft): **8.0**
Structural Grade: **0**
O&M Grade: **0**
Clock Start/From:
Clock To:
1st Value:
2nd Value:
Value Percent:
Continuous Index:
Within 8" of Joint: **NO**
Remarks: **M-604-116**
