Profile/Photo Observation Report

Street:	W Cleveland Ave. Alley	Flow Control:	Not Controlled
City:	Hobart, IN	Year Renewed:	
Location:	Other	Tape/Media #:	
Purpose:	Not Known	Dia/Height:	12"
Use:	Sanitary	Material:	CP
Drain Area:	NA	Lining:	
Category:	NA		
Comment:

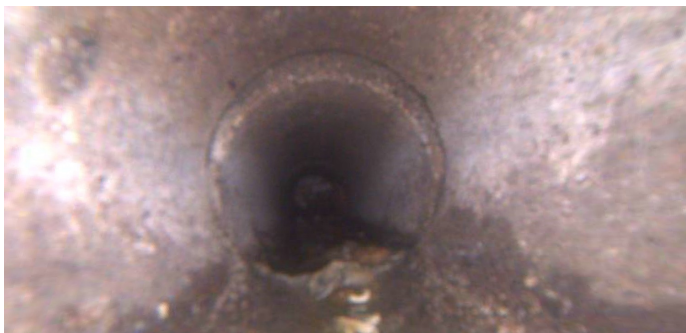
Code: **AMH**
Description: **Manhole**

Distance (ft): **.0**
Structural Grade: **0**
O&M Grade: **0**
Clock Start/From:
Clock To:
1st Value:
2nd Value:
Value Percent:
Continuous Index:
Within 8" of Joint: **NO**
Remarks: **M-604-116**

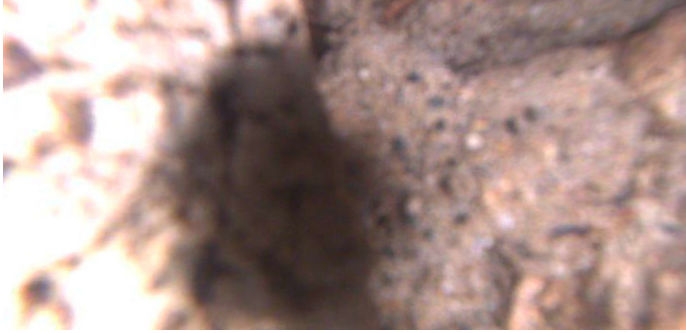
Code: **AEP**
Description: **End of Pipe**

Distance (ft): **8.0**
Structural Grade: **0**
O&M Grade: **0**
Clock Start/From:
Clock To:
1st Value:
2nd Value:
Value Percent:
Continuous Index:
Within 8" of Joint: **NO**
Remarks: **M-604-116**
