Profile/Photo Observation Report

Date:	09/16/2022	Weather:		Coding:	PACP 7.0
Pipe Length (ft):	249.8	Owner:	City of Hobart	Pre Clean:	No Pre-Cleaning
P.O.#:	YES502259	Surveyor:	S. Bucklin	PSR:	M-605-001-M-705-055
Customer:	City of Hobart	Clean Date:		Shape:	C

Street:	East 3rd Street	Flow Control:	Not Controlled
City:	Hobart, IN	Year Renewed:	
Location:	Local rural streets with light traffic, t	Tape/Media #:	
Purpose:	Routine Assessment	Dia/Height:	10"
Use:	Sanitary Sewage Pipe	Material:	VCP
Drain Area:		Lining:	None
Category:	NA		
Comment:			
Location Details:		Direction of Survey:	Downstream
US MH:	M-605-001	DS MH:	M-705-055
		Total Length Surveyed (ft):	246.3

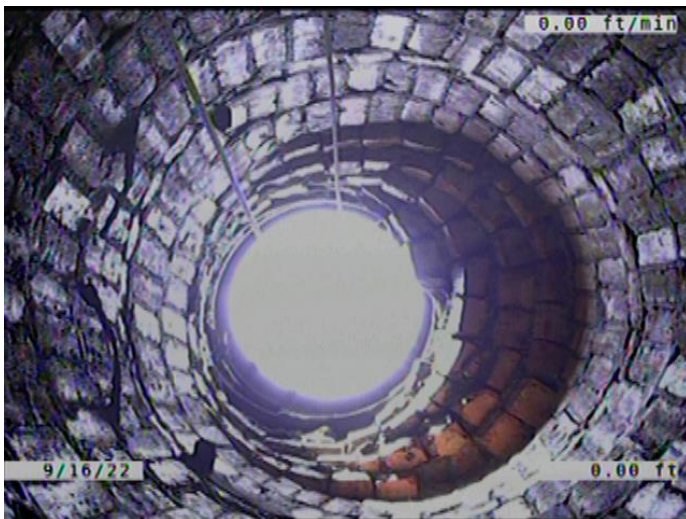
Code: **AMH**
Description: **Manhole**

Distance (ft): **.0**
Structural Grade: **0**
O&M Grade: **0**
Clock Start/From:
Clock To:
1st Value:
2nd Value:
Value Percent:
Continuous Index:
Within 8" of Joint: **NO**
Remarks: **M-605-001**

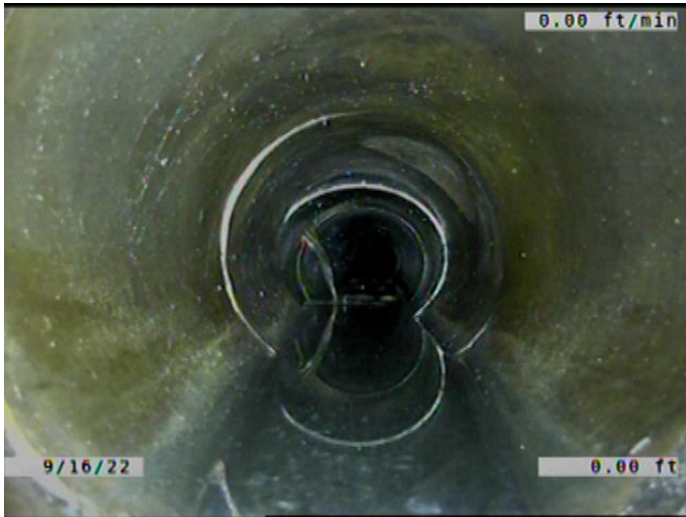
Code: **MWL**
 Description: **Miscellaneous Water Level**

Distance (ft): **.0**
 Structural Grade: **0**
 O&M Grade: **0**
 Clock Start/From:
 Clock To:
 1st Value:
 2nd Value:
 Value Percent: **10.000**
 Continuous Index:
 Within 8" of Joint: **NO**
 Remarks:

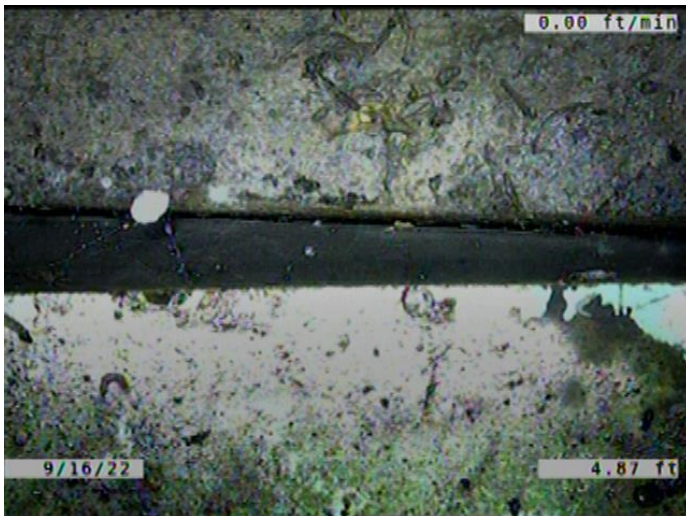
Code: **MMC**
Description: **Miscellaneous Material Change**

Distance (ft): **4.9**
Structural Grade: **0**
O&M Grade: **0**
Clock Start/From:
Clock To:
1st Value:
2nd Value:
Value Percent:
Continuous Index:
Within 8" of Joint: **NO**
Remarks: **VCP TO PVC**

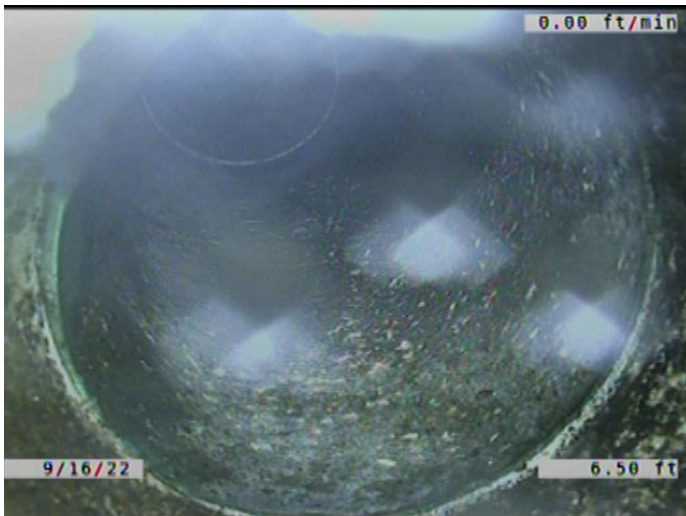
Code: **TFA**
 Description: **Tap Factory Activity**

Distance (ft): **6.5**
 Structural Grade: **0**
 O&M Grade: **0**
 Clock Start/From: **11**
 Clock To:
 1st Value: **6.000**
 2nd Value:
 Value Percent:
 Continuous Index:
 Within 8" of Joint: **YES**
 Remarks:

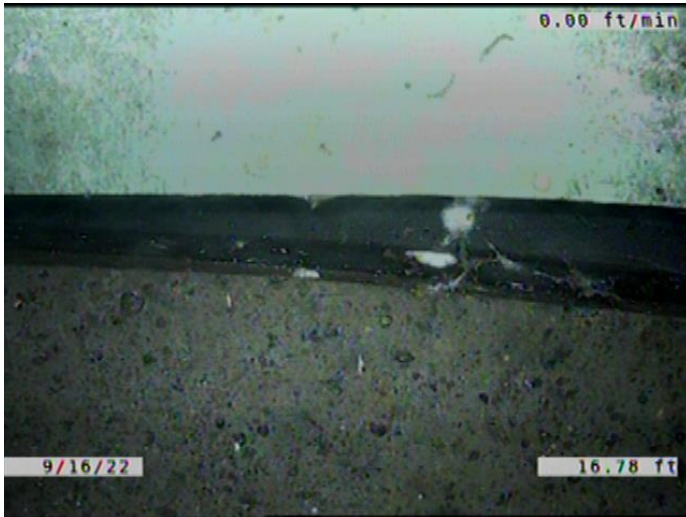
Code:	MMC
Description:	Miscellaneous Material Change
Distance (ft):	16.8
Structural Grade:	0
O&M Grade:	0
Clock Start/From:	
Clock To:	
1st Value:	
2nd Value:	
Value Percent:	
Continuous Index:	
Within 8" of Joint:	NO
Remarks:	PVC TO VCP

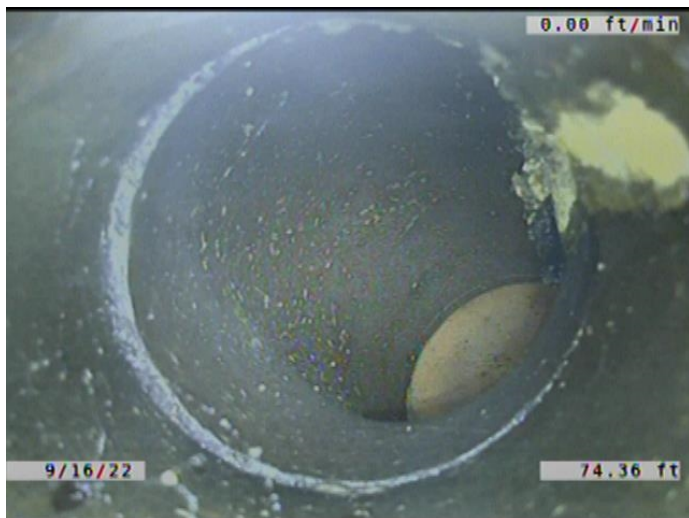
Code: **TFC**
 Description: **Tap Factory Capped**

Distance (ft): **74.4**
 Structural Grade: **0**
 O&M Grade: **0**
 Clock Start/From: **1**
 Clock To:
 1st Value: **6.000**
 2nd Value:
 Value Percent:
 Continuous Index:
 Within 8" of Joint: **YES**
 Remarks:

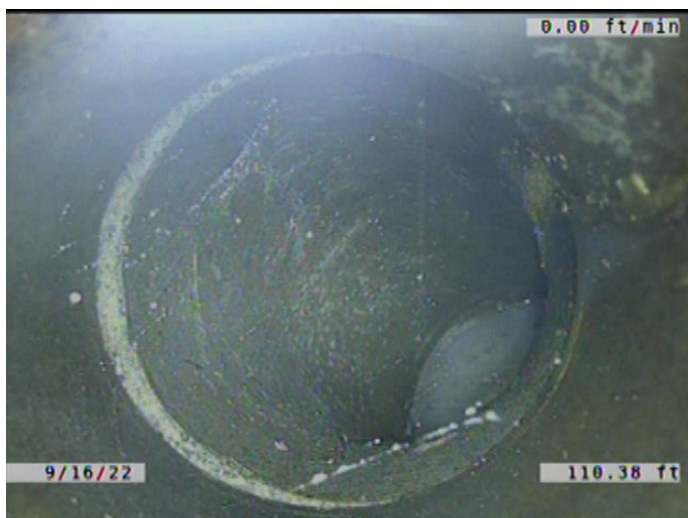
Code:	TF
Description:	Tap Factory
Distance (ft):	110.4
Structural Grade:	0
O&M Grade:	0
Clock Start/From:	1
Clock To:	
1st Value:	6.000
2nd Value:	
Value Percent:	
Continuous Index:	
Within 8" of Joint:	YES
Remarks:

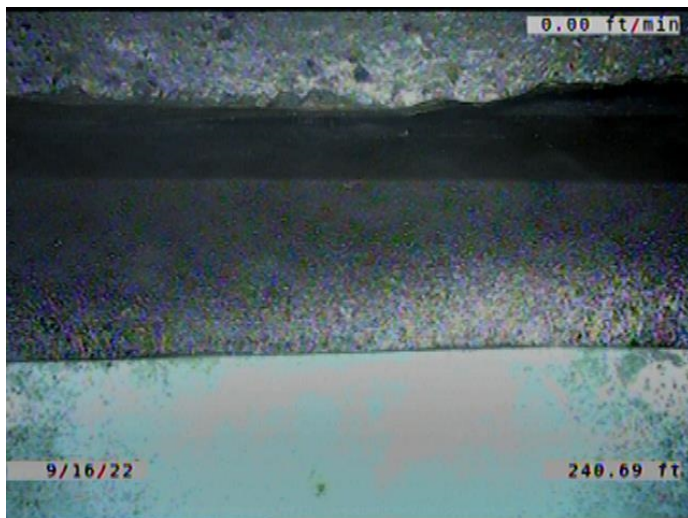
Code: **MMC**
Description: **Miscellaneous Material Change**

Distance (ft): **240.7**
Structural Grade: **0**
O&M Grade: **0**
Clock Start/From:
Clock To:
1st Value:
2nd Value:
Value Percent:
Continuous Index:
Within 8" of Joint: **NO**
Remarks: **VCP TO PVC**

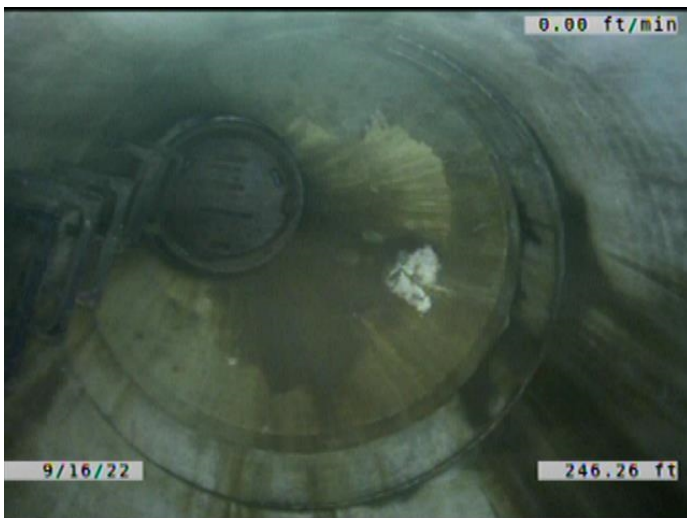
Code:	AMH
Description:	Manhole
Distance (ft):	246.3
Structural Grade:	0
O&M Grade:	0
Clock Start/From:	
Clock To:	
1st Value:	
2nd Value:	
Value Percent:	
Continuous Index:	
Within 8" of Joint:	NO
Remarks:	M-705-055
