Profile/Photo Observation Report

Date:	08/11/2022	Weather:		Coding:	PACP 7.0
Pipe Length (ft):	127.0	Owner:	City of Hobart	Pre Clean:	Heavy Cleaning
P.O.#:	YES502259	Surveyor:	S. Bucklin	PSR:	P-605-070-006
Customer:	City of Hobart	Clean Date:	08/01/2022	Shape:	C

Street:	Ellendale Street	Flow Control:	Not Controlled
City:	Hobart, IN	Year Renewed:	
Location:	Local rural streets with light traffic, t	Tape/Media #:	
Purpose:	Routine Assessment	Dia/Height:	12"
Use:	Sanitary Sewage Pipe	Material:	VCP
Drain Area:		Lining:	None
Category:	NA		
Comment:			
Location Details:		Direction of Survey:	Downstream
US MH:	M-605-006	DS MH:	M-605-070
		Total Length Surveyed (ft):	129.3

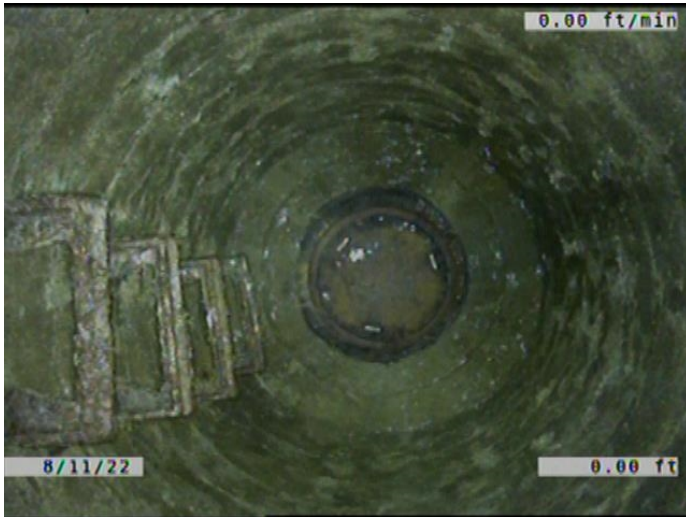
Code: **AMH**
Description: **Manhole**

Distance (ft): **.0**
Structural Grade: **0**
O&M Grade: **0**
Clock Start/From:
Clock To:
1st Value:
2nd Value:
Value Percent:
Continuous Index:
Within 8" of Joint: **NO**
Remarks: **M-605-006**

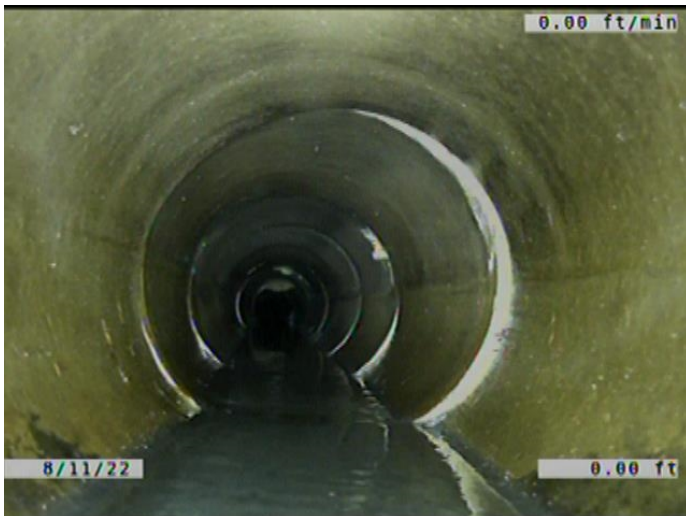
Code: **MWL**
Description: **Miscellaneous Water Level**

Distance (ft): **.0**
Structural Grade: **0**
O&M Grade: **0**
Clock Start/From:
Clock To:
1st Value:
2nd Value:
Value Percent: **5.000**
Continuous Index:
Within 8" of Joint: **NO**
Remarks:

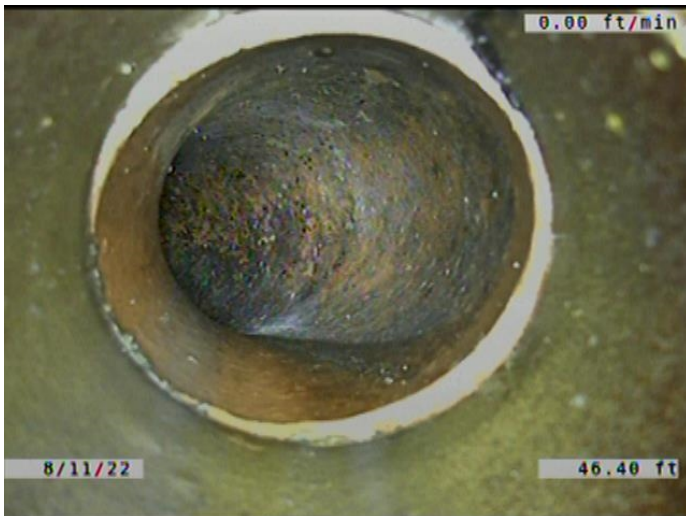
Code:	TB
Description:	Tap Break-in/Hammer
Distance (ft):	46.4
Structural Grade:	0
O&M Grade:	0
Clock Start/From:	12
Clock To:	
1st Value:	6.000
2nd Value:	
Value Percent:	
Continuous Index:	
Within 8" of Joint:	YES
Remarks:

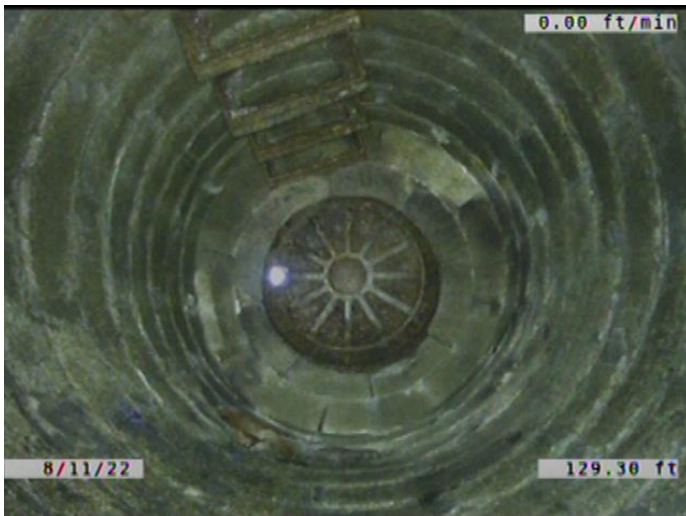
Code: **AMH**
 Description: **Manhole**

Distance (ft): **129.3**
 Structural Grade: **0**
 O&M Grade: **0**
 Clock Start/From:
 Clock To:
 1st Value:
 2nd Value:
 Value Percent:
 Continuous Index:
 Within 8" of Joint: **NO**
 Remarks: **M-605-070**
