Profile/Photo Observation Report

Date:	11/16/2021	Weather:		Coding:	PACP 7.0
Pipe Length (ft):	208.9	Owner:	City of Hobart	Pre Clean:	Heavy Cleaning
P.O.#:	YES502259	Surveyor:	S. Bucklin	PSR:	P-605-072-008
Customer:	City of Hobart	Clean Date:	11/16/2021	Shape:	C

Street:	South Ash Street	Flow Control:	Not Controlled
City:	Hobart, IN	Year Renewed:	
Location:	Local rural streets with light traffic, t	Tape/Media #:	
Purpose:	Routine Assessment	Dia/Height:	12"
Use:	Sanitary Sewage Pipe	Material:	VCP
Drain Area:		Lining:	None
Category:	NA		
Comment:			
Location Details:		Direction of Survey:	Downstream
US MH:	M-605-008	DS MH:	M-605-072
		Total Length Surveyed (ft):	208.9

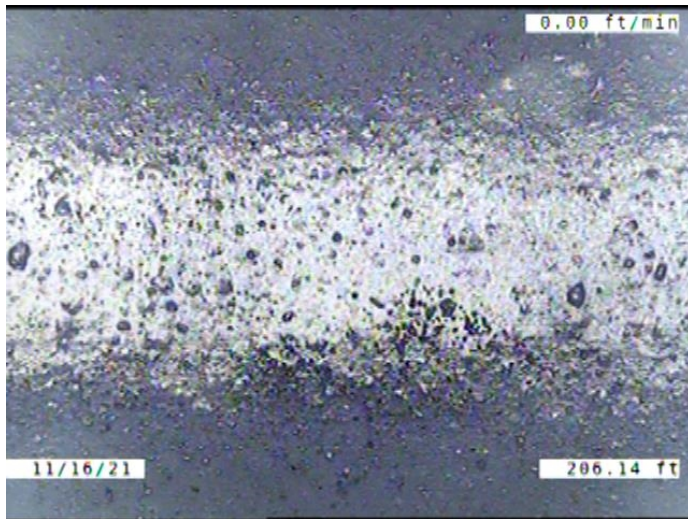
Code: **MCU**
 Description: **Miscellaneous Camera Underwater**

Distance (ft): **206.1**
 Structural Grade: **0**
 O&M Grade: **4**
 Clock Start/From:
 Clock To:
 1st Value:
 2nd Value:
 Value Percent:
 Continuous Index:
 Within 8" of Joint: **NO**
 Remarks: **Out at 207.5**

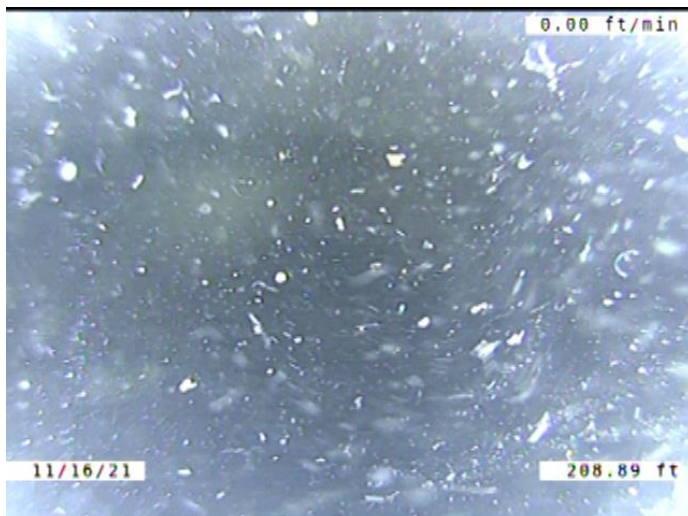
Code: **MGO**
 Description: **Miscellaneous General Observation**

Distance (ft): **208.9**
 Structural Grade: **0**
 O&M Grade: **0**
 Clock Start/From:
 Clock To:
 1st Value:
 2nd Value:
 Value Percent:
 Continuous Index:
 Within 8" of Joint: **NO**
 Remarks: **CAMERA UNDER WATER. OPENED THE MANHOLE COVER AND VERIFIE**
