Profile/Photo Observation Report

Date:	08/09/2022	Weather:		Coding:	PACP 7.0
Pipe Length (ft):	227.0	Owner:	City of Hobart	Pre Clean:	Heavy Cleaning
P.O.#:	YES502259	Surveyor:	S. Bucklin	PSR:	P-605-030-009
Customer:	City of Hobart	Clean Date:	07/29/2022	Shape:	C

Street:	South Connection Street	Flow Control:	Not Controlled
City:	Hobart, IN	Year Renewed:	
Location:	Local rural streets with light traffic, t	Tape/Media #:	
Purpose:	Routine Assessment	Dia/Height:	18"
Use:	Sanitary Sewage Pipe	Material:	VCP
Drain Area:		Lining:	None
Category:	NA		
Comment:			
Location Details:		Direction of Survey:	Downstream
US MH:	M-605-009	DS MH:	M-605-030
		Total Length Surveyed (ft):	225.5

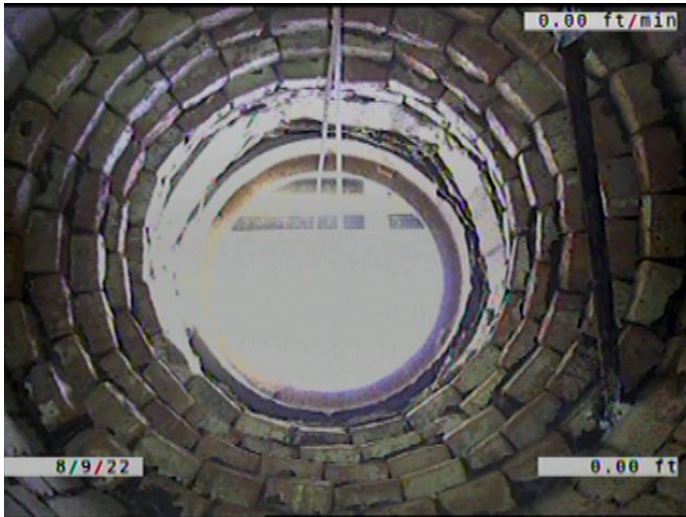
Code: **AMH**
Description: **Manhole**

Distance (ft): **.0**
Structural Grade: **0**
O&M Grade: **0**
Clock Start/From:
Clock To:
1st Value:
2nd Value:
Value Percent:
Continuous Index:
Within 8" of Joint: **NO**
Remarks: **M-605-009**

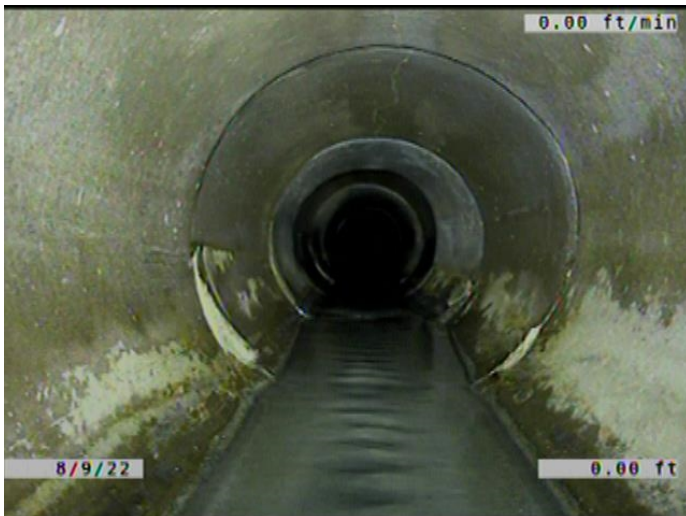
Code: **MWL**
Description: **Miscellaneous Water Level**

Distance (ft): **.0**
Structural Grade: **0**
O&M Grade: **0**
Clock Start/From:
Clock To:
1st Value:
2nd Value:
Value Percent: **5.000**
Continuous Index:
Within 8" of Joint: **NO**
Remarks:

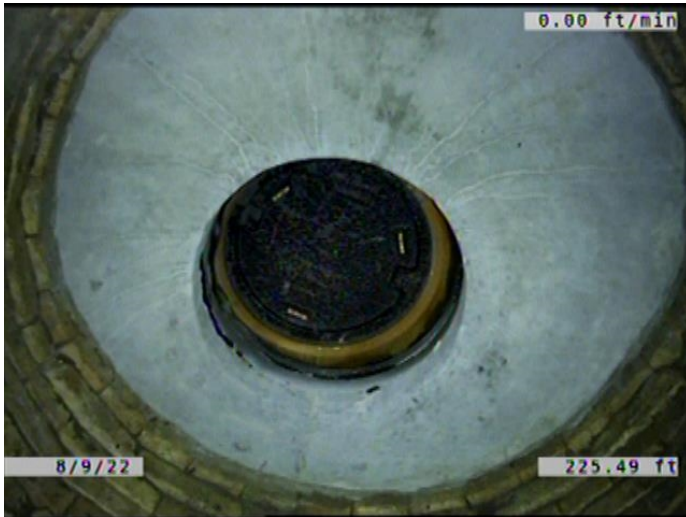
Code:	AMH
Description:	Manhole
Distance (ft):	225.5
Structural Grade:	0
O&M Grade:	0
Clock Start/From:	
Clock To:	
1st Value:	
2nd Value:	
Value Percent:	
Continuous Index:	
Within 8" of Joint:	NO
Remarks:	M-605-030
