Profile/Photo Observation Report

Date:	11/18/2021	Weather:		Coding:	PACP 7.0
Pipe Length (ft):	231.4	Owner:	City of Hobart	Pre Clean:	Heavy Cleaning
P.O.#:	YES502259	Surveyor:	S. Bucklin	PSR:	P-605-036-010
Customer:	City of Hobart	Clean Date:	11/17/2021	Shape:	C

Street:	South Pennsylvania Street	Flow Control:	Not Controlled
City:	Hobart, IN	Year Renewed:	
Location:	Local rural streets with light traffic, t	Tape/Media #:	
Purpose:	Routine Assessment	Dia/Height:	12"
Use:	Sanitary Sewage Pipe	Material:	VCP
Drain Area:		Lining:	None
Category:	NA		
Comment:			
Location Details:		Direction of Survey:	Downstream
US MH:	M-605-010	DS MH:	M-605-036
		Total Length Surveyed (ft):	231.4

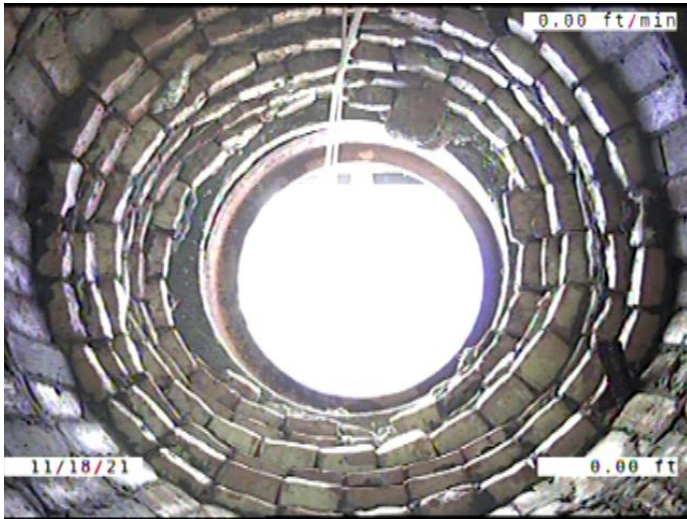
Code: **AMH**
Description: **Manhole**

Distance (ft): **.0**
Structural Grade: **0**
O&M Grade: **0**
Clock Start/From:
Clock To:
1st Value:
2nd Value:
Value Percent:
Continuous Index:
Within 8" of Joint: **NO**
Remarks: **M-605-010**

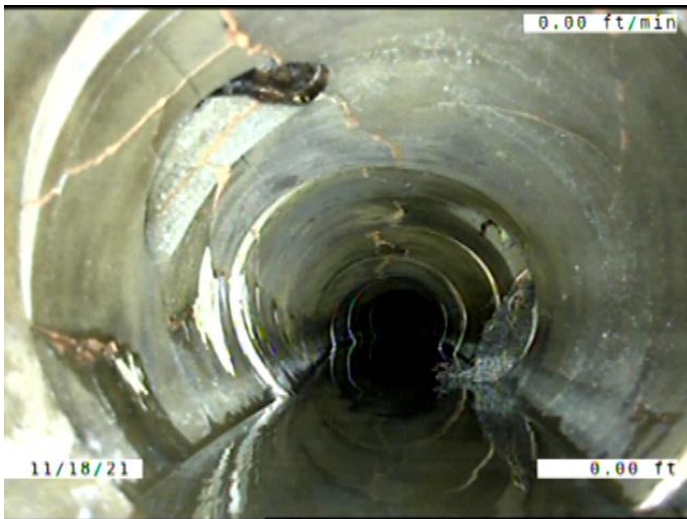
Code: **MWL**
Description: **Miscellaneous Water Level**

Distance (ft): **.0**
Structural Grade: **0**
O&M Grade: **0**
Clock Start/From:
Clock To:
1st Value:
2nd Value:
Value Percent: **5.000**
Continuous Index:
Within 8" of Joint: **NO**
Remarks:
