Profile/Photo Observation Report

Date:	11/18/2021	Weather:		Coding:	PACP 7.0
Pipe Length (ft):	231.4	Owner:	City of Hobart	Pre Clean:	Heavy Cleaning
P.O.#:	YES502259	Surveyor:	S. Bucklin	PSR:	P-605-036-010
Customer:	City of Hobart	Clean Date:	11/17/2021	Shape:	C

Street:	South Pennsylvania Street	Flow Control:	Not Controlled
City:	Hobart, IN	Year Renewed:	
Location:	Local rural streets with light traffic, t	Tape/Media #:	
Purpose:	Routine Assessment	Dia/Height:	12"
Use:	Sanitary Sewage Pipe	Material:	VCP
Drain Area:		Lining:	None
Category:	NA		
Comment:			
Location Details:		Direction of Survey:	Downstream
US MH:	M-605-010	DS MH:	M-605-036
		Total Length Surveyed (ft):	231.4

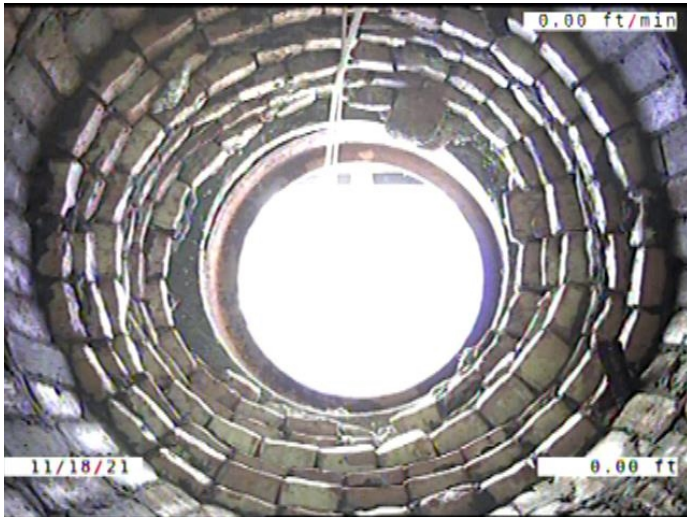
Code: **AMH**
 Description: **Manhole**

Distance (ft): **.0**
 Structural Grade: **0**
 O&M Grade: **0**
 Clock Start/From:
 Clock To:
 1st Value:
 2nd Value:
 Value Percent:
 Continuous Index:
 Within 8" of Joint: **NO**
 Remarks: **M-605-010**

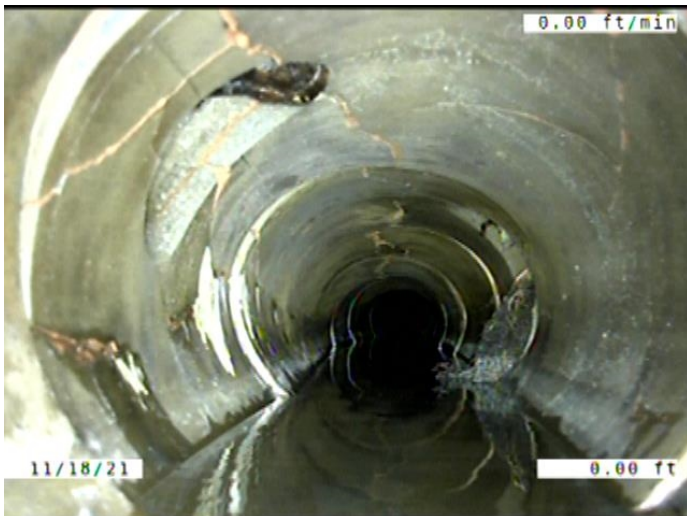
Code: **MWL**
 Description: **Miscellaneous Water Level**

Distance (ft): **.0**
 Structural Grade: **0**
 O&M Grade: **0**
 Clock Start/From:
 Clock To:
 1st Value:
 2nd Value:
 Value Percent: **5.000**
 Continuous Index:
 Within 8" of Joint: **NO**
 Remarks:

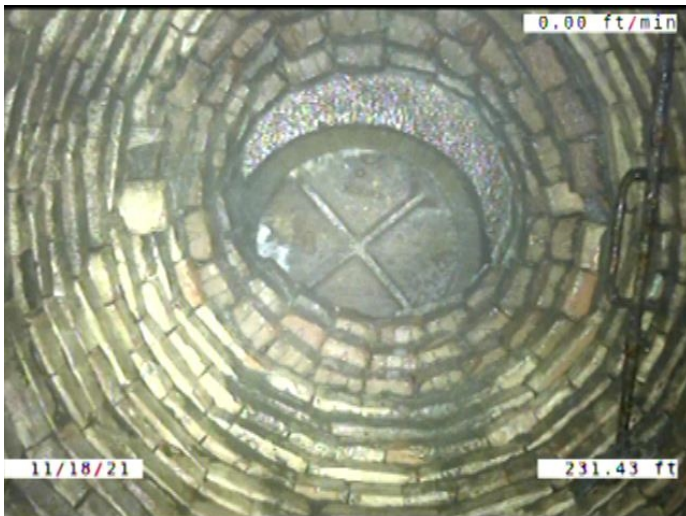
Code: **AMH**
 Description: **Manhole**

Distance (ft): **231.4**
 Structural Grade: **0**
 O&M Grade: **0**
 Clock Start/From:
 Clock To:
 1st Value:
 2nd Value:
 Value Percent:
 Continuous Index:
 Within 8" of Joint: **NO**
 Remarks: **M-605-036**
