Profile/Photo Observation Report

Date:	11/17/2021	Weather:		Coding:	PACP 7.0
Pipe Length (ft):	233.0	Owner:	City of Hobart	Pre Clean:	Heavy Cleaning
P.O.#:	YES502259	Surveyor:	S. Bucklin	PSR:	P-605-042-011
Customer:	City of Hobart	Clean Date:	11/17/2021	Shape:	C

Street:	South Washington Street	Flow Control:	Not Controlled
City:	Hobart, IN	Year Renewed:	
Location:	Local rural streets with light traffic, t	Tape/Media #:	
Purpose:	Routine Assessment	Dia/Height:	12"
Use:	Sanitary Sewage Pipe	Material:	VCP
Drain Area:		Lining:	None
Category:	NA		
Comment:			
Location Details:		Direction of Survey:	Downstream
US MH:	M-605-011	DS MH:	M-605-042
		Total Length Surveyed (ft):	127.6

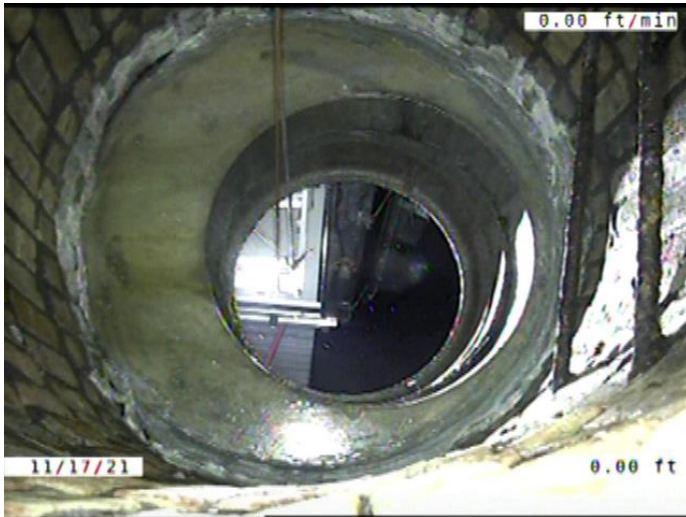
Code: **AMH**
Description: **Manhole**

Distance (ft): **.0**
Structural Grade: **0**
O&M Grade: **0**
Clock Start/From:
Clock To:
1st Value:
2nd Value:
Value Percent:
Continuous Index:
Within 8" of Joint: **NO**
Remarks: **M-605-011**

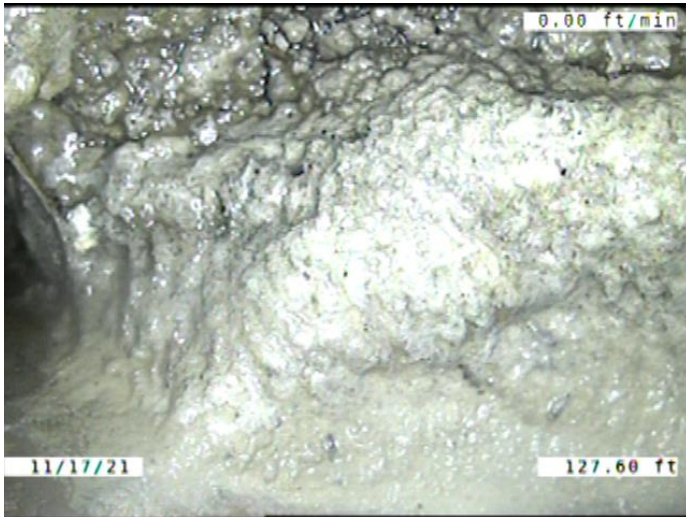
Code:	MSA
Description:	Miscellaneous Survey Abandoned
Distance (ft):	127.6
Structural Grade:	0
O&M Grade:	0
Clock Start/From:	
Clock To:	
1st Value:	
2nd Value:	
Value Percent:	
Continuous Index:	
Within 8" of Joint:	NO
Remarks:	M-605-042
