## Profile/Photo Observation Report

Date:	<b>11/17/2021</b>	Weather:		Coding:	<b>PACP 7.0</b>
Pipe Length (ft):	<b>233.0</b>	Owner:	<b>City of Hobart</b>	Pre Clean:	<b>Heavy Cleaning</b>
P.O.#:	<b>YES502259</b>	Surveyor:	<b>S. Bucklin</b>	PSR:	<b>P-605-042-011</b>
Customer:	<b>City of Hobart</b>	Clean Date:	<b>11/17/2021</b>	Shape:	<b>C</b>

Street:	<b>South Washington Street</b>	Flow Control:	<b>Not Controlled</b>
City:	<b>Hobart, IN</b>	Year Renewed:	
Location:	<b>Local rural streets with light traffic, t</b>	Tape/Media #:	
Purpose:	<b>Routine Assessment</b>	Dia/Height:	<b>12"</b>
Use:	<b>Sanitary Sewage Pipe</b>	Material:	<b>VCP</b>
Drain Area:		Lining:	<b>None</b>
Category:	<b>NA</b>		
Comment:			
Location Details:		Direction of Survey:	<b>Downstream</b>
US MH:	<b>M-605-011</b>	DS MH:	<b>M-605-042</b>
		Total Length Surveyed (ft):	<b>127.6</b>

O&M Index:	<b>2.18</b>	O&M Quick:	<b>372E</b>	O&M Rating:	<b>83.00</b>
Structural Index:	<b>3.58</b>	Structural Quick:	<b>514E</b>	Structural Rating:	<b>143.00</b>
Overall Index:	<b>2.90</b>	Overall Quick:	<b>514E</b>	Overall Rating:	<b>226.00</b>

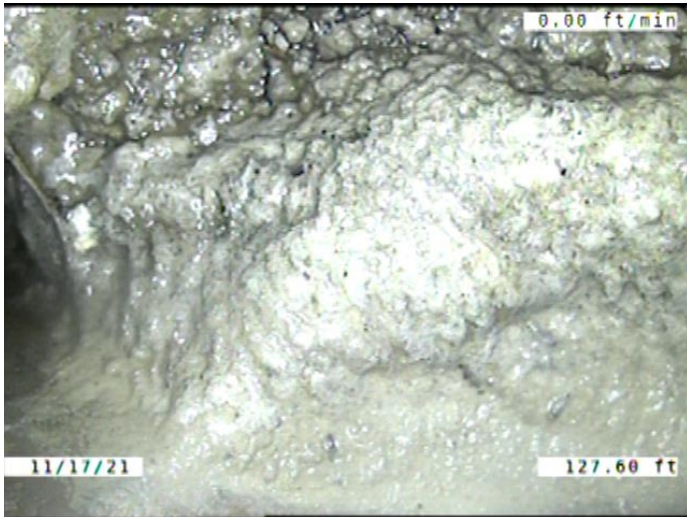
Code:	<b>MSA</b>
Description:	<b>Miscellaneous Survey Abandoned</b>
Distance (ft):	<b>127.6</b>
Structural Grade:	<b>0</b>
O&M Grade:	<b>0</b>
Clock Start/From:	
Clock To:	
1st Value:	
2nd Value:	
Value Percent:	
Continuous Index:	
Within 8" of Joint:	<b>NO</b>
Remarks:	<b>M-605-042</b>
