Profile/Photo Observation Report

| P.O.#: | YES502259 | Surveyor: | S. Bucklin | PSR: | P-605-016-015 |

| Street: | West 2nd Street | Flow Control: | Not Controlled |

| US MH: | M-605-015 | DS MH: | M-605-016 |

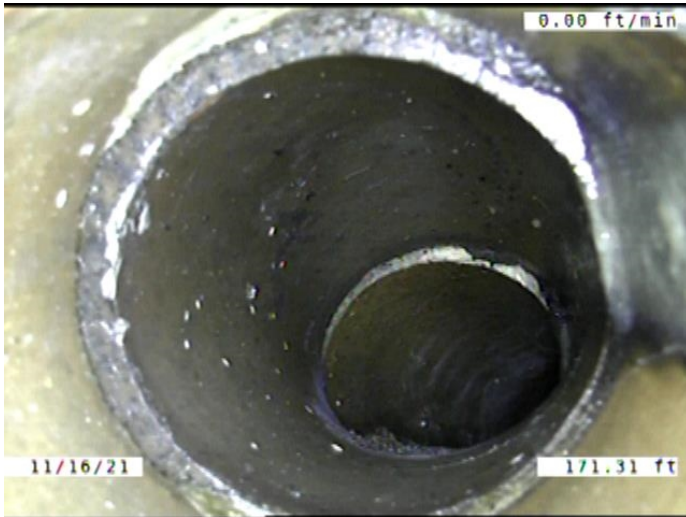
| | Position | Code | Observation | Video (sec) | Grade |
|--|---|---|---|---|---|
| | 159.8 | TBD | Tap Break-in/Hammer Defective | 1101 | M 3 |

Code: **TBD**
Description: **Tap Break-in/Hammer Defective**

Distance (ft): **159.8**
Structural Grade: **0**
O&M Grade: **3**
Clock Start/From: **11**
Clock To:
1st Value: **4.000**
2nd Value:
Value Percent:
Continuous Index:
Within 8" of Joint: **NO**
Remarks: **CONNECTION LOOKS TO BE BROKEN. ACTIVE TAP**

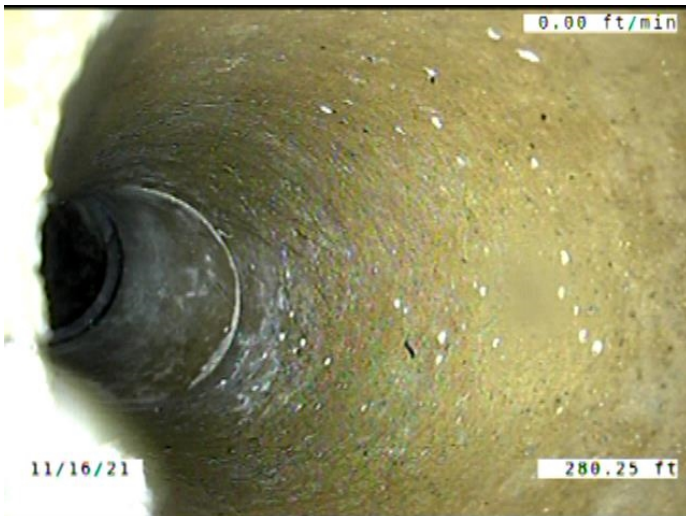
Code: **TB**
Description: **Tap Break-in/Hammer**

Distance (ft): **255.2**
Structural Grade: **0**
O&M Grade: **0**
Clock Start/From: **10**
Clock To:
1st Value: **4.000**
2nd Value:
Value Percent:
Continuous Index:
Within 8" of Joint: **NO**
Remarks: **ENCRUSTATION IN THE TAP**
