Profile/Photo Observation Report

Date:	10/19/2021	Weather:		Coding:	PACP 6.0
Pipe Length (ft):		Owner:	Hobart, IN	Pre Clean:	Not Known
P.O.#:	897_1	Surveyor:	M. Pielacha	PSR:	P-605-018-019
Customer:	Hobart, IN	Clean Date:		Shape:	C

Street:	Court Street	Flow Control:	
City:	Hobart, IN	Year Renewed:	
Location:	Light Highway	Tape/Media #:	897
Purpose:	Routine Assessment	Dia/Height:	10"
Use:	Sanitary	Material:	VCP
Drain Area:		Lining:	
Category:	NA		
Comment:

Location Details:		Direction of Survey:	Upstream
US MH:	M-605-18	DS MH:	M-605-19
		Total Length Surveyed (ft):	160.3

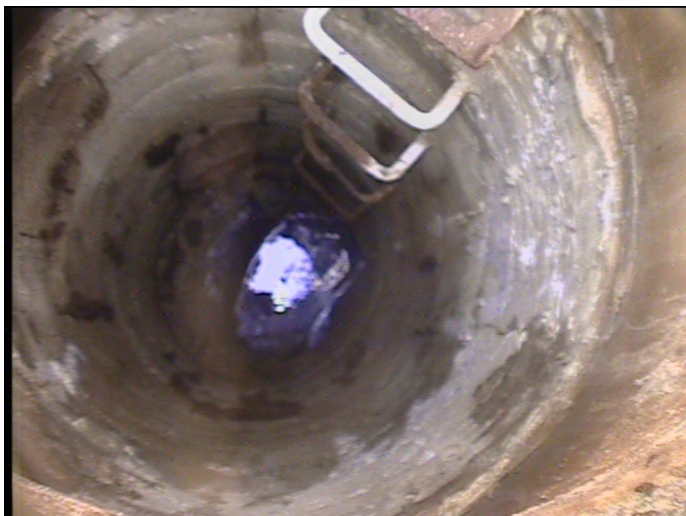
Code: **AMH**
 Description: **Manhole**

Distance (ft): **.0**
 Structural Grade: **0**
 O&M Grade: **0**
 Clock Start/From:
 Clock To:
 1st Value:
 2nd Value:
 Value Percent:
 Continuous Index:
 Within 8" of Joint: **NO**
 Remarks: **M-605-19**

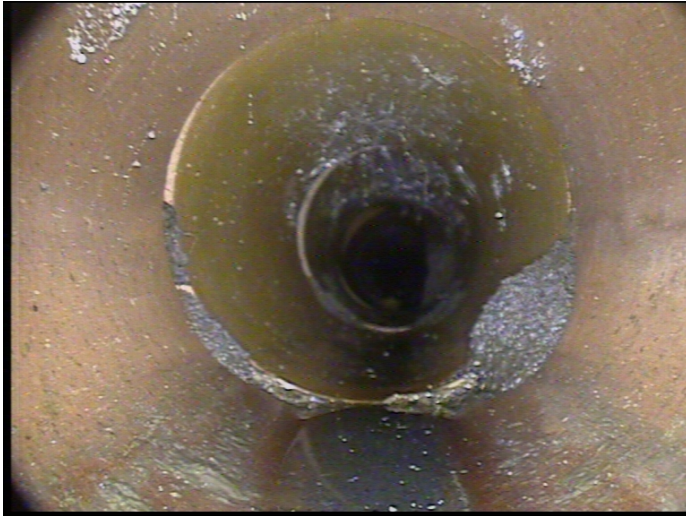
Code: **MWL**
Description: **Water Level**

Distance (ft): **.0**
Structural Grade: **0**
O&M Grade: **0**
Clock Start/From:
Clock To:
1st Value:
2nd Value:
Value Percent: **5.000**
Continuous Index:
Within 8" of Joint: **NO**
Remarks:

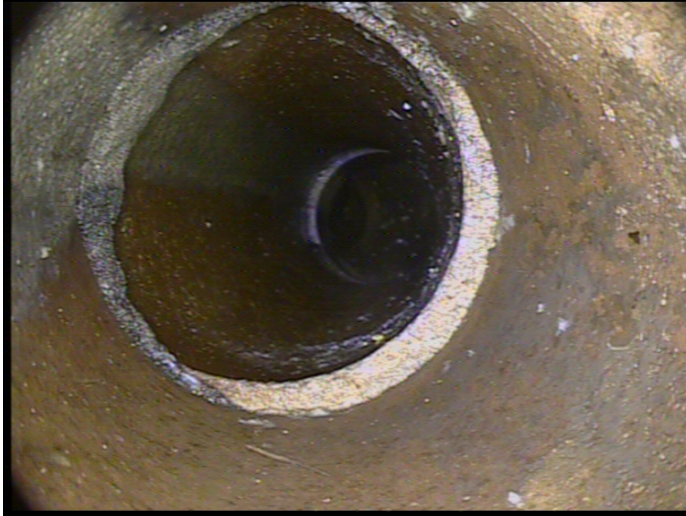
Code: **TF**
Description: **Tap Factory**

Distance (ft): **9.0**
Structural Grade: **0**
O&M Grade: **0**
Clock Start/From: **10**
Clock To:
1st Value: **4.000**
2nd Value:
Value Percent:
Continuous Index:
Within 8" of Joint: **NO**
Remarks:

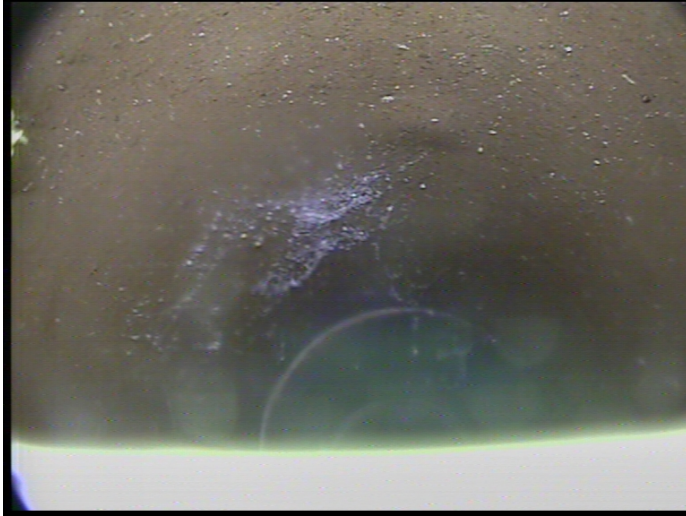
Code: **MWL**
Description: **Water Level**

Distance (ft): **63.1**
Structural Grade: **0**
O&M Grade: **0**
Clock Start/From:
Clock To:
1st Value:
2nd Value:
Value Percent: **40.000**
Continuous Index:
Within 8" of Joint: **NO**
Remarks:

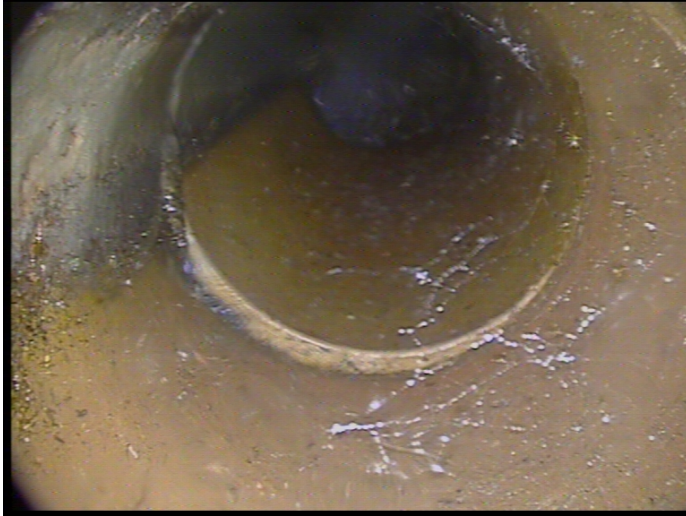
Code: **TF**
Description: **Tap Factory**

Distance (ft): **87.8**
Structural Grade: **0**
O&M Grade: **0**
Clock Start/From: **10**
Clock To:
1st Value: **4.000**
2nd Value:
Value Percent:
Continuous Index:
Within 8" of Joint: **NO**
Remarks:

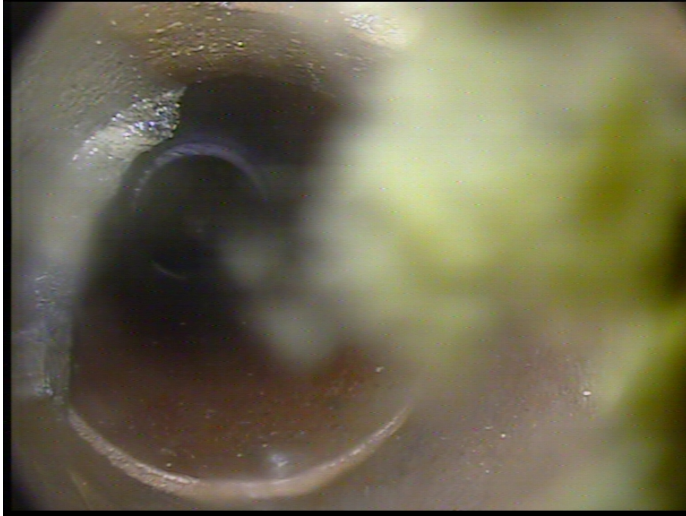
Code: **TF**
Description: **Tap Factory**

Distance (ft): **134.8**
Structural Grade: **0**
O&M Grade: **0**
Clock Start/From: **10**
Clock To:
1st Value: **4.000**
2nd Value:
Value Percent:
Continuous Index:
Within 8" of Joint: **NO**
Remarks:

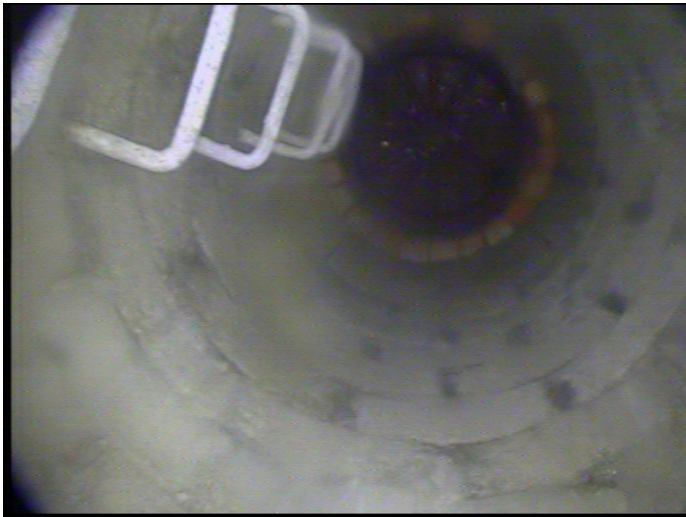
Code: **AMH**
Description: **Manhole**

Distance (ft): **160.3**
Structural Grade: **0**
O&M Grade: **0**
Clock Start/From:
Clock To:
1st Value:
2nd Value:
Value Percent:
Continuous Index:
Within 8" of Joint: **NO**
Remarks: **M-605-18**
